Student Research Report

**Main Mall Tree Inventory**

**Jane Ho**

**April 12, 2018**

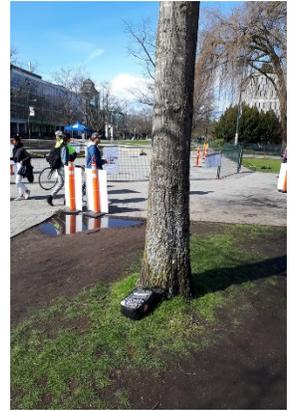
(figure 4). Therefore, the oaks located here are currently under a lot of stress. The two oaks that are closest to BIOL at the major intersection are assumed to be younger than most of the oaks on Main Mall based on their size. Since these trees are younger, they require frequent irrigation, especially within the root ball (Lilly et al., 2010). According to Lilly et al. (2010), one of the most important treatments following construction damage is maintaining adequate drainage and water supply to the root zone. Furthermore, they suggest that a “slow soaking of the entire root zone” is ideal for watering (Lilly et al., p.225, 2010). It is important to avoid watering directly or near the tree trunk and shallow watering should not be done to avoid shallow rooting (Lilly et al., 2010). Construction and maintenance operations can also cause water flow to be filled with pollutants and chemicals. Treatment of water is a consideration to be taken but one that is costly (Lilly et al., 2010). In addition, some tree defects that were noticed during inventory were girdling roots, cankers, and trunk injury. These defects disrupt the tree’s vascular system (Lilly et al., 2010).

*Figure 4: This tree is located at a busy intersection and by construction. Photo taken by Jane Ho on March 27, 2018.*

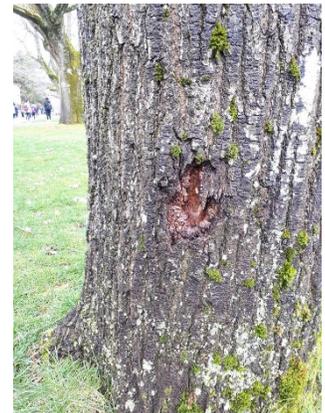
*Figure 5: Many trees had cracks that may result from mechanical damage or vandalism. Photo taken by Jane Ho on March 27, 2018.*

A number of trees had cracks that are most likely to have resulted from mechanical damage. Young and newly planted oaks should be protected from this kind of damage as it can affect future growth conditions. Installing a temporary metal tree guard around the trunk would be a solution. Tree guards can also discourage vandalism and feeding by some animals (Lilly et al., 2010).

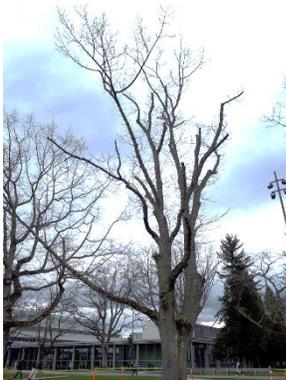
*Figure 6: Large codominant stems were often spotted for the trees on Main Mall. Photo taken by Jane Ho on March 25, 2018.*

A number of oaks lacked a central leader and codominant stems were a trait obvious for some trees (figure 6). Oaks are more susceptible to codominant stems (Andra, 2018). Codominant stems indicate a weakened part of the tree. If the conditions ignored major concerns are branch tear out and insect infiltration (Andra, 2018). Further, Andra (2018) adds that untreated codominant stems will eventually push themselves against each other until the weaker side splits off from the trunk. The installation of static cabling systems can help to support these trees or bracing can be done in combination with cabling (Lilly et al., 2010).

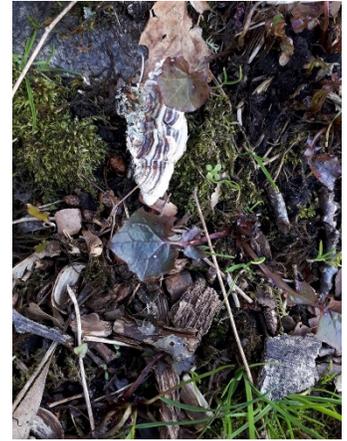
During inventory, there were signs of root pathogens, cankers and fungi spotted. Identification of species is referenced from online resources. A university arborist reported that there was turkey tail fungus on the oaks but signs would be most evident high up in the crown. I had also spotted the fruiting body on a tree near the BIOL (figure 7). They are able to colonize plants stressed by water shortage, sunburn, damage, or wounding (Hickman et al., 2011). It is a common decay for hardwoods and invades the cambium layer of trees to accelerate a tree's demise (Lee, 2013). There was a lack of information online about the management of turkey tail but research shows that the fungus has great cultural value. Glaeser and Smith (2010) advises sanitation pruning to remove infected branches and to prevent spread.

Figure 7: *Trametes versicolor* fruiting body. Photo taken by Jane Ho on March 25, 2018.

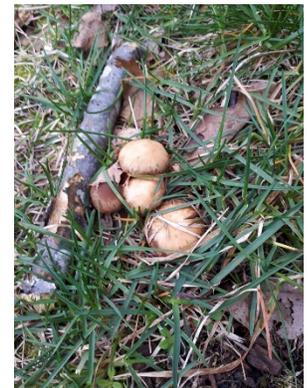
For one to two trees, tan coloured mushrooms in clusters were seen in the rooting zone (figure 8). It is assumed that the observed fungus is Armillaria root disease (*Armillaria spp.*); however, further examination of the tree is needed to confirm the fungus species. Symptoms of Armillaria root rot include reduced height, chlorosis, chronosequence, resinosis, rapid tree death for saplings, and production of stress crop (Hamelin, 2017). One management strategy would be reducing the inoculum by stumping. This effective method dries out the roots and the fungus. The downside of this method is that it is quite costly.

Figure 8: Fruiting body of fungus believed to be *Armillaria*. Photo taken by Jane Ho on March 25, 2018.

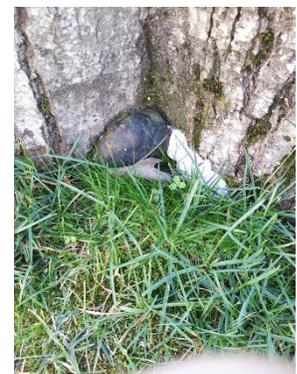
There is one type of canker observed that may be the *Nectria* (*Nectria spp.*) canker. The oval layered appearance of the canker is a characteristic of *Nectria* species. The canker invades the tree while it is dormant and as the tree attempts to seal off the fungus, a canker scar forms (Burke, 2017). Another sign of the fungus

body that was spotted on a few occasions. Photo taken by Jane Ho on March 18, 2018.

are red orange fruiting bodies (Burke, 2017). Although I did see red orange stains, they did not look like fruiting bodies. For young oaks, the canker can girdle, kill or increase susceptibility to winds (Arbor Consulting, 2003). Control of this canker can be done by minimizing pruning during wet weather, avoiding pruning wounds, removing cankered branches, and sterilizing pruning tools before pruning uninfected trees (Arbor Consulting, 2003).

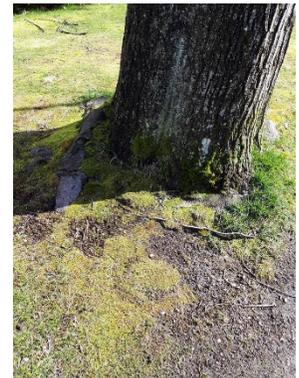
*Figure 10: Girdling roots.  
Photo taken by Jane Ho on  
March 27, 2018.*

A few trees have demonstrated girdling roots (figure 10). Girdling can be dealt with by removing the portion of the root that is in contact with the stem (Lilly et al., 2010). If girdling is severe enough to impact the structural stability of the tree, it may have to be removed (Lilly et al., 2010). Ultimately, Lilly et al., (2010) says the most efficient way to deal with girdling roots is to prevent them from occurring. This can be done through loosening up the roots during planting and making sure the soil is not too packed when a tree is being planted.
