# Everett Crowley Park

An assessment of current and future restoration efforts

Greenest City Scholar  
Vancouver Park Board

Completed by Lorraine Campbell  
August 2017

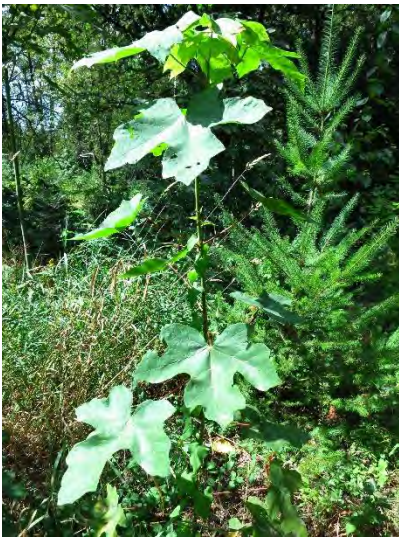
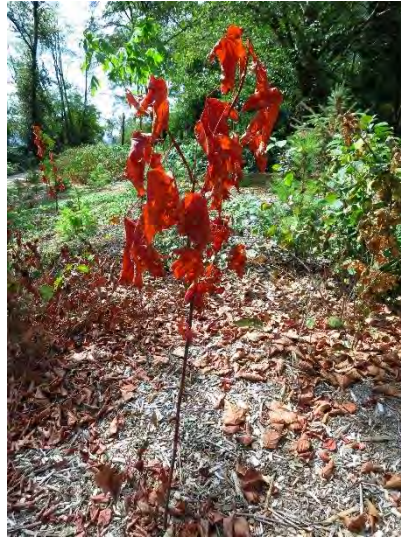
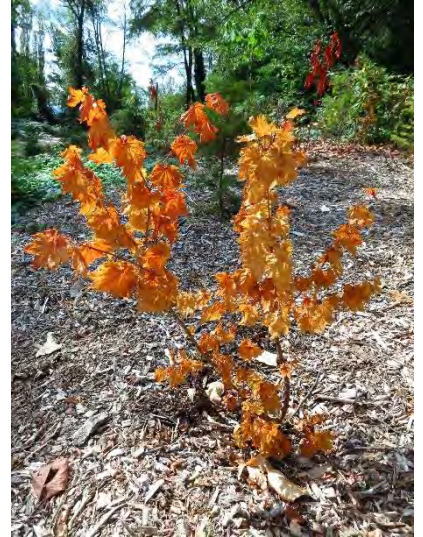
Overall, plant health and sapling survival of planted trees and shrubs of average or above average health on all sites. The greatest problem observed was that on drier sites the maples seemed to be suffering (e.g., site 2016 b) as indicated by 5 maples (1 big leaf and 4 vine) appearing to have died over the dry summer observation period. Shrubs were also, overall, in good health and seemed to be surviving. Shrub species such as rose, thimbleberry, red osier dogwood, ocean spray and snowberry were not within every planted site but seem to be surviving where they have been planted. It is unclear how they will fare within the shade of their neighbours when the trees grow.

A healthy big leaf maple sapling (left), a dead big leaf maple (middle) and a dead vine maple (right)

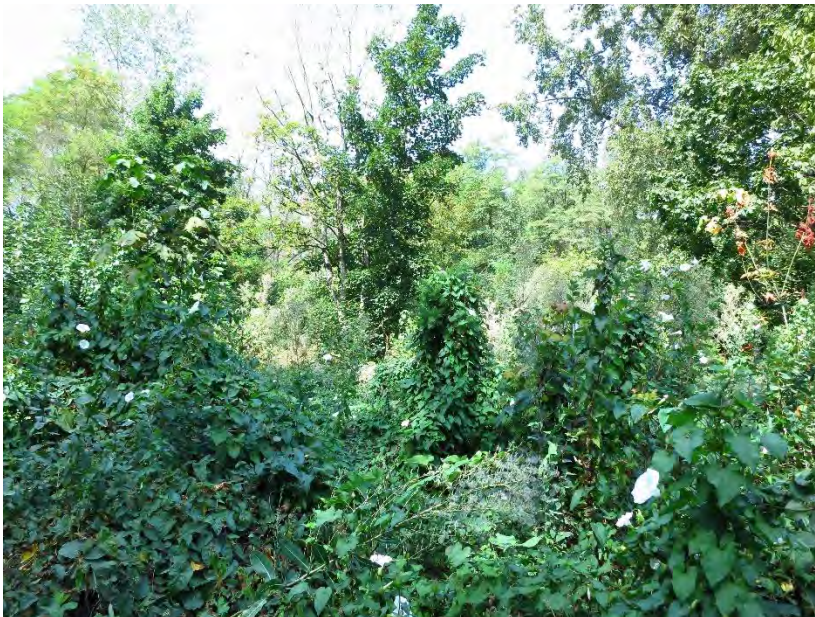
As would be expected, on the older sites (e.g. 2009) have the most growth and invasive plant encroachment. Immediate work is required on these sites or many of the planted shrubs and trees will be lost. There is no evidence that the 2009 sites had mulch put down after the sites were cleared. This could be influencing the heavy growth of weeds and invasive plants on these sites.

Invasive plant encroachment in a 2009 restoration site

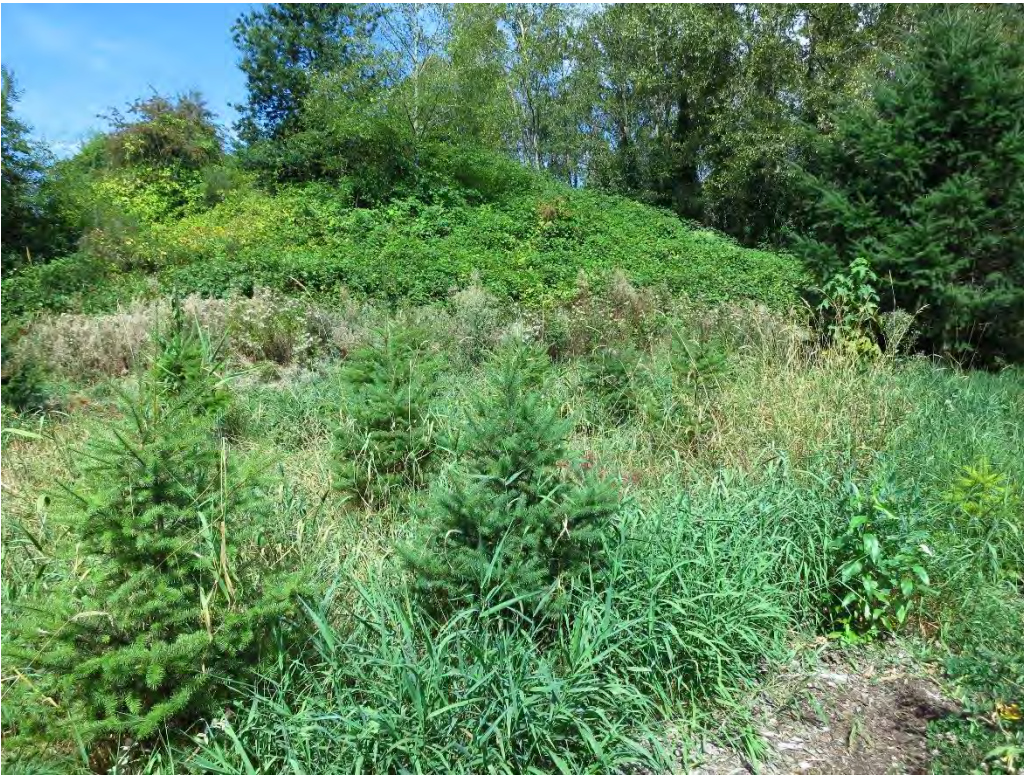
Site 2016a with morning glory covering the ground and climbing several young trees. Blackberry on the periphery of the site is thick and starting to spread into the site.

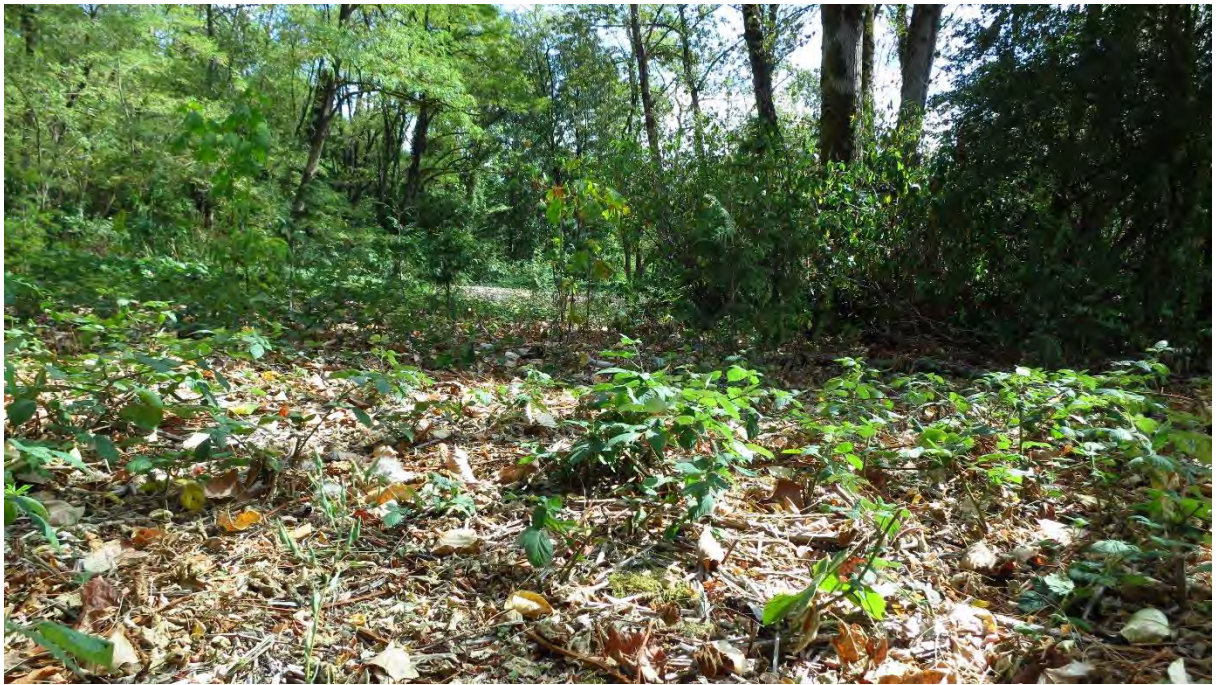
Site 2016c with blackberry stalks across the ground. Matting and climbing is minimal and maintenance of the site would be quick and uncomplicated

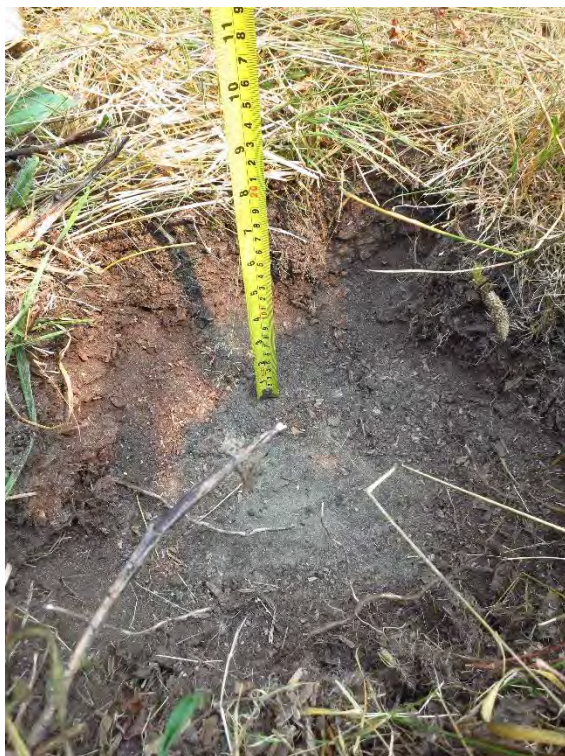
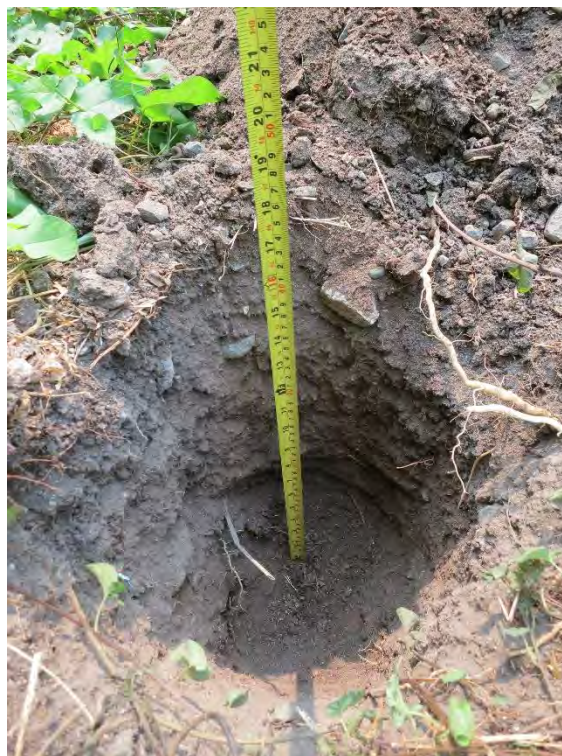
Soil pits for restoration sites 2009 a (left) and 2009 b (right)

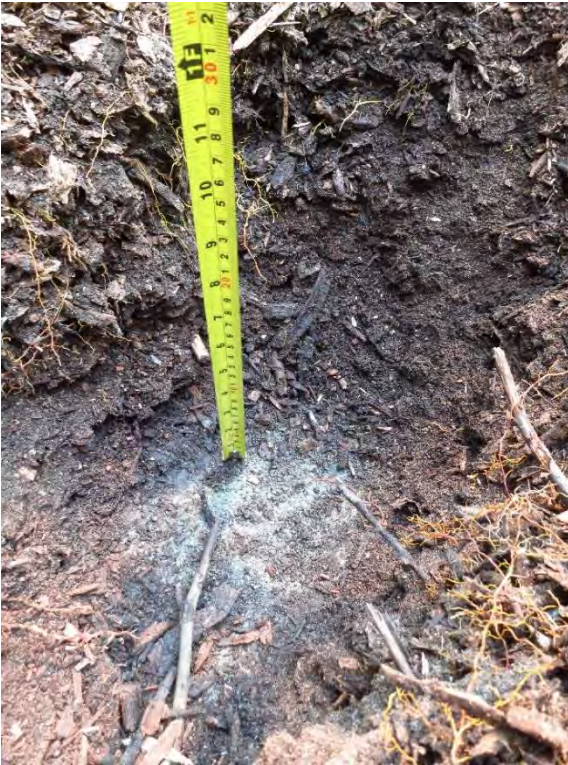
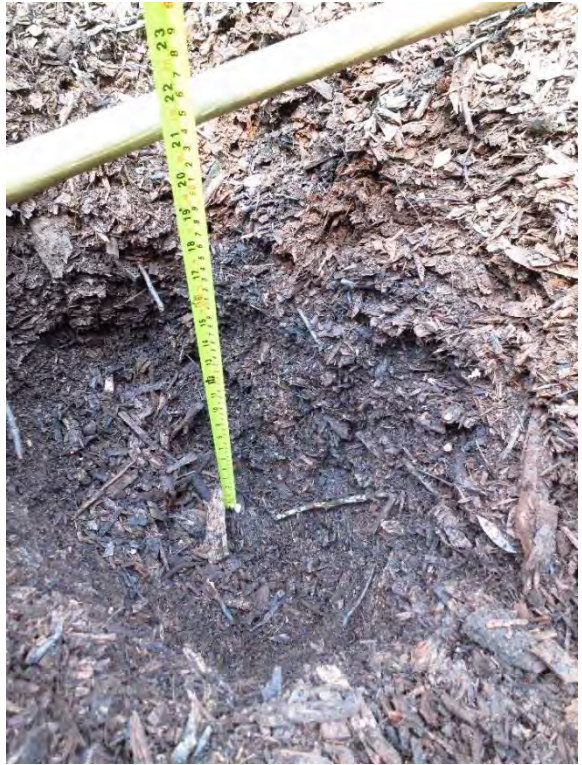
Soil pits for restoration sites 2015 a (left) and 2015 b (right)

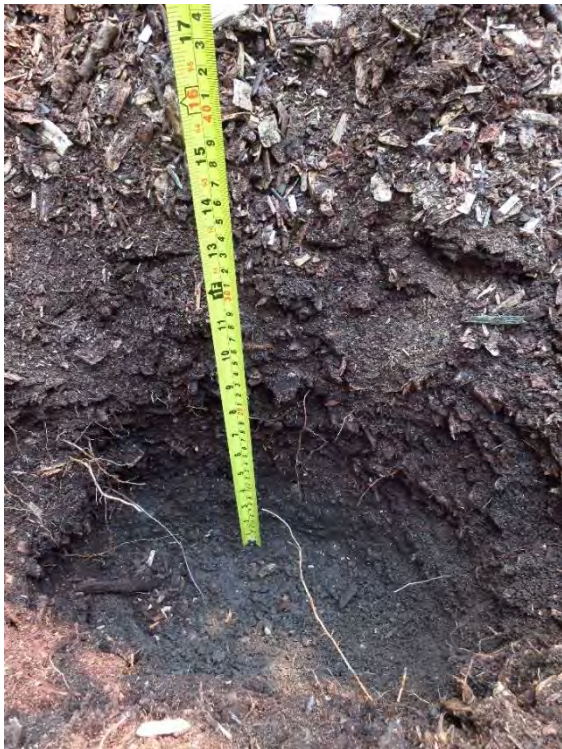
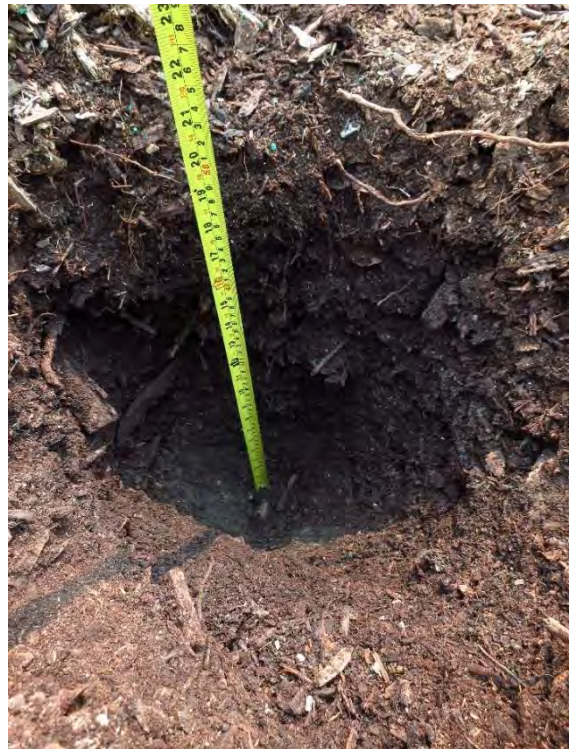
Soil pits for restoration sites 2016 a (left) and 2016 d(right)

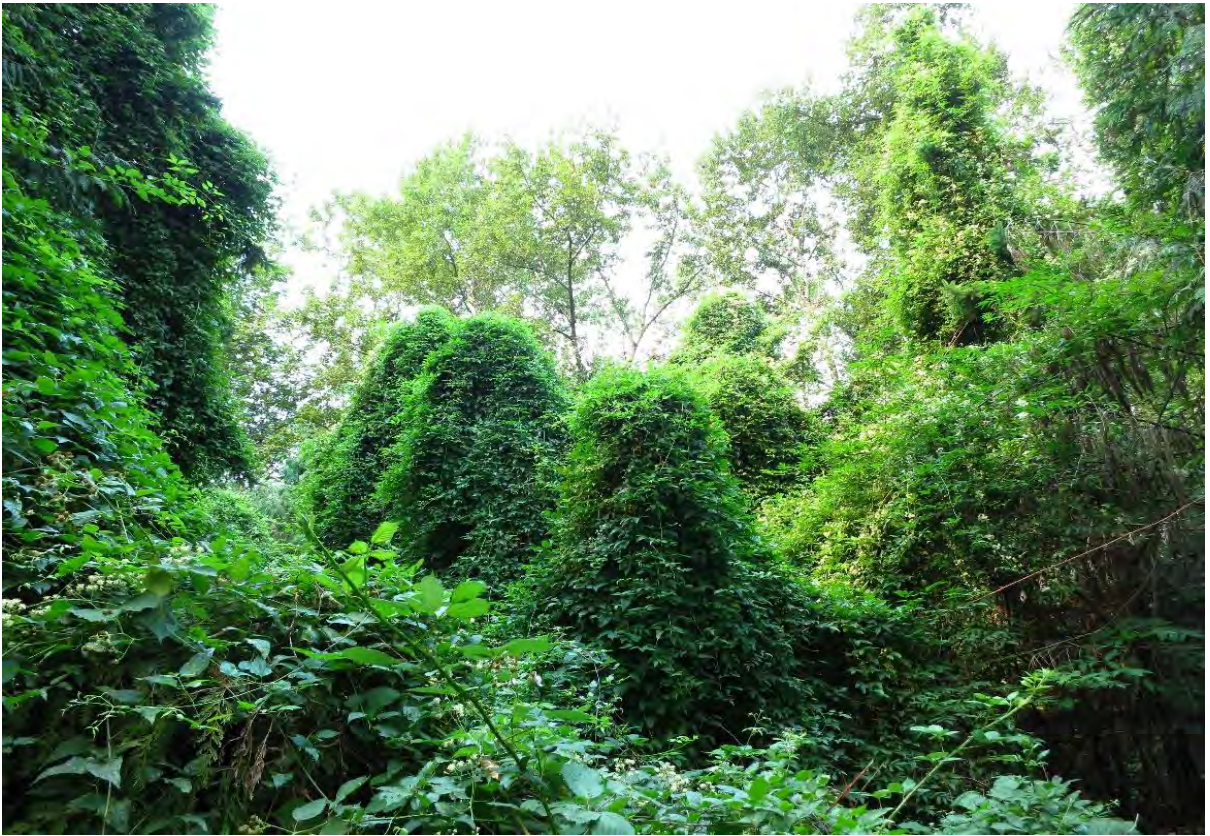
When walking along the primary and secondary trails, there are blackberry, morning glory, clematis, English ivy or knotweed problems almost consistently. These species grow in thickets and/or dense vines that climb and overtake native plants (see photo on following page). There are few areas unaffected by invasive plants and virtually all areas will require attention at some point. The west area of the park where underplanting was done in 2015, as well as the east side of the park near Avalon Pond and the outflow stream, in general, seem to be slightly more open and less affected by invasive plants. The south slopes have minimal canopy cover and are thick with blackberry. These slopes also are likely to have thinner, less developed soils.

Morning glory completely overtaking trees within ECP

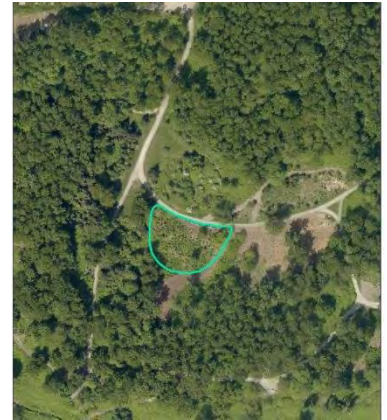
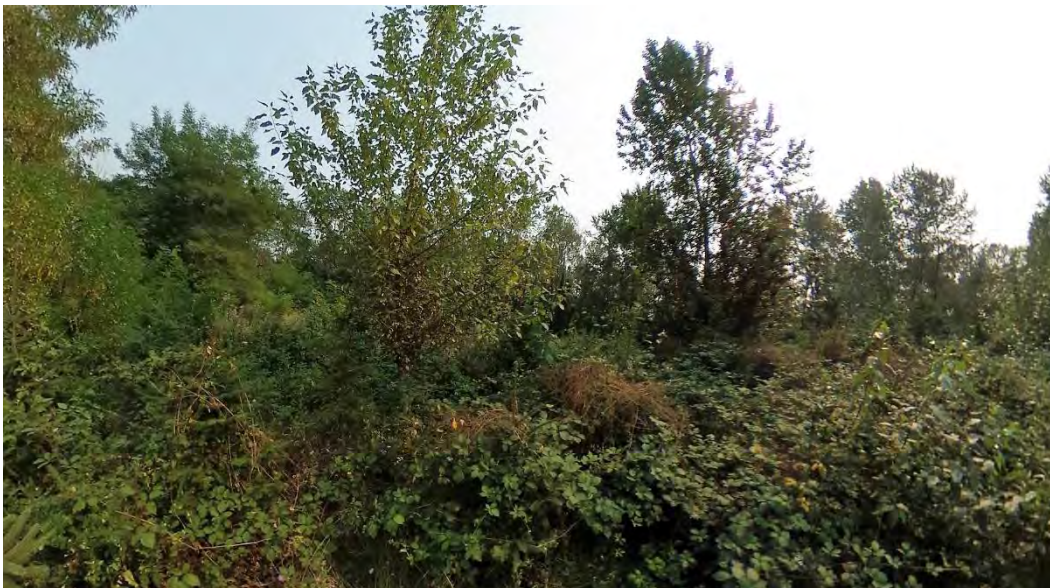
**Conditions:** Limited natural regeneration occurring, likely, because invasive plants have matted the floor. Immediate attention required on this site involving manual brushing and pulling before natives that are still surviving succumb to smothering

- Cleavers; smothering and covering many saplings
- Himalayan blackberry; abundant and smothering small saplings and covering the floor
- Morning glory; abundant and smothering small saplings and covering the floor
- Black locust; a few smaller trees
- Knotweed; creeping in from stand outside of plot
- ❖ South end has complete smothering by blackberry, cleavers and morning glory

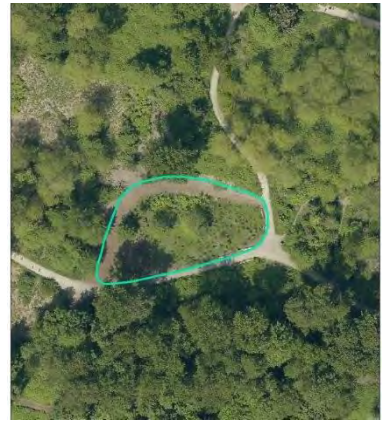
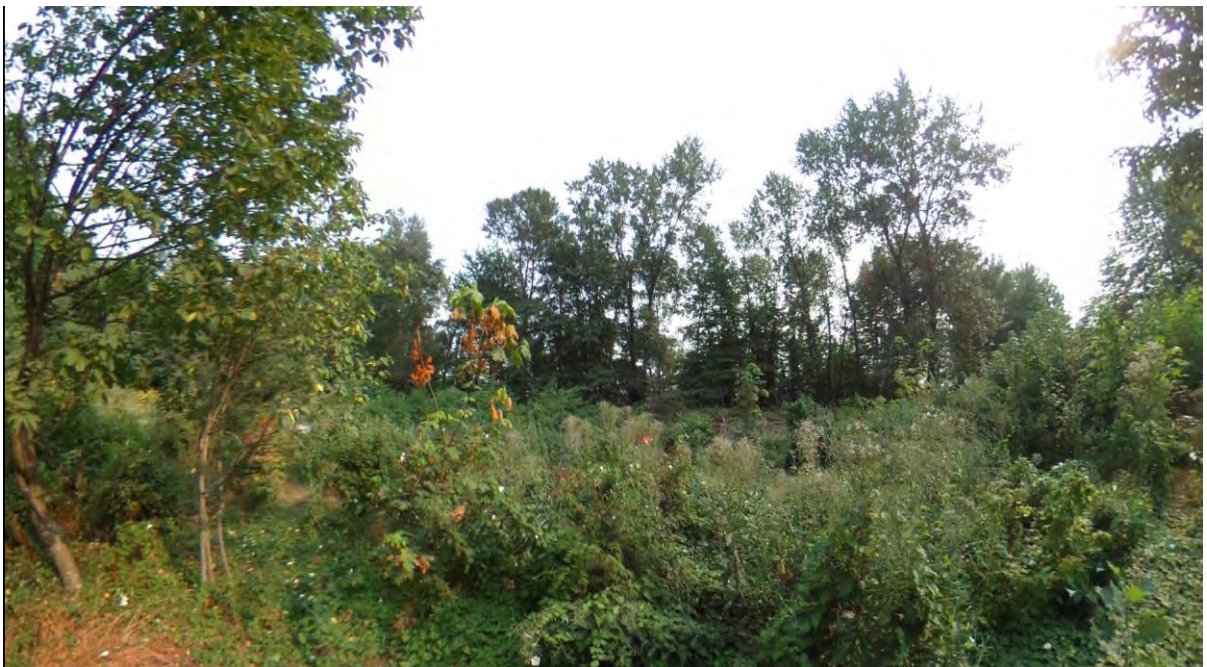
## 2009 b

**Conditions:** All trees/shrubs in the plot are battling with weeds and invasives. This site has a lot of diversity and many native plants; however, it is extremely overgrown. Worth the effort to clean up manually.

- Cleaver; abundant in NE end especially
- Himalayan blackberry; surprisingly little amounts
- Maple (sycamore?); large tree in plot producing many seedlings
- Morning glory; so thick in places that it is hard to even know what or if something is under it. It is thick amongst the snowberry.
- ❖ Various weeds and grasses

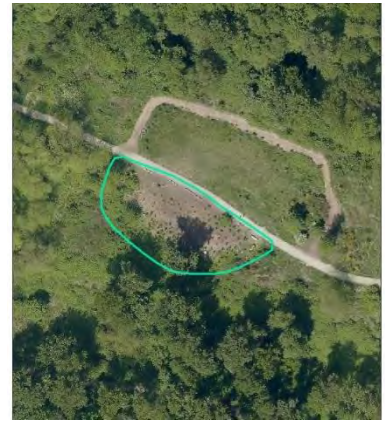
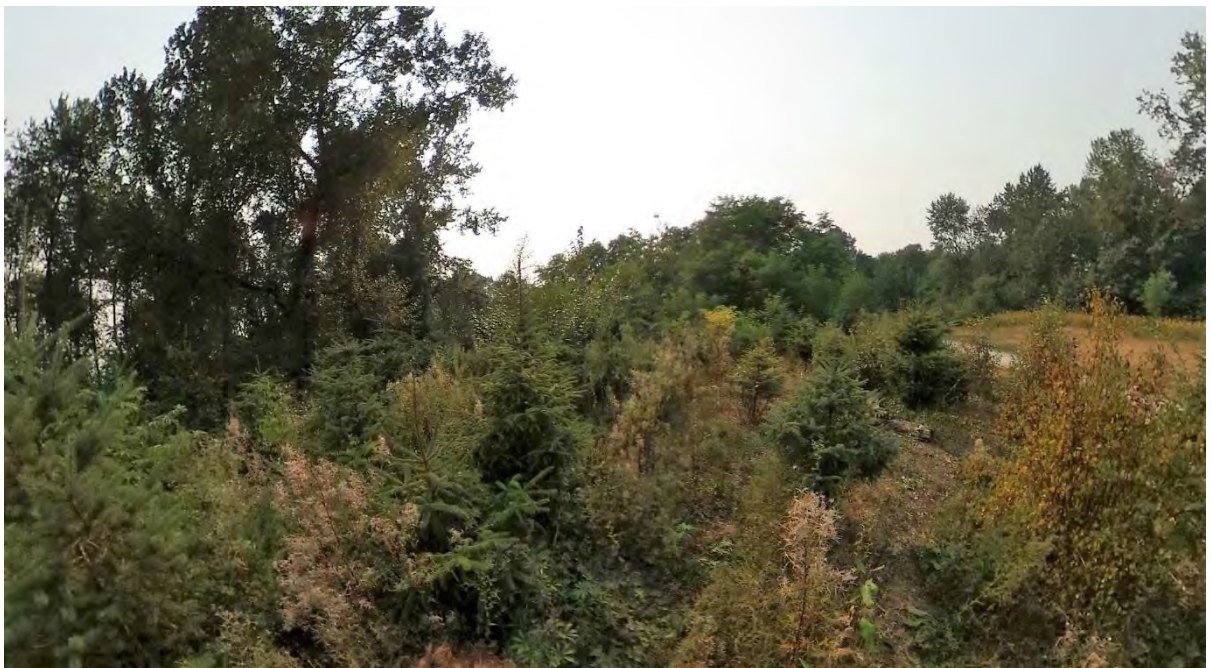
## 2009 c

**Conditions:** All trees/shrubs in the plot are battling with weeds and invasive plants

- Black locust
- Cleaver
- Himalayan blackberry; patches throughout and growing up onto many of the trees (e.g. Sitka spruce)
- Knotweed; signs of recent treatment
- Morning glory
- Various weeds and grasses
- Scotch

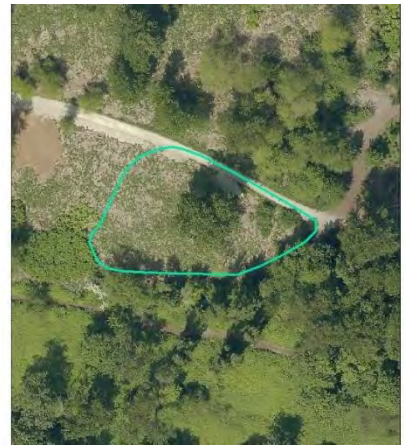
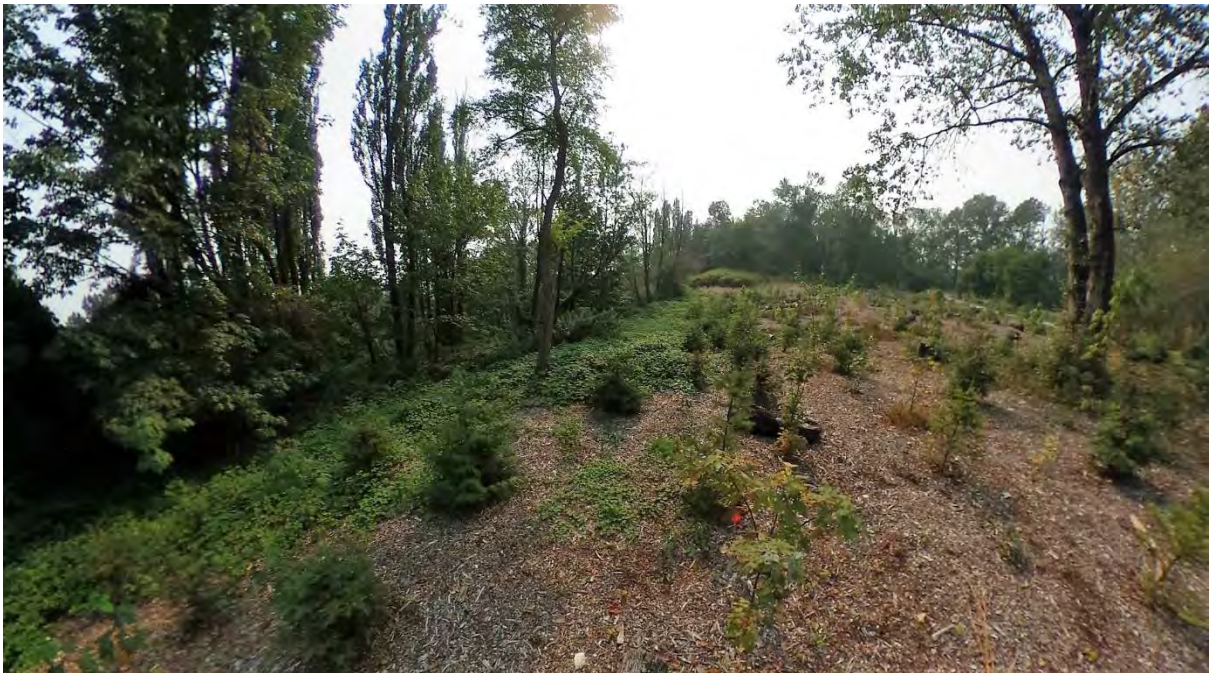
## 2015 b

**Conditions:** Mostly clear of invasive plants but some are starting to re-establish, especially in the south end

- Himalayan blackberry; floor on the south end of site is completely covered
- Morning glory, patch around elderberry in NE corner
- Scotch broom
- ❖ North end mostly clear except for the occasional invasive shooting up.
- ❖ Unknown woody species is quite abundant and appears to have killed 5 or more saplings, potentially by shading

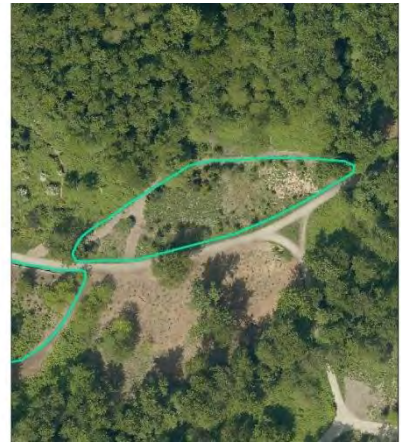
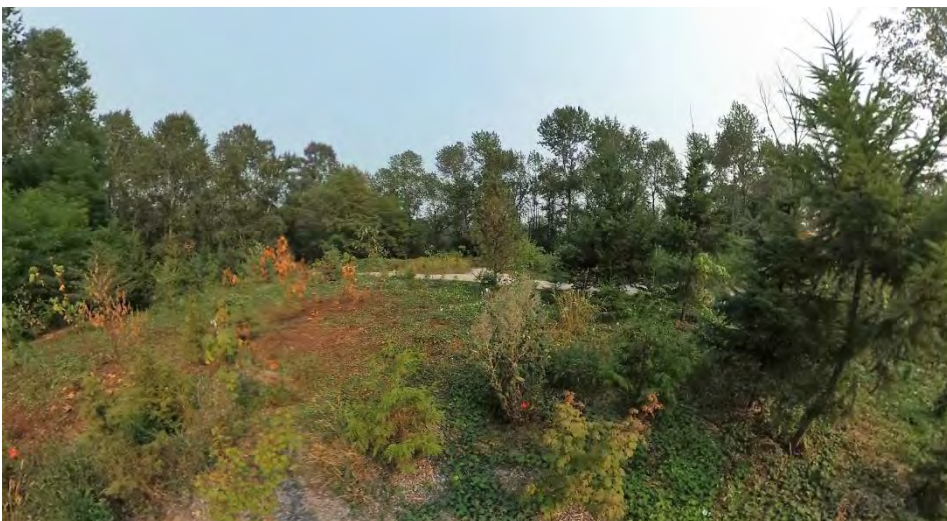
## 2016 a

**Conditions:** This site has a large area that has died. After a conversation with park workers they said that it had been covered in morning glory, which they cleared, after this clearing everything turned brown and most saplings (maples, alder etc.) have appeared to have died.

- Himalayan blackberry creeping in from outside plot (it covers adjacent slopes of Mt. Everett). Some has been cut down in the NW corner and is starting to re-sprout.
- Morning glory; abundant throughout site and covering most of the floor. It is smothering many of the Douglas-fir and other species
- Scotch broom scattered throughout the plot

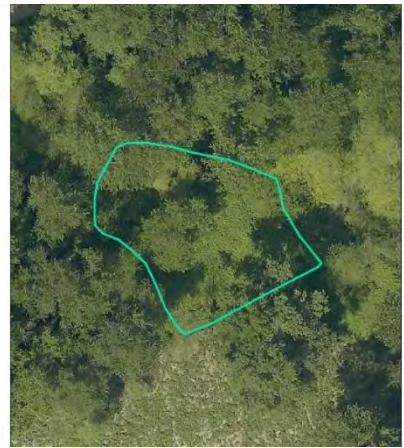
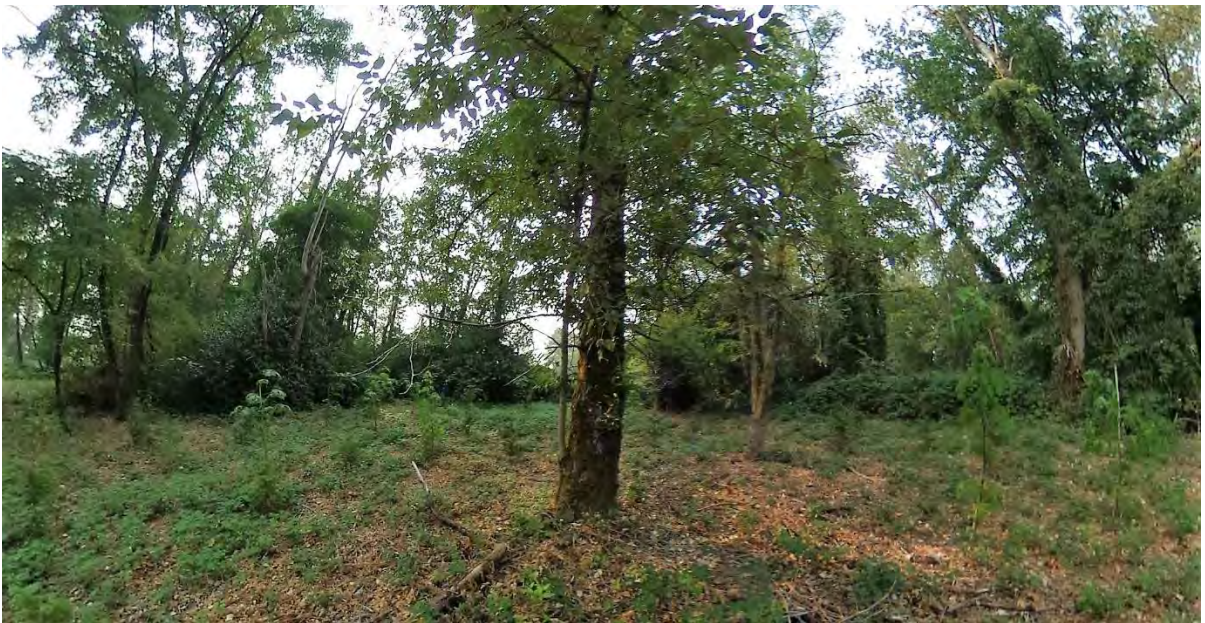
## 2016 c

**Conditions:** Blackberry has not started to grow as a vine, it is mostly sporadic shoots throughout the site

- Himalayan blackberry; predominantly covering entire floor in new shoots. Not spreading in vine form very much yet.
- Morning glory
