Everett Crowley Park

An assessment of current and future restoration efforts

Greenest City Scholar
Vancouver Park Board

Completed by Lorraine Campbell
August 2017

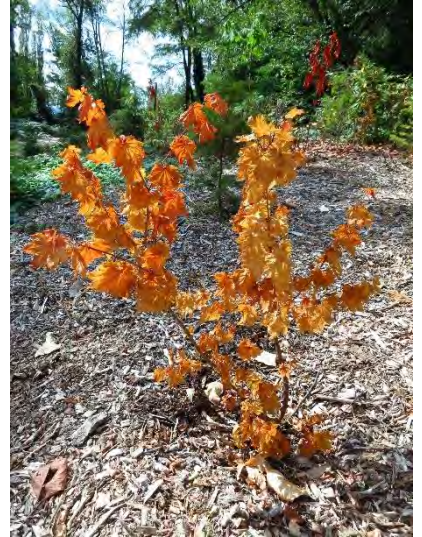
Overall, plant health and sapling survival of planted trees and shrubs of average or above average health on all sites. The greatest problem observed was that on drier sites the maples seemed to be suffering (e.g., site 2016 b) as indicated by 5 maples (1 big leaf and 4 vine) appearing to have died over the dry summer observation period. Shrubs were also, overall, in good health and seemed to be surviving. Shrub species such as rose, thimbleberry, red osier dogwood, ocean spray and snowberry were not within every planted site but seem to be surviving where they have been planted. It is unclear how they will fare within the shade of their neighbours when the trees grow.

A healthy big leaf maple sapling (left), a dead big leaf maple (middle) and a dead vine maple (right)

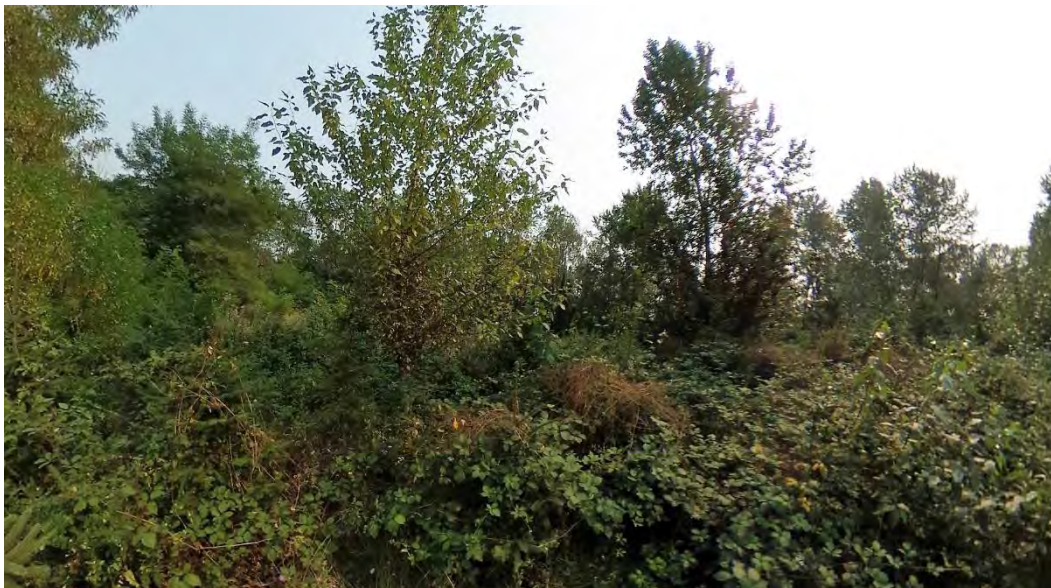
Conditions: Limited natural regeneration occurring, likely, because invasive plants have matted the floor. Immediate attention required on this site involving manual brushing and pulling before natives that are still surviving succumb to smothering

- Cleavers; smothering and covering many saplings
- Himalayan blackberry; abundant and smothering small saplings and covering the floor
- Morning glory; abundant and smothering small saplings and covering the floor
- Black locust; a few smaller trees
- Knotweed; creeping in from stand outside of plot
- ❖ South end has complete smothering by blackberry, cleavers and morning glory

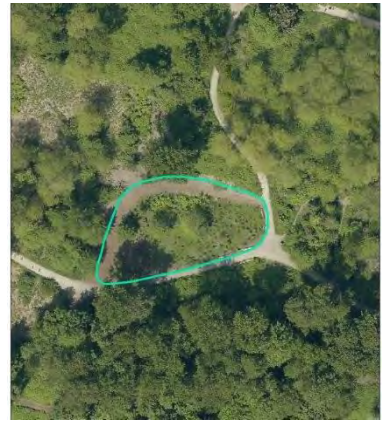
2009 b

Conditions: All trees/shrubs in the plot are battling with weeds and invasives. This site has a lot of diversity and many native plants; however, it is extremely overgrown. Worth the effort to clean up manually.

- Cleaver; abundant in NE end especially
- Himalayan blackberry; surprisingly little amounts
- Maple (sycamore?); large tree in plot producing many seedlings
- Morning glory; so thick in places that it is hard to even know what or if something is under it. It is thick amongst the snowberry.
- ❖ Various weeds and grasses

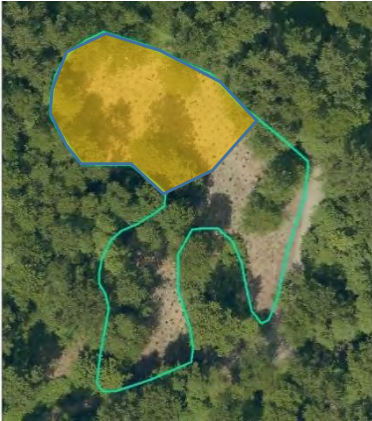
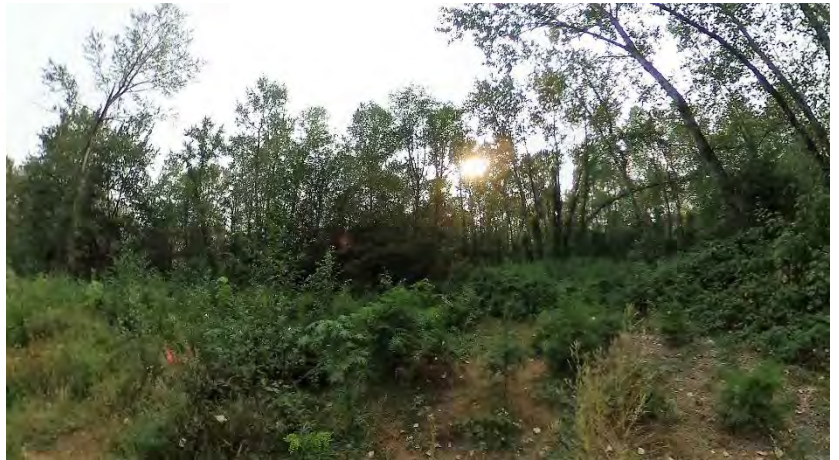
2015 a

Conditions: The north end and centre east side of this plot may be the restored site with the greatest diversity. Blackberry and morning glory are creeping in and are growing over native plants, including full smothering of some; however, these plants remain relatively healthy.

- Cherry species; a few
- Himalayan blackberry
- Knotweed; small patch
- Morning glory; smothering species including cedar, current and Douglas fir

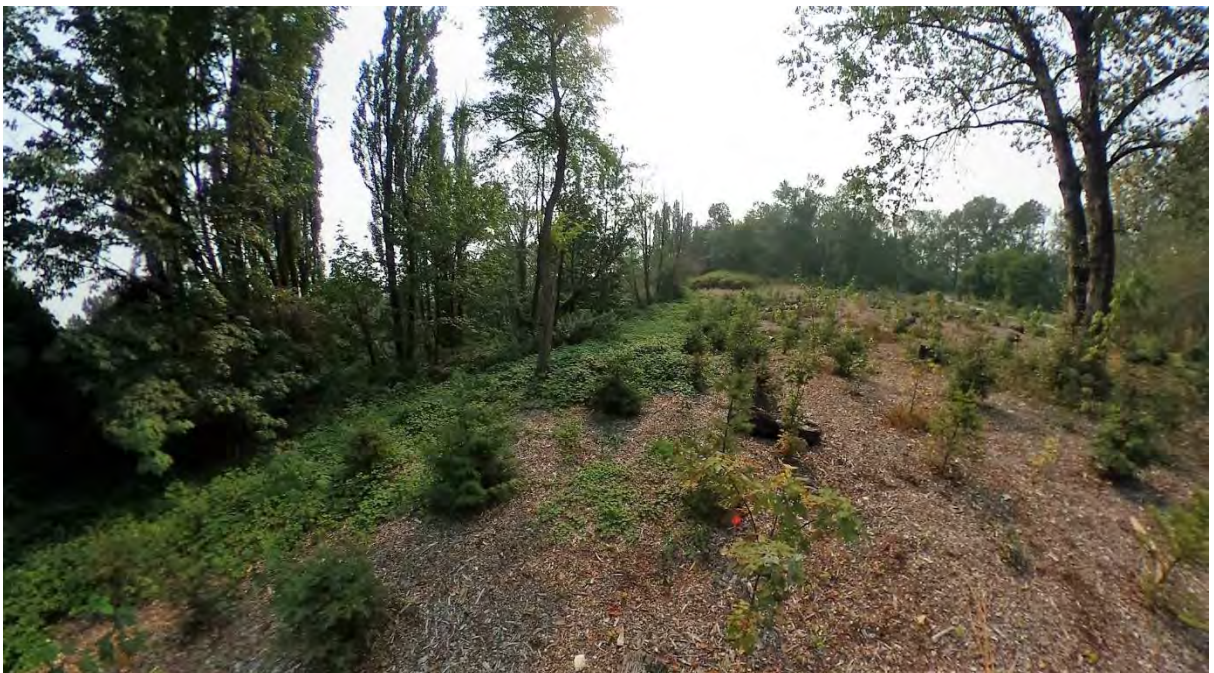
2015 b

Conditions: Mostly clear of invasive plants but some are starting to re-establish, especially in the south end

- Himalayan blackberry; floor on the south end of site is completely covered
- Morning glory, patch around elderberry in NE corner
- Scotch broom
- ❖ North end mostly clear except for the occasional invasive shooting up.
- ❖ Unknown woody species is quite abundant and appears to have killed 5 or more saplings, potentially by shading

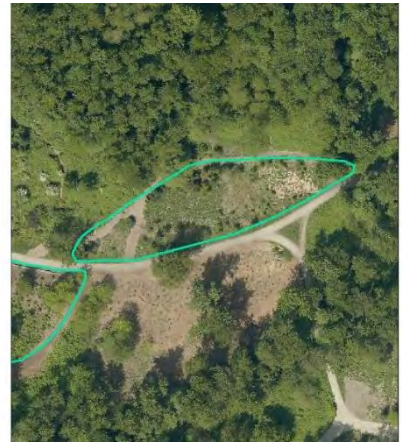
2016 a

Conditions: This site has a large area that has died. After a conversation with park workers they said that it had been covered in morning glory, which they cleared, after this clearing everything turned brown and most saplings (maples, alder etc.) have appeared to have died.

- Himalayan blackberry creeping in from outside plot (it covers adjacent slopes of Mt. Everett). Some has been cut down in the NW corner and is starting to re-sprout.
- Morning glory; abundant throughout site and covering most of the floor. It is smothering many of the Douglas-fir and other species
- Scotch broom scattered throughout the plot

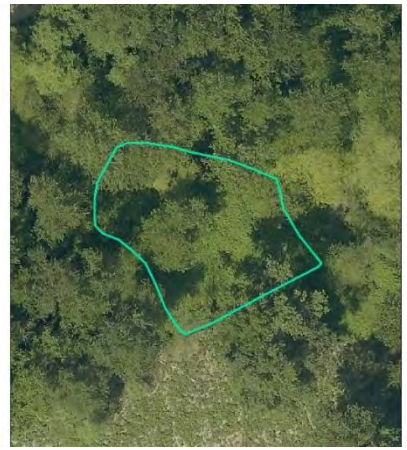
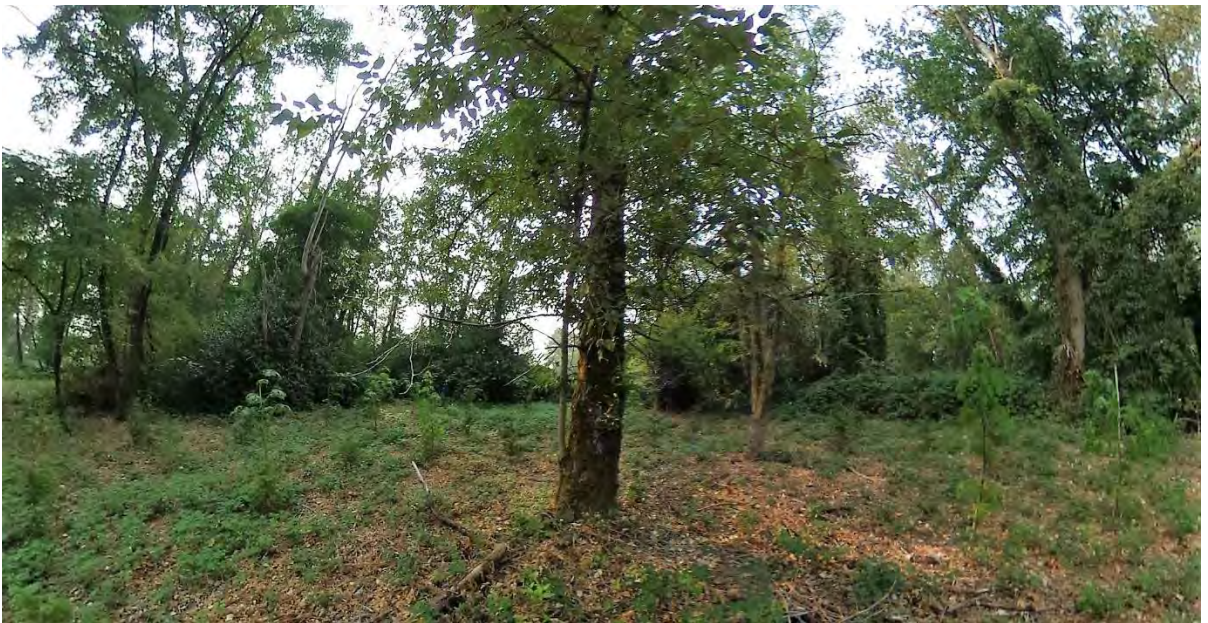
2016 c

Conditions: Blackberry has not started to grow as a vine, it is mostly sporadic shoots throughout the site

- Himalayan blackberry; predominantly covering entire floor in new shoots. Not spreading in vine form very much yet.
- Morning glory
