UBC Social Ecological Economic Development Studies (SEEDS) Sustainability Program

Student Research Report

Living Breakwaters: Archival Project and Aerial Photography Study

The Archival Project and Aerial Photography Study is a subproject (SP1) of the Living Breakwaters Resilience Project (LBRP).

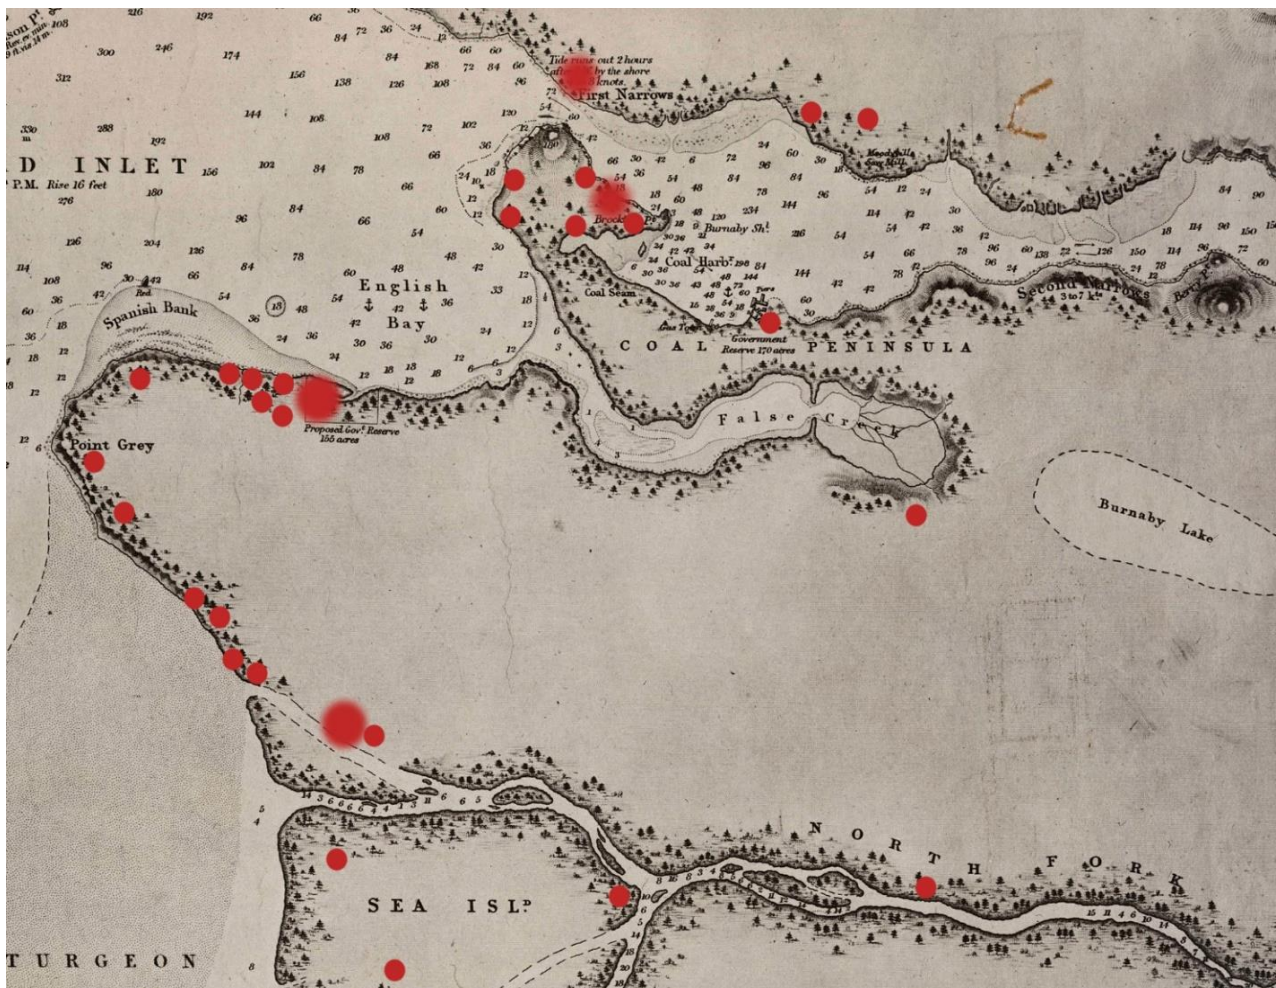
Fig. 4. Native Settlement prior to Colonial Period

This map (see Fig. 4) shows different locations of native settlement in the Lower Mainland. Smaller markings indicate temporary settlements, bigger markings indicate villages.

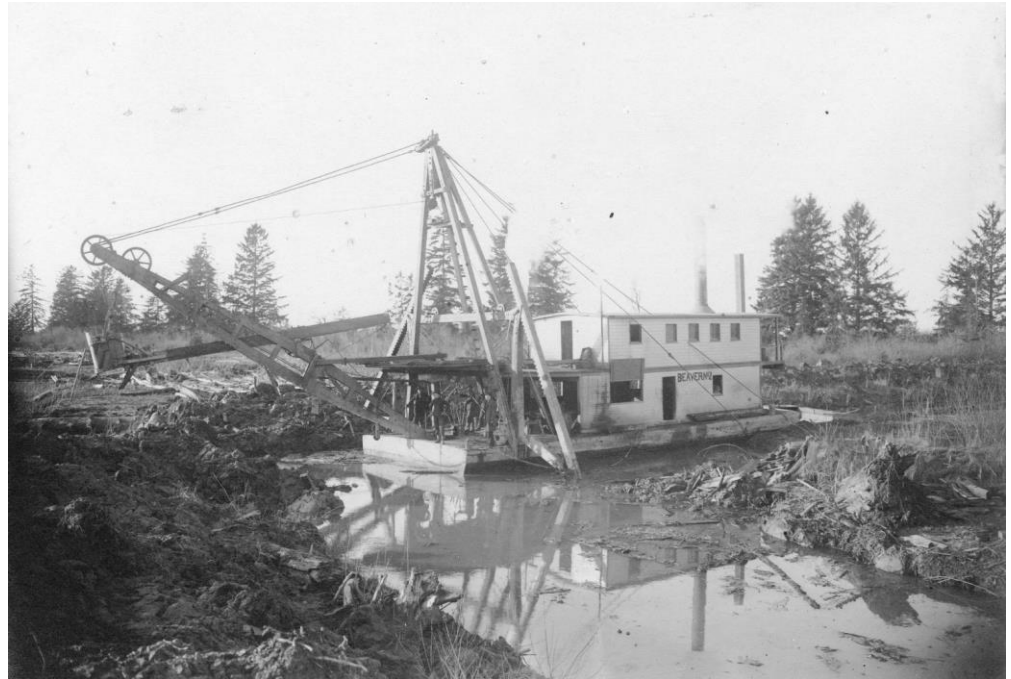
Fig. 7. Dredging Ditches on Lulu Island

This picture from 1891 (see Fig. 7) shows a heavy machinery dredging float that digs ditches as a measure of floodproofing.

Fig. 7. Dredging Ditches on Lulu Island. From: Vancouver Archives, *Dredging ditches on Lulu Island*, 1891.

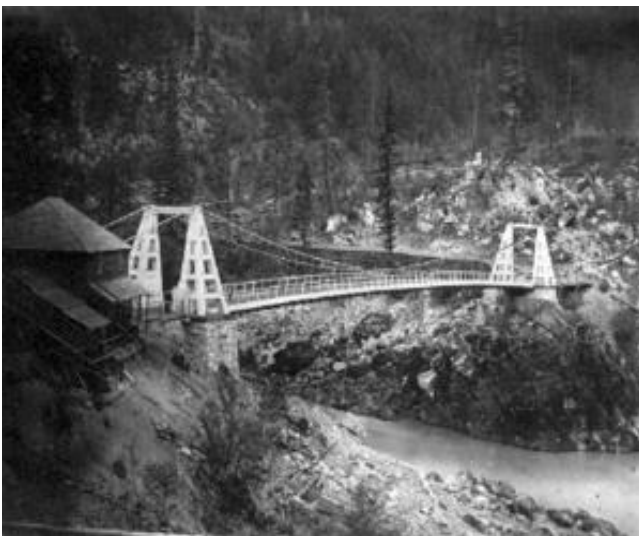
Fig. 8. Alexandra Suspension Bridge (1868) Fig. 9. Bridge during the 1894 flood

The Alexandra Suspension bridge located few kilometers north of Spuzzum can serve as visualizing aid for the flood extent. Erected in 1863, the suspension bridge spanned 23m above normal water levels in the Fraser Canyon and was washed away and destroyed by the flood (Northwest Hydraulic Consultants 8).

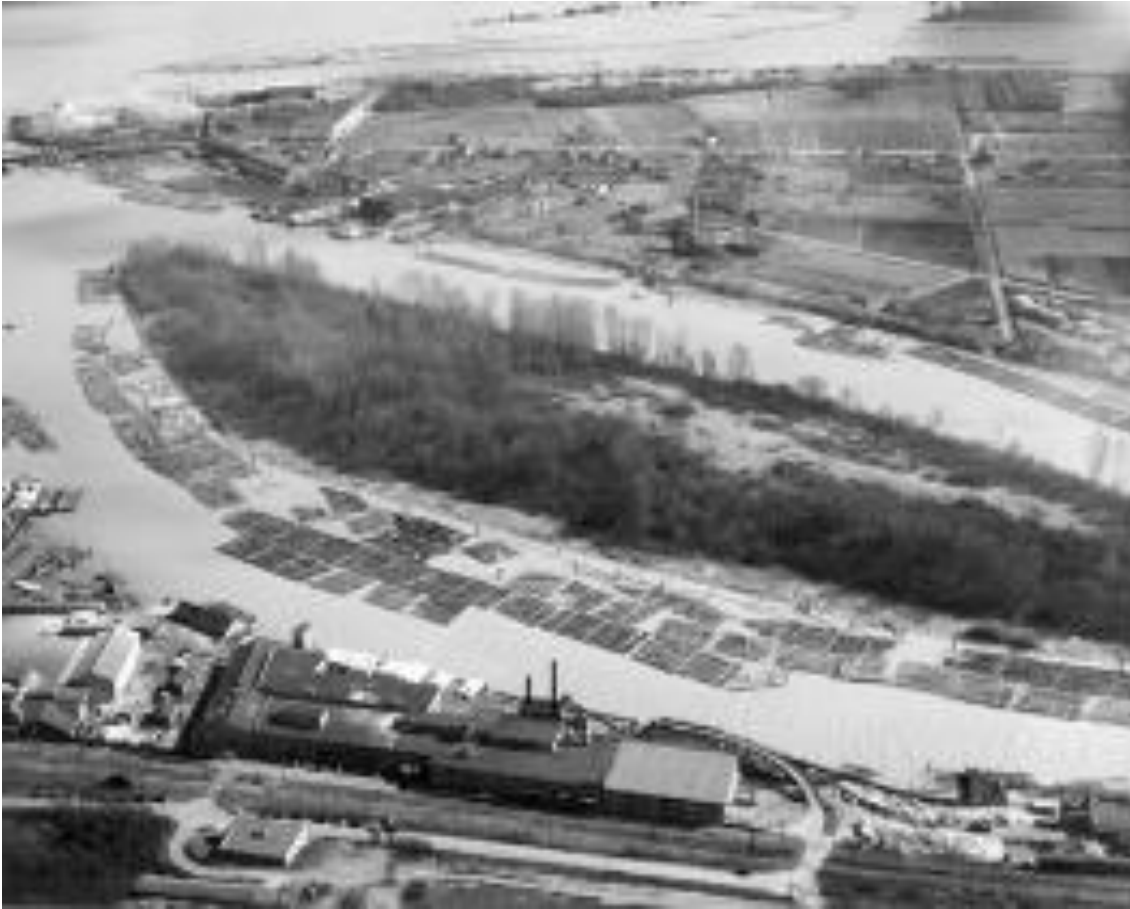
Fig. 10. Aerial view of Poplar Island during 1948 flood (upstream)

Poplar Island is the island well visible in the forefront. Located behind Poplar Island is the upstream tip of Queensborough, and after that, with difficult visibility in the distance, Annacis Island, that was completely submerged during the 1894 flood (see Fig. 10 for upstream and Fig. 11 for downstream part).

Fig. 10. Aerial view of Poplar Island during 1948 flood (upstream). From: Vancouver Archives, *Aerial view of Annacis Island during the Fraser River flood*, 1948.

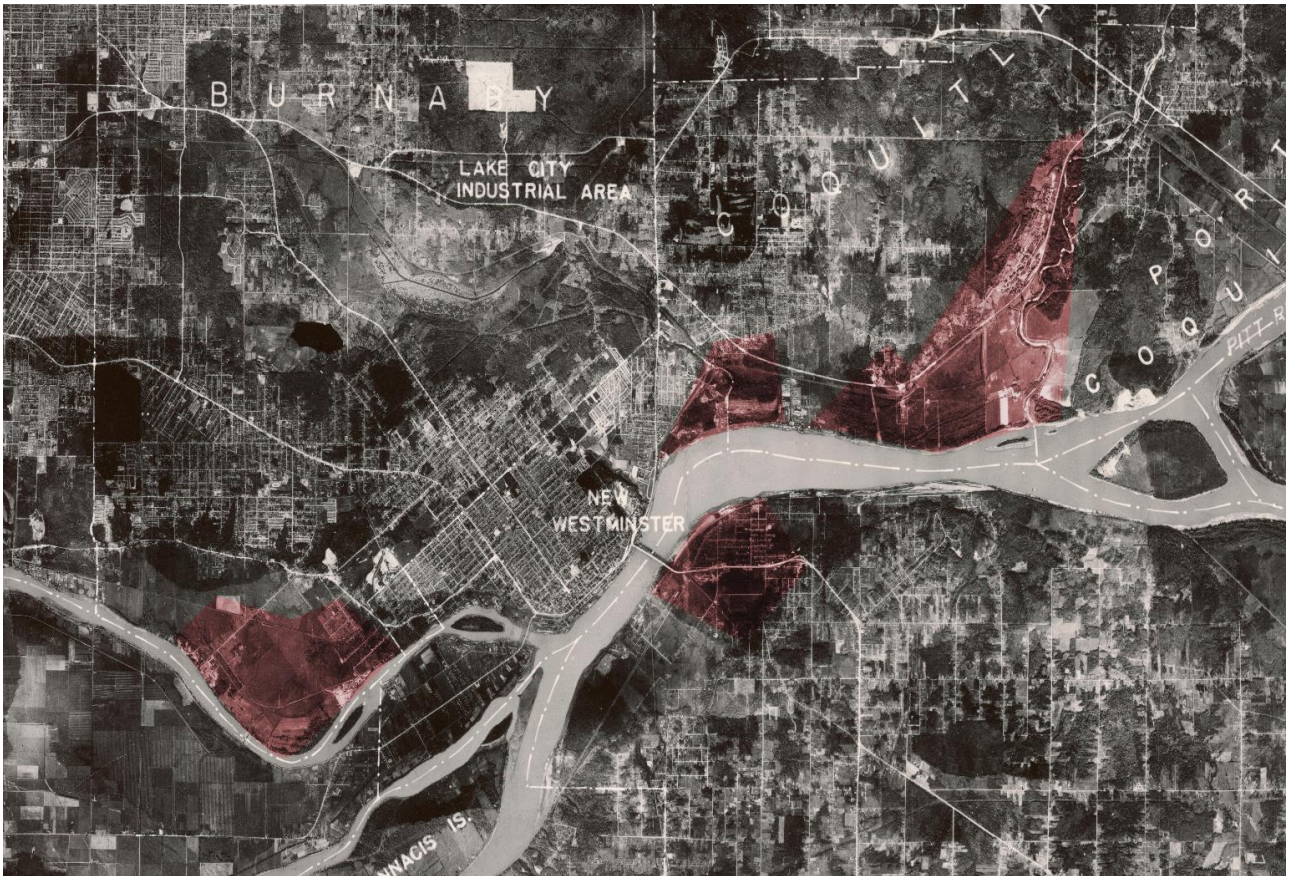
Fig. 28. Floodplain of 1948 on aerial of 1952

For illustration purposes, the flooded area of 1948 from Richmond up to the Coquitlam River, mapped onto an aerial of the 50s (see Fig. 28). Considerable parts of the tip of New Westminster and large areas adjacent to the Coquitlam River would be inundated. Today, the area of the 1948 floodplain is with exception of larger areas around the Coquitlam River mouth completely covered by infrastructure.

Fig. 28. Floodplain of 1948 on aerial of 1952. Base Image: Vancouver Archives, *Composite aerial mosaic of metropolitan Vancouver*, 1952; Floodplain mapping based on: Doberstein, Brent, et al., *Protect, accommodate, retreat or avoid (PARA): Canadian community options for flood disaster risk reduction and flood resilience*, Areas flooded 1948, 2018.

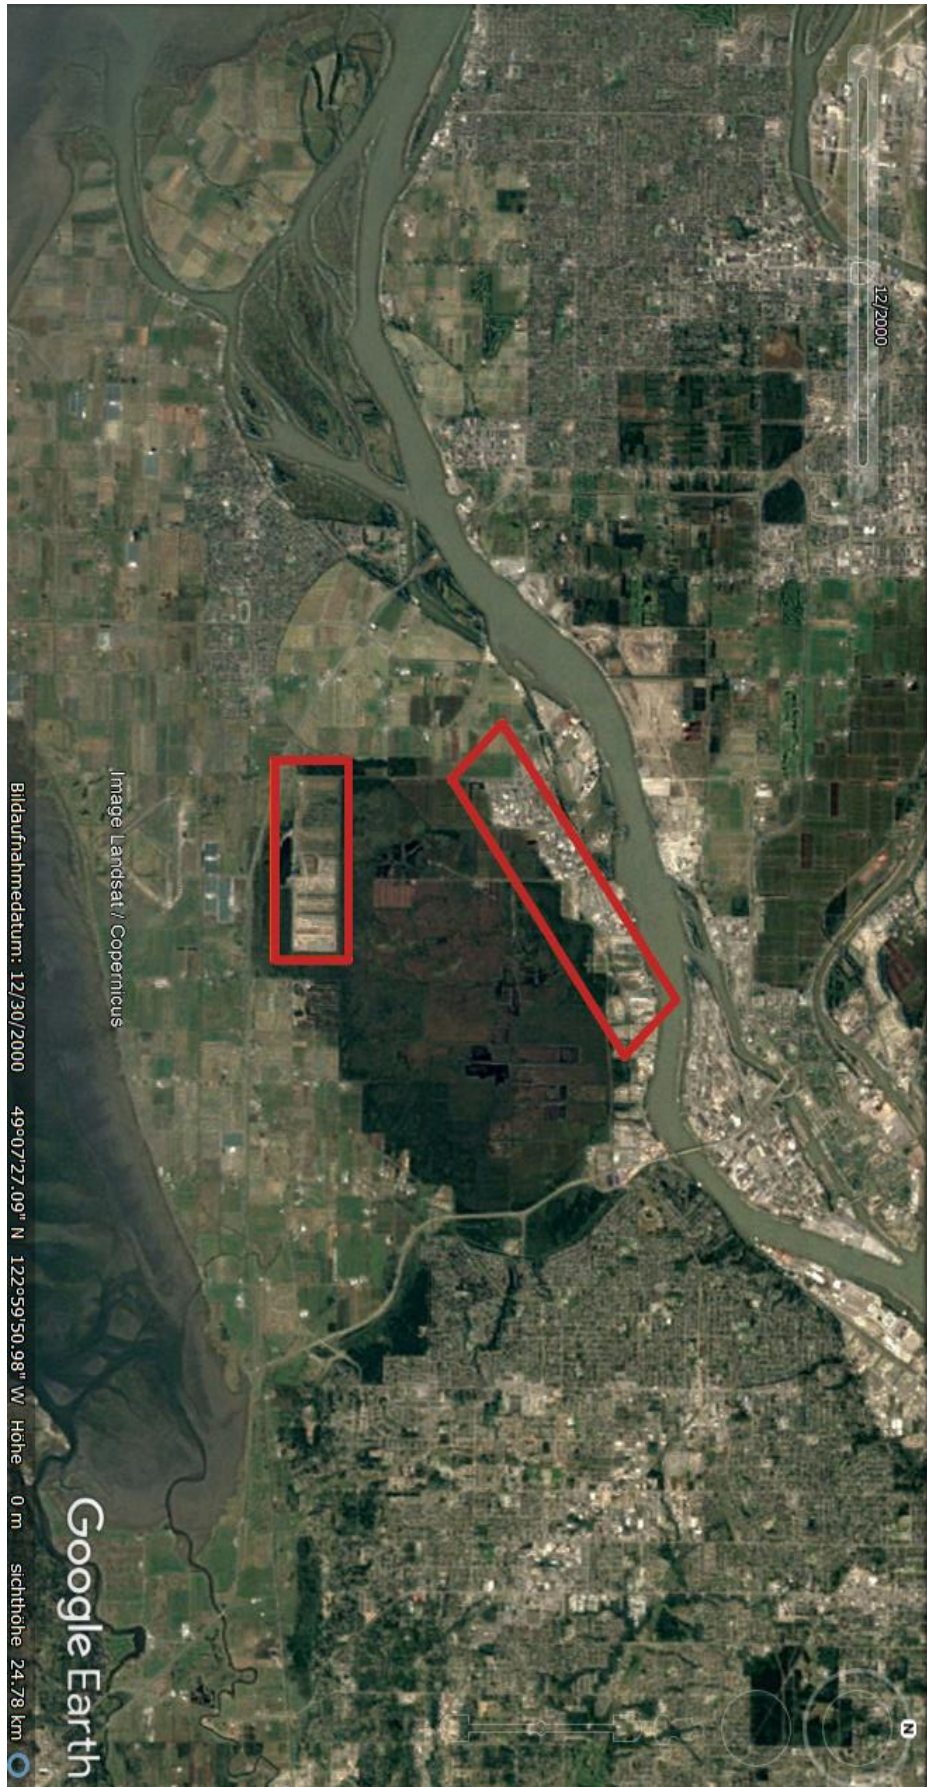
Fig. 37. Wetland Loss area I, highlighted

A close-up aerial of the south-west section of the map, of land close to the main channel and Annacis Island (the island in the upper middle), visualizes the change in wetland composition. Conditions 1985:

Fig. 37. Wetland Loss area I, highlighted. Base Image: Google Earth

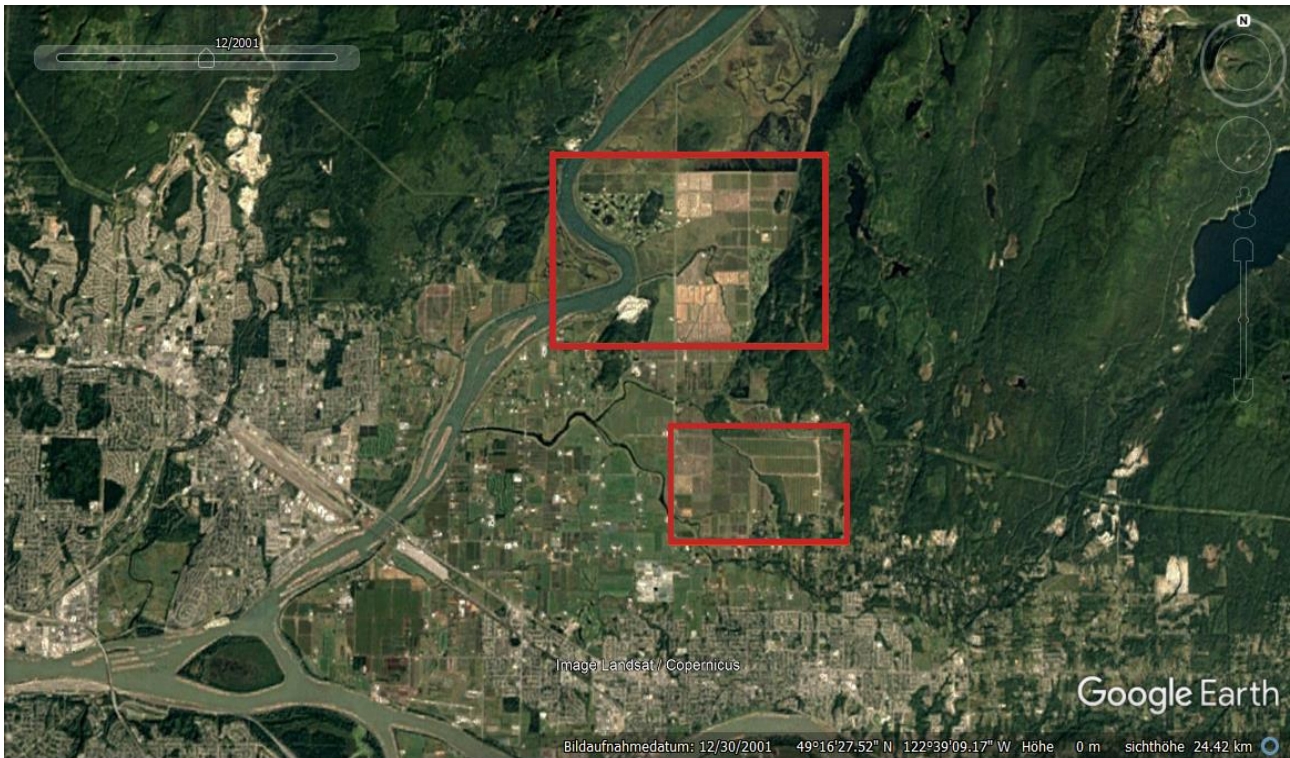
Fig. 40. Wetland Loss area II, highlighted

The areas subject to change, highlighted:

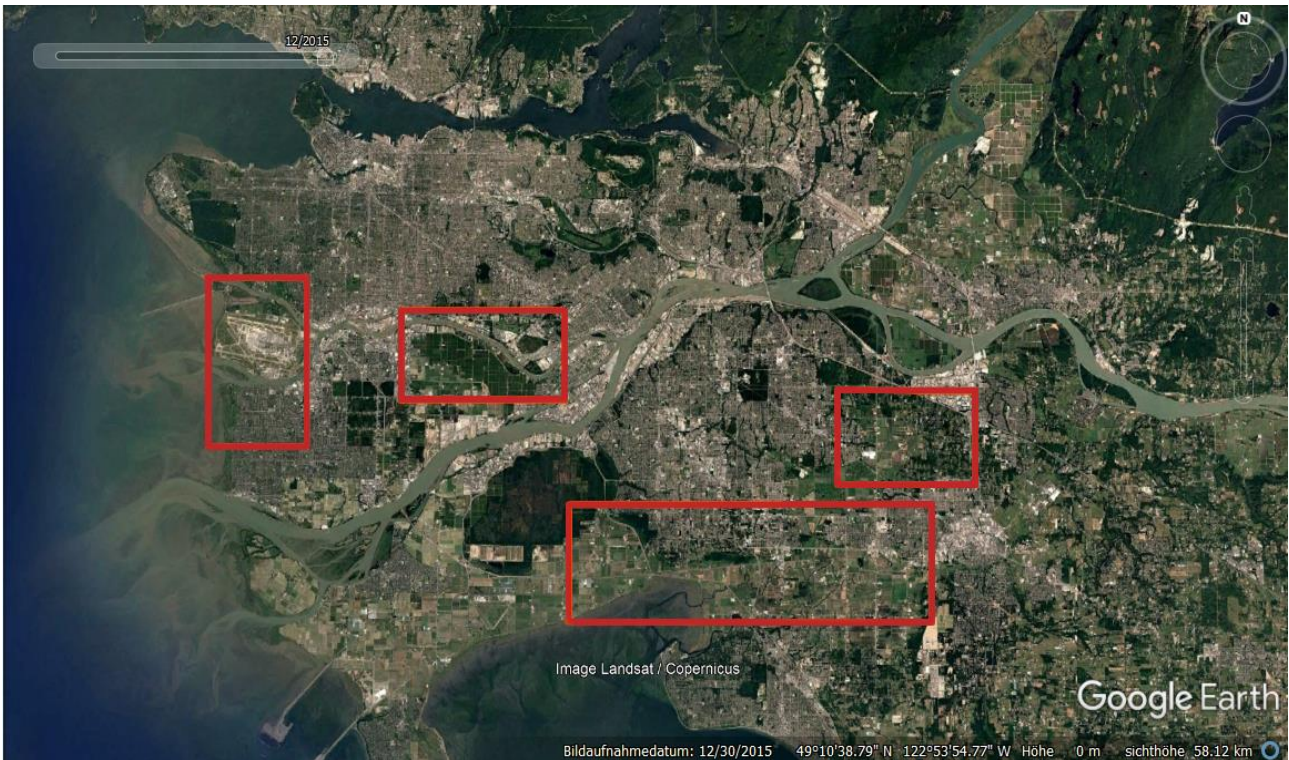
Fig. 41. Aerial with high flood risk areas

This Aerial (see Fig. 41) of 2015 shows the areas severely threatened by flood risk. The areas were identified via www.seeing.climatecentral.org; Projection for 1m sea level rise.

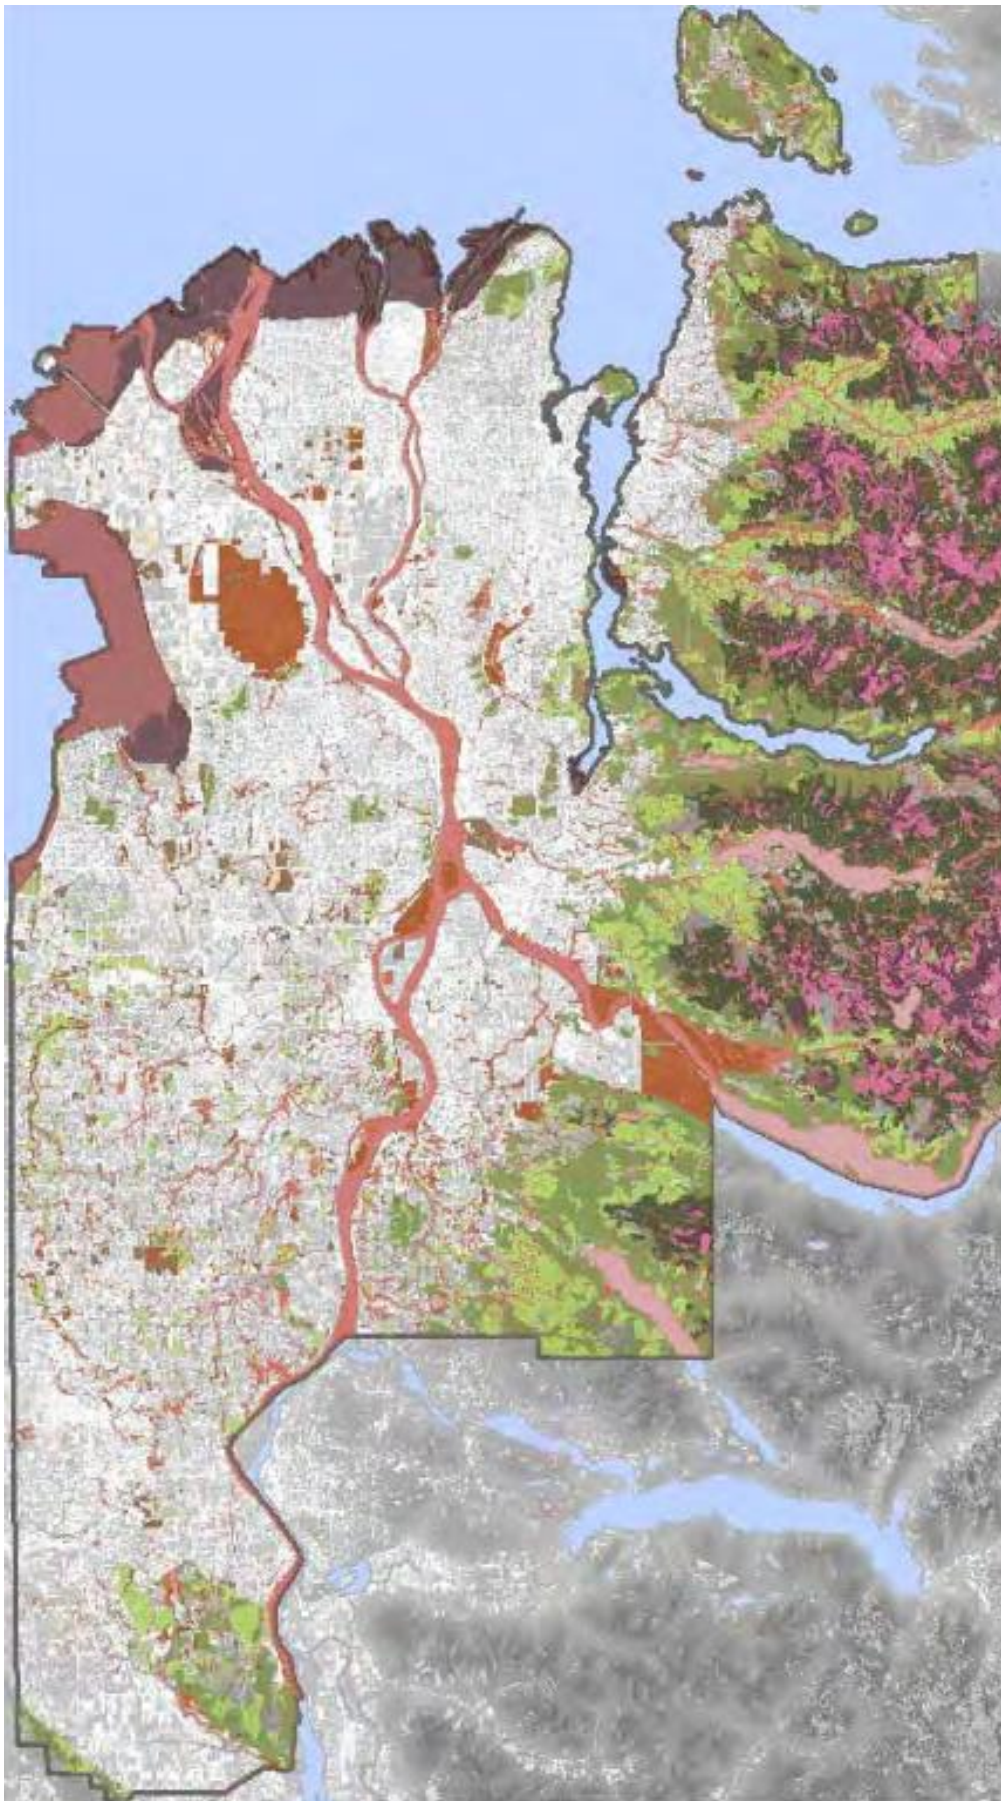
Fig. 42. Sensitive Ecosystem map

The areas marked in different colors differentiate various, sensitive habitats throughout Greater Vancouver. Of special interest for this study, and identified as sensitive to environmental influences, is the entire coastline of BC and the closer coastline environment, the wetland areas, and all river environments.

As well, with the exception of False Creek, all Focus Areas lie in the midst of sensitive and threatened ecosystems as identified by the Sensitive Ecosystem Report (see Fig. 42).

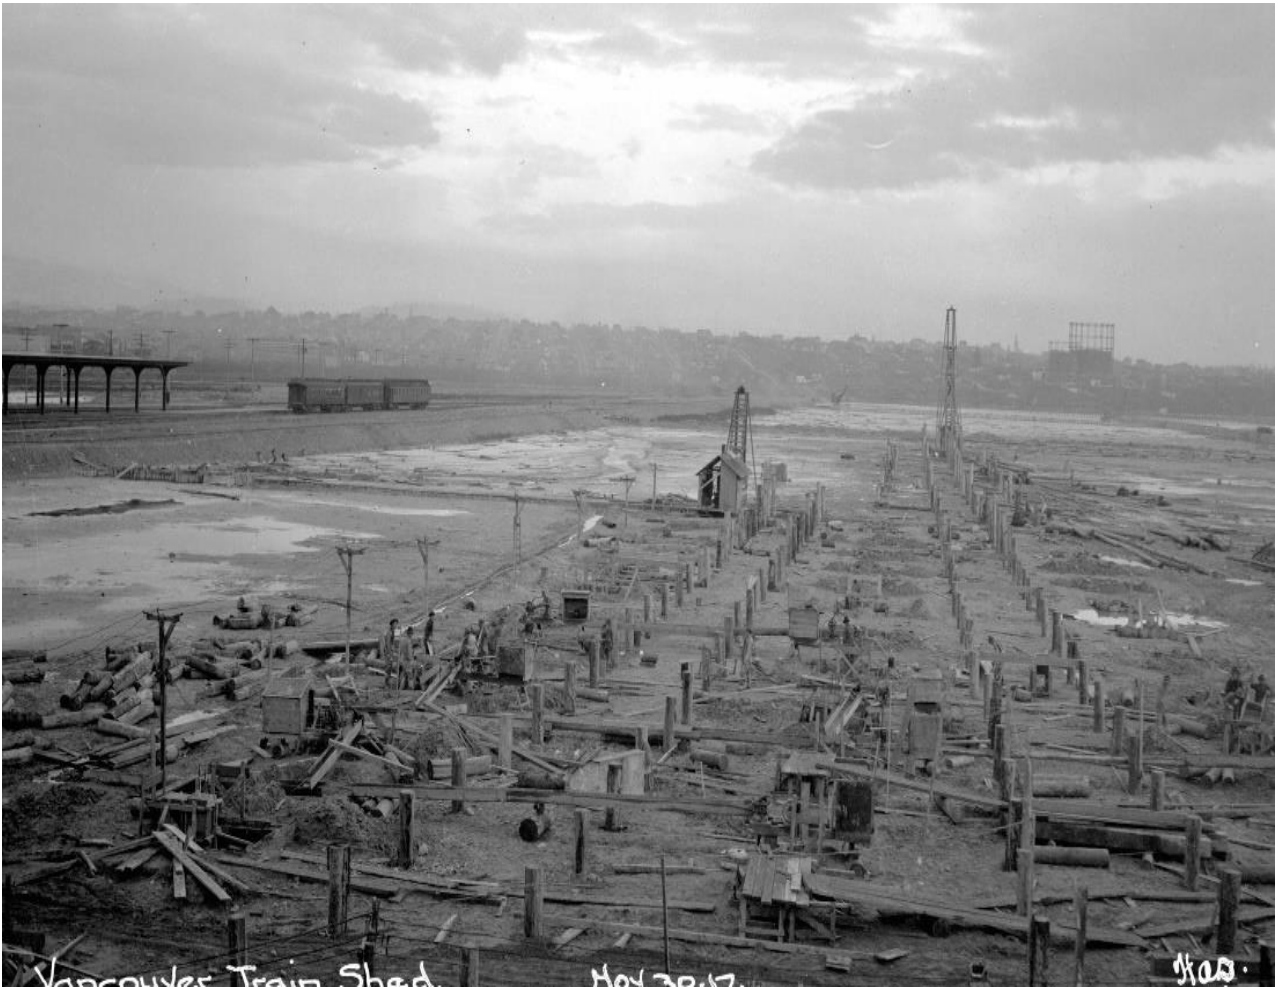
Fig. 47. Construction CPR rail lot

These photographs (see Fig. 47 and 48) show the rail lot in its construction phase. The space was drained in 1910, after that the construction works commenced.

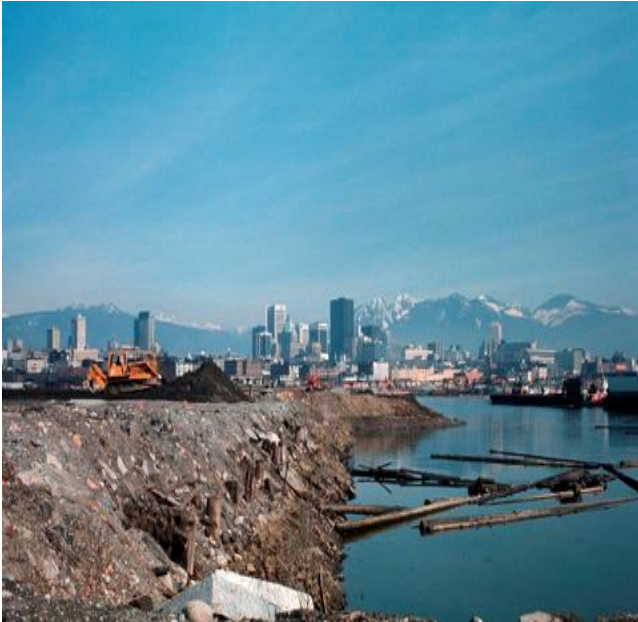
Fig. 55. Construction of the Seawall I

With the seawall construction starting as early as 1917 and being completed in 1980, the construction of the False Creek portion of the structure would not start until 1974. The whole shoreline of the area is circumscribed with the wall, Vancouver's landmark hard infrastructure to fend off the threats of flooding. The pictures below show the seawall in its early construction stages in 1974.

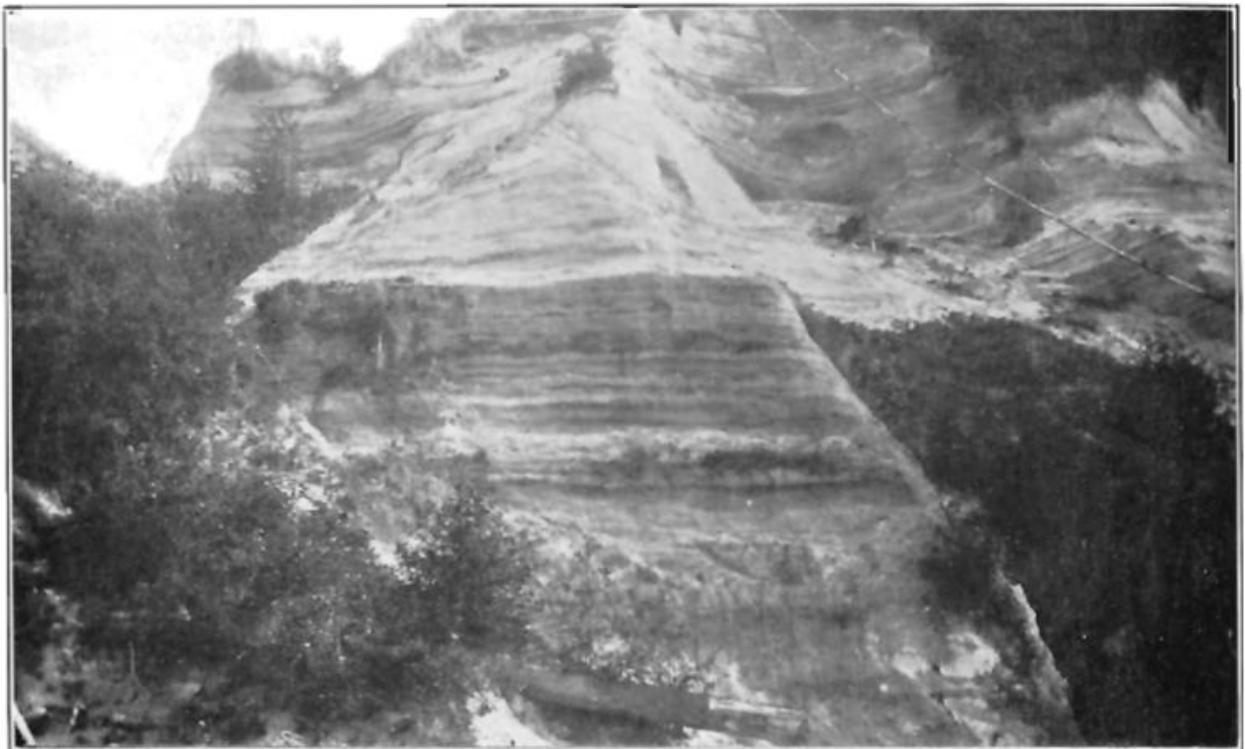
Fig. 63. Bare cliff photograph (1923)

The bare cliffs were also photographed and published in a geological survey in 1923 (see Fig. 63).

B. Pleistocene deposits in sea-cliff on the northwest side of point Grey, Vancouver, B.C. The lower, darker-coloured beds are plant-bearing, interglacial beds. The cliff is about 200 feet high. (Page 43.)

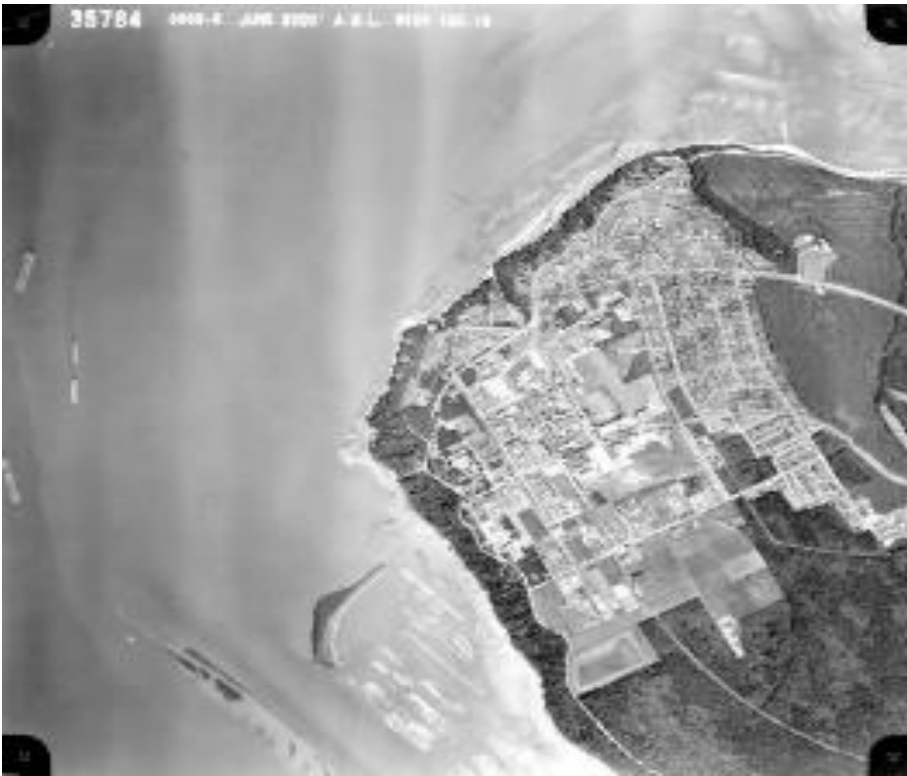
Fig. 65. UBC aerial (1956)

This aerial from 1956 shows a much more advanced university complex. Fig. 65 and 66 visualize well how the site expands in close proximity to the cliffs.

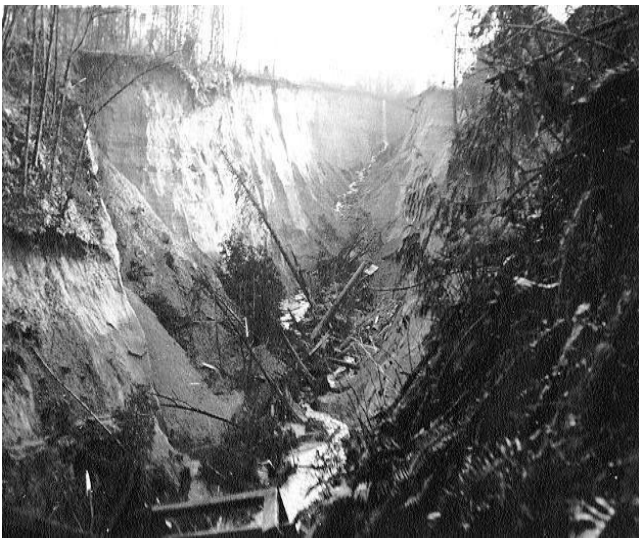
Fig. 67. Graham's Ravine

With the land getting more developed throughout the following decades, the cut back of vegetation along with the urbanization of the area can be regarded as a contributing factor to substantial erosion (UBC/Pacific Spirit Park Cliff Erosion Management Planning 22-25). One of such events was a landslide that took place in close proximity to Green College in 1935. Caused by an extreme storm, extensive water runoff cut a large ravine into the ground behind the buildings, in its dimension large enough to partly destroy and washout infrastructure like streets (see Fig. 67 and 68).

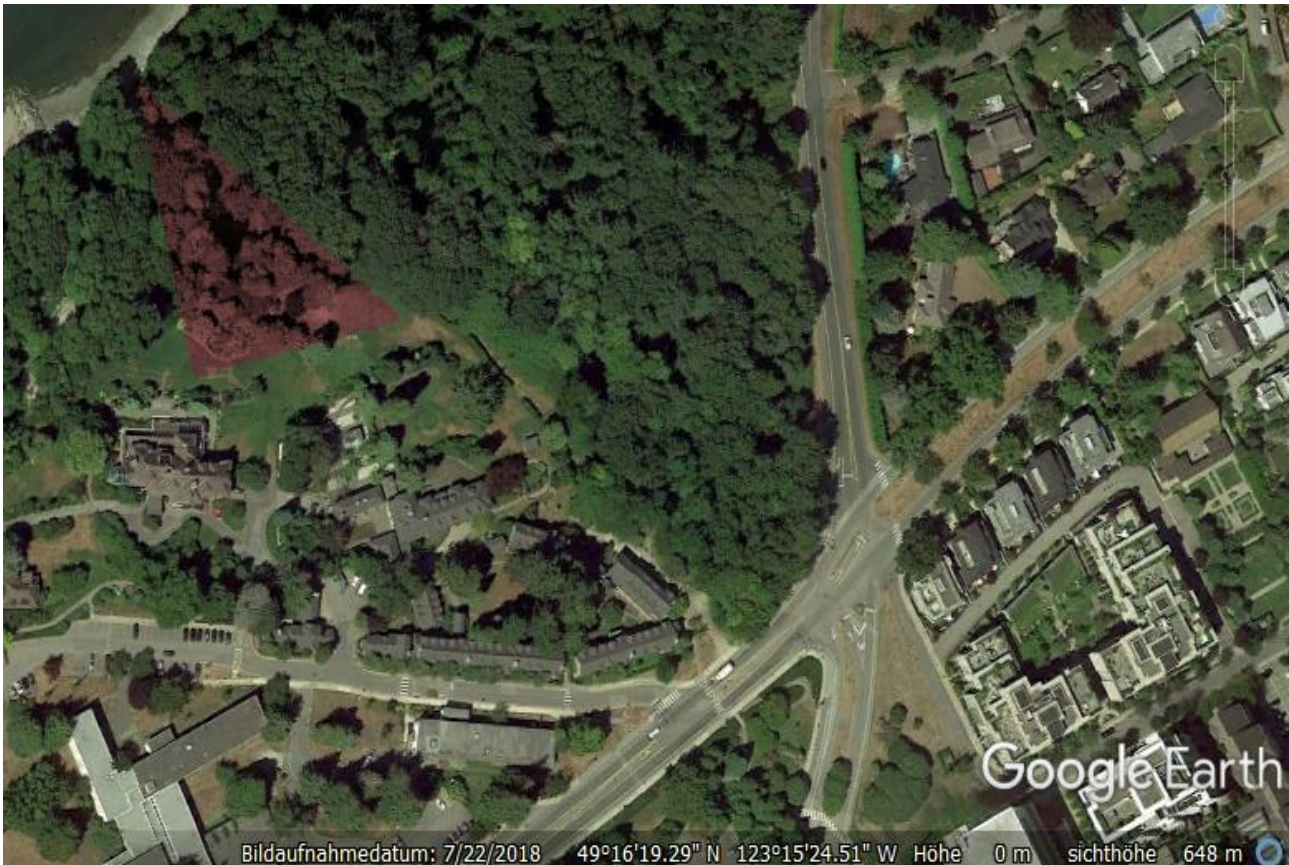
Fig. 69. Approximate location Graham's Ravine

The approximate location of the ravine, highlighted in red:

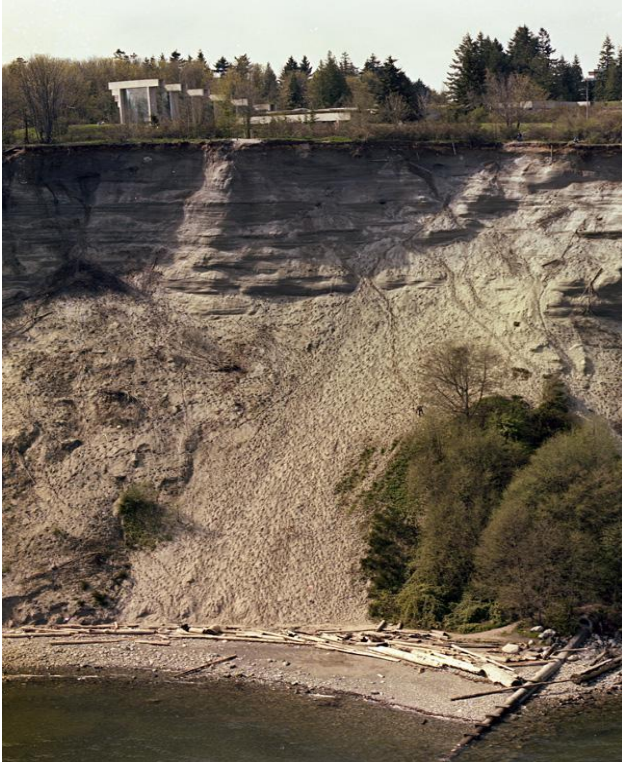
Fig. 70. Museum of Anthropology

The Museum of Anthropology is located in close proximity to cliffs with considerable slope instability.

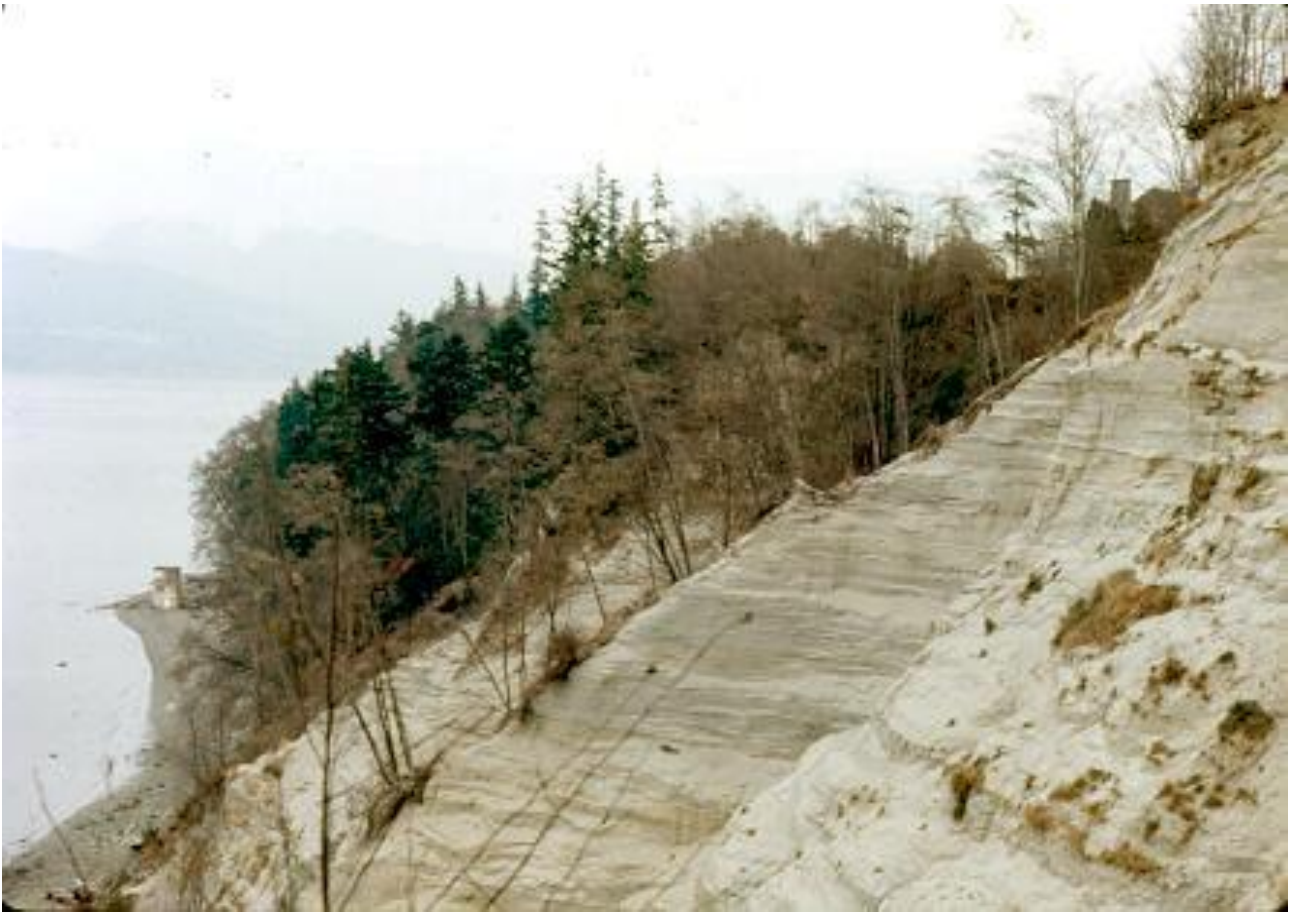
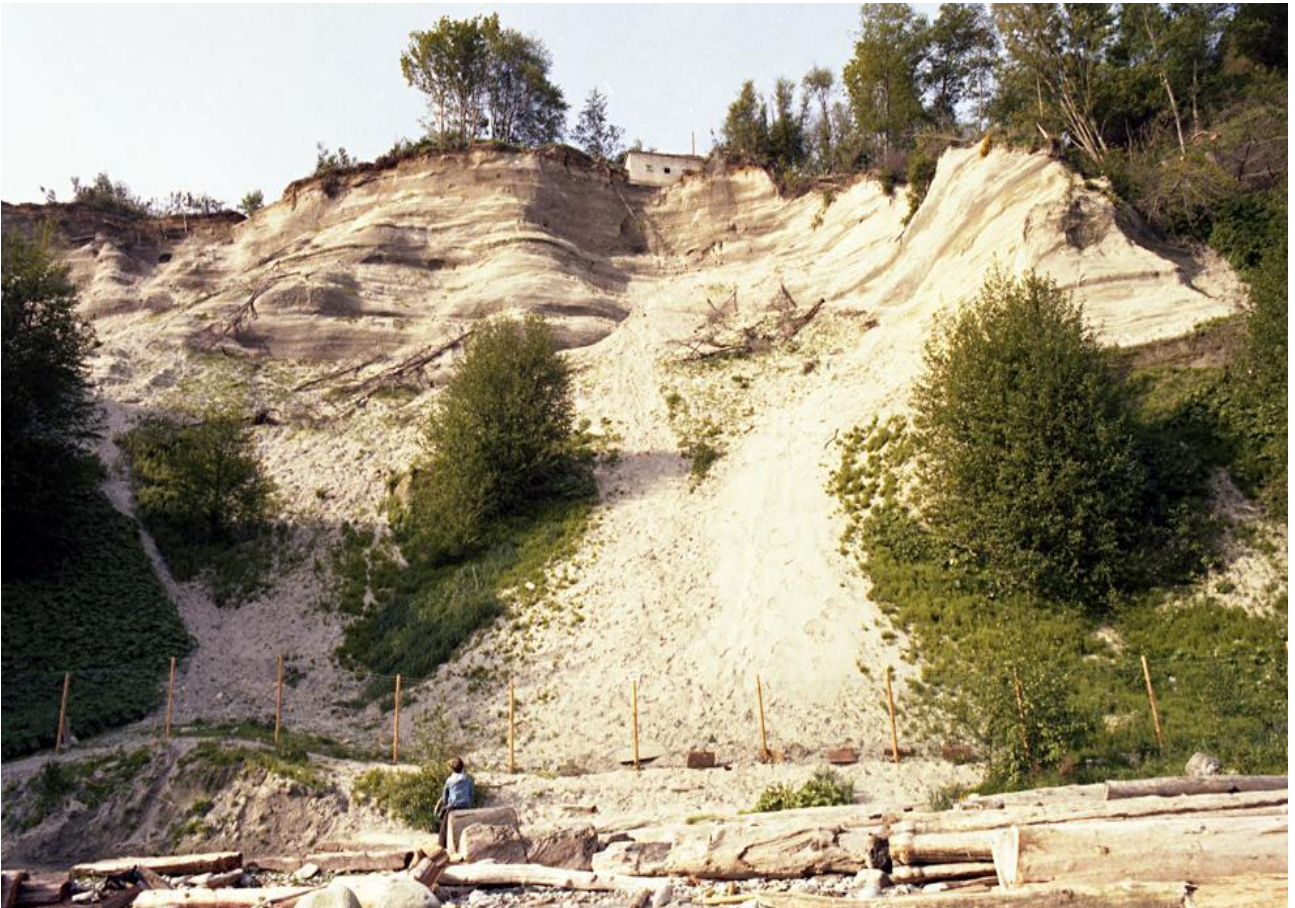
Fig. 71 and 72 show the conditions of the UBC cliffs before the Cliff Erosion Task Force initiated a large-scale replanting in order to stabilize the slopes.

Fig. 71. Bare UBC cliffs I

Fig. 72. Bare UBC cliffs II

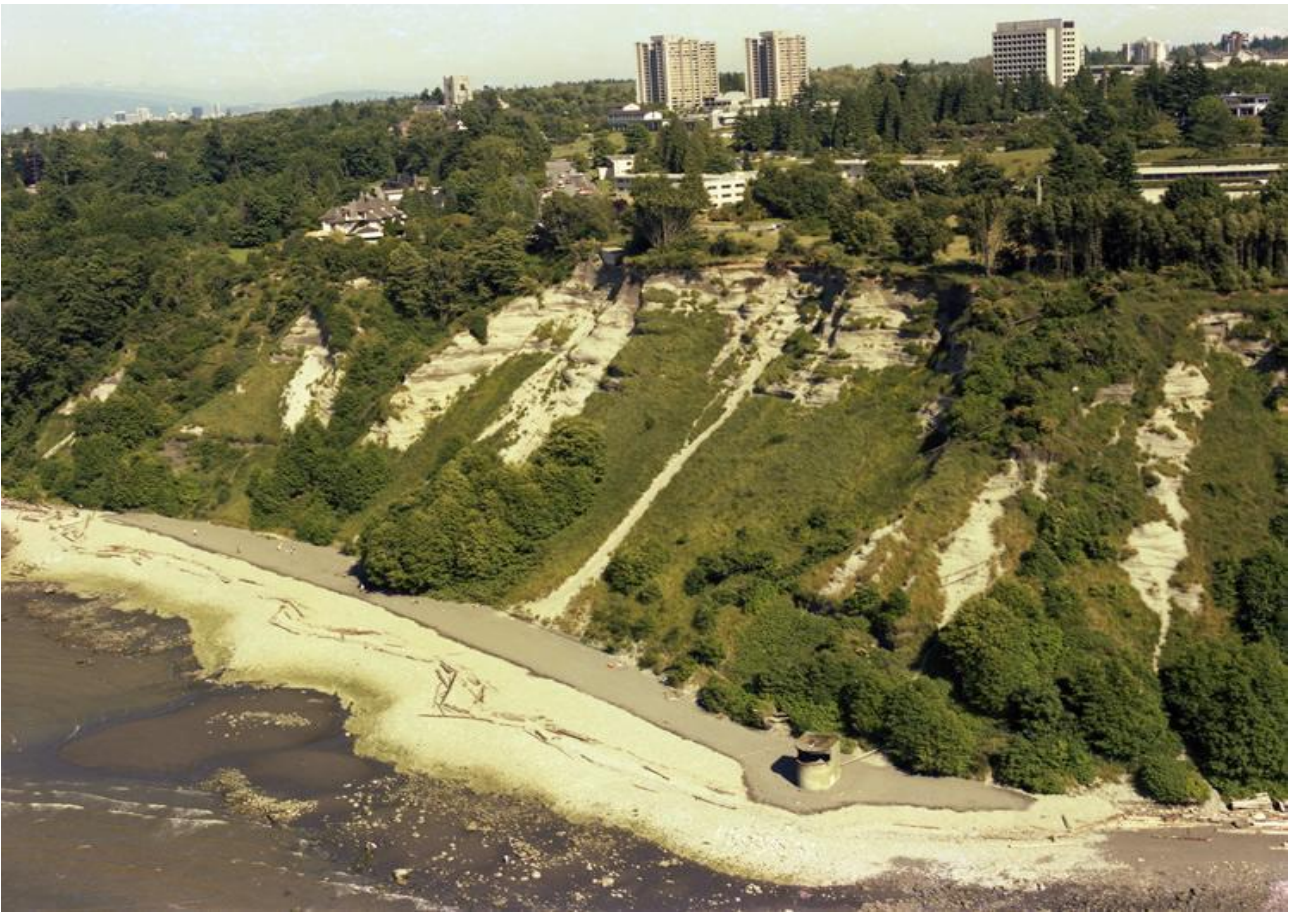
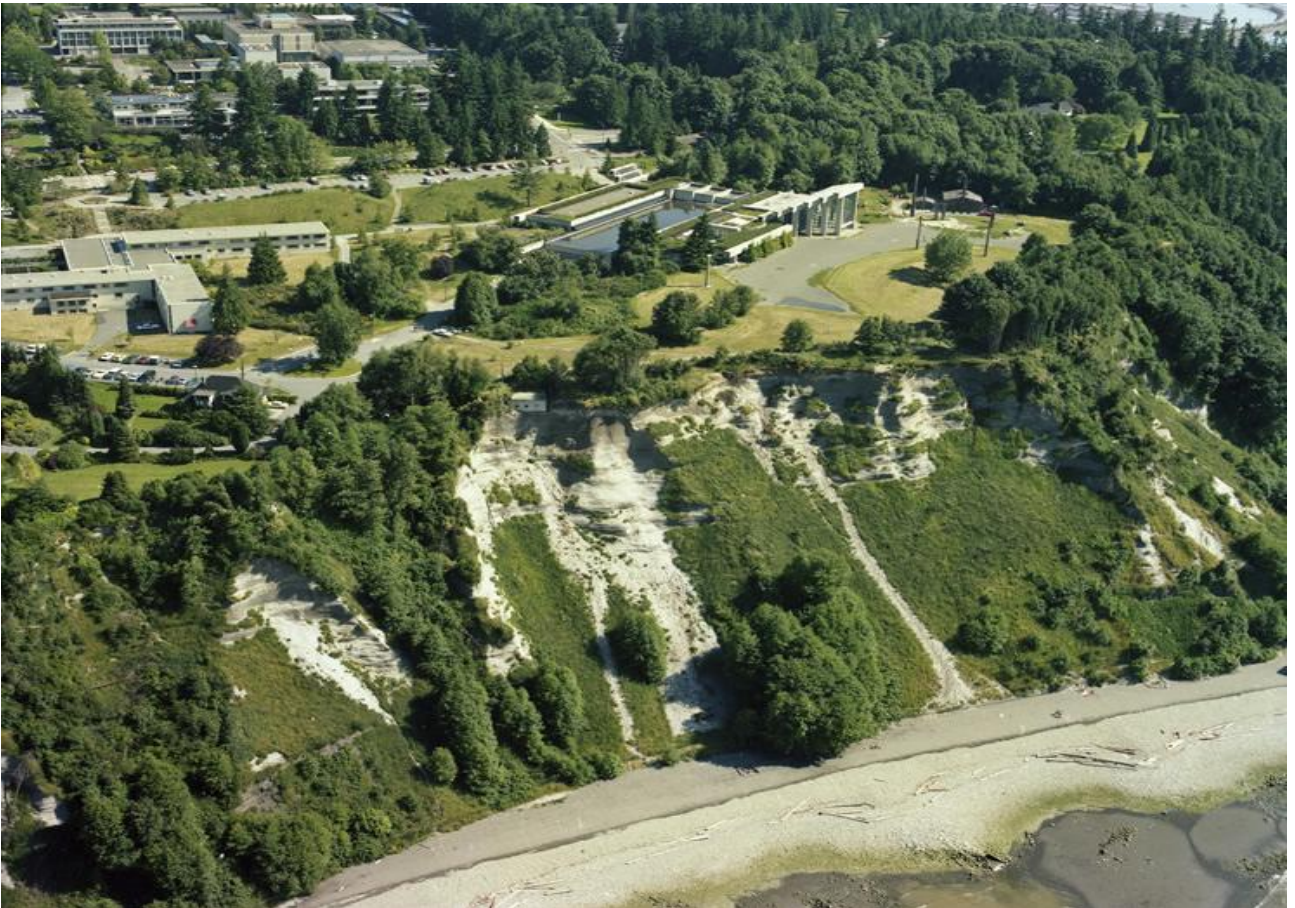
Fig. 73 and 74 show the planted, transformed cliffs.

Fig. 73. Planted UBC cliffs I

Fig. 74. Planted UBC cliffs II

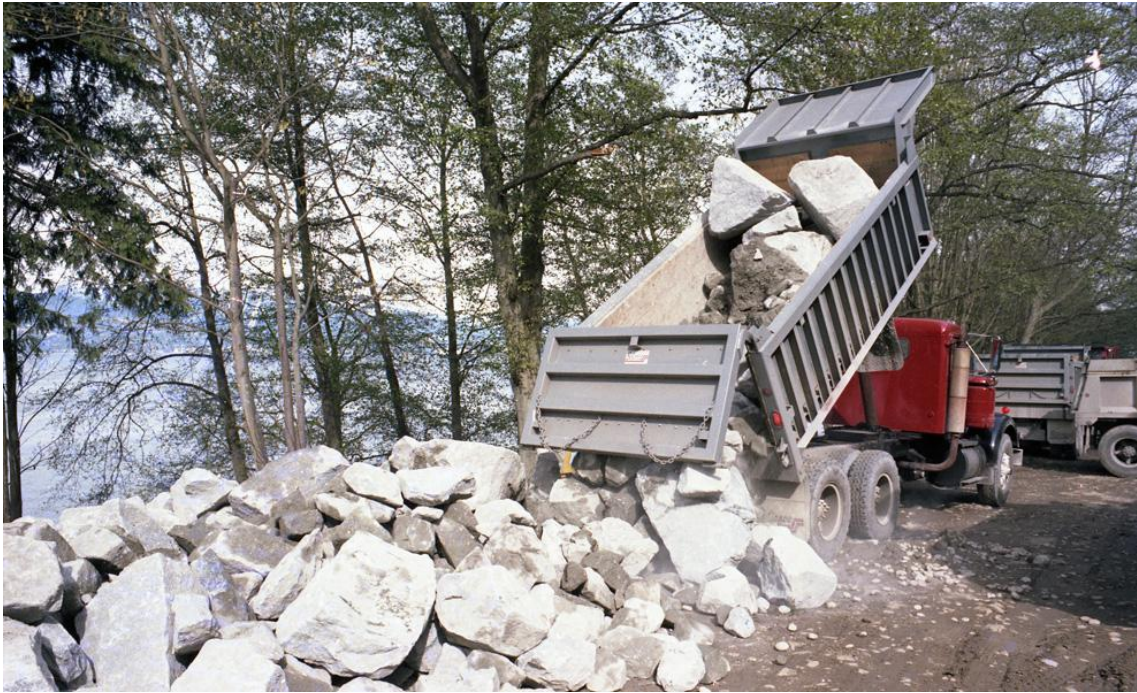
Fig. 75. Armoring the shoreline

The Task Force resorted to extensive protection measures (UBC/Pacific Spirit Park Cliff Erosion Management Planning 12), like preventing base erosion of the cliffs by putting riprap structures in place (see Fig. 75), as well as planting vegetation on the bare cliffs (see Fig. 76 and 77).
