UBC Social Ecological Economic Development Studies (SEEDS) Sustainability Program

Student Research Report

Living Breakwaters: Archival Project and Aerial Photography Study

The Archival Project and Aerial Photography Study is a subproject (SP1) of the Living Breakwaters Resilience Project (LBRP).

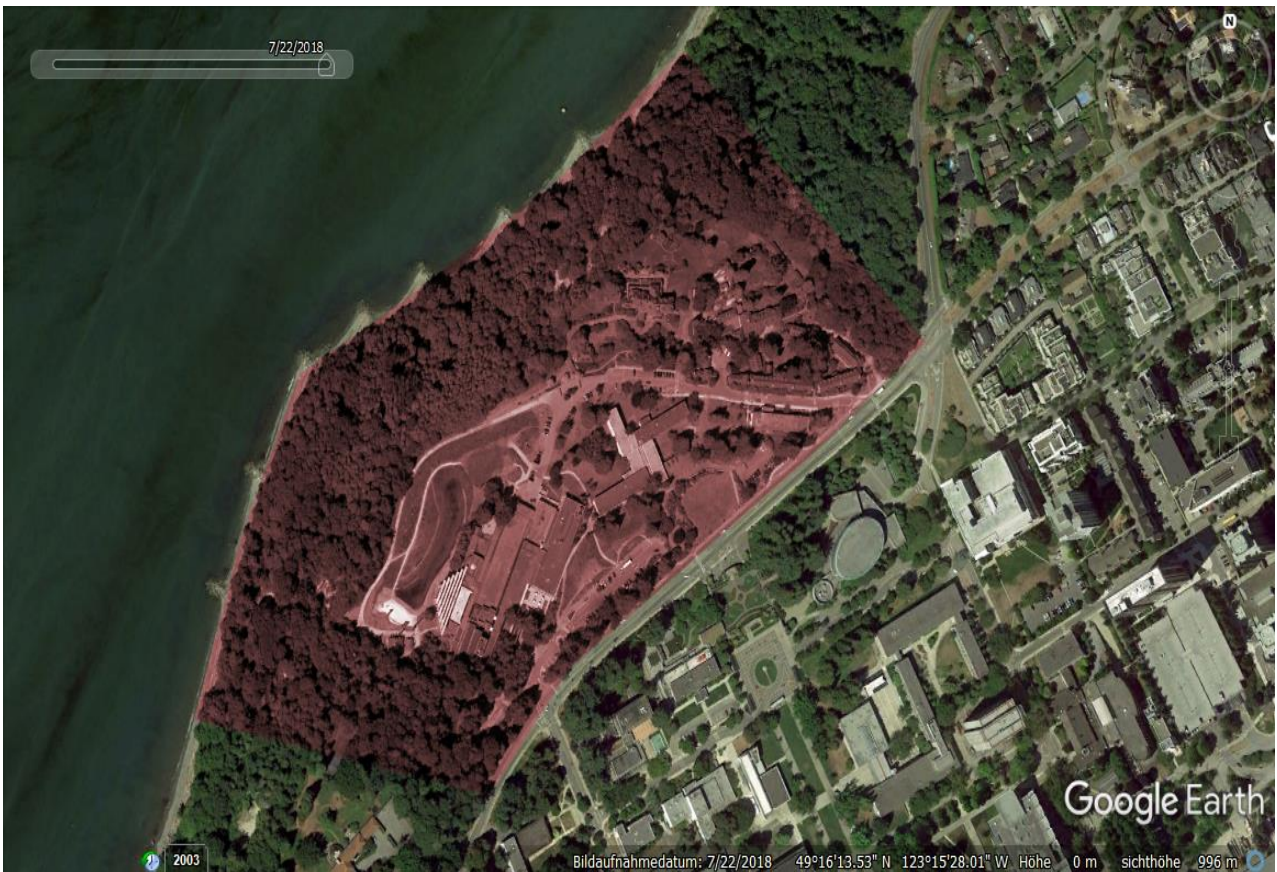
Fig. 78. Area with slope instabilities

In 2016 a study assessed the current state of the UBC cliffs and came to the conclusion that the slopes between Trail 3 and 4 (see Fig. 78) have stability problems and were subject to a moderate-high probability to fail if not stabilized (Lee et al. Appendix C), other studies evaluated similarly (Aecom 11-13).

As noted in the studies, the area identified as possibly threatened by future by slope failure encompasses the Museum of Anthropology (the south-western portion of infrastructure in highlighted area in above visual), as well as the entire Green Campus (north-eastern infrastructure in the highlighted area, above visual).

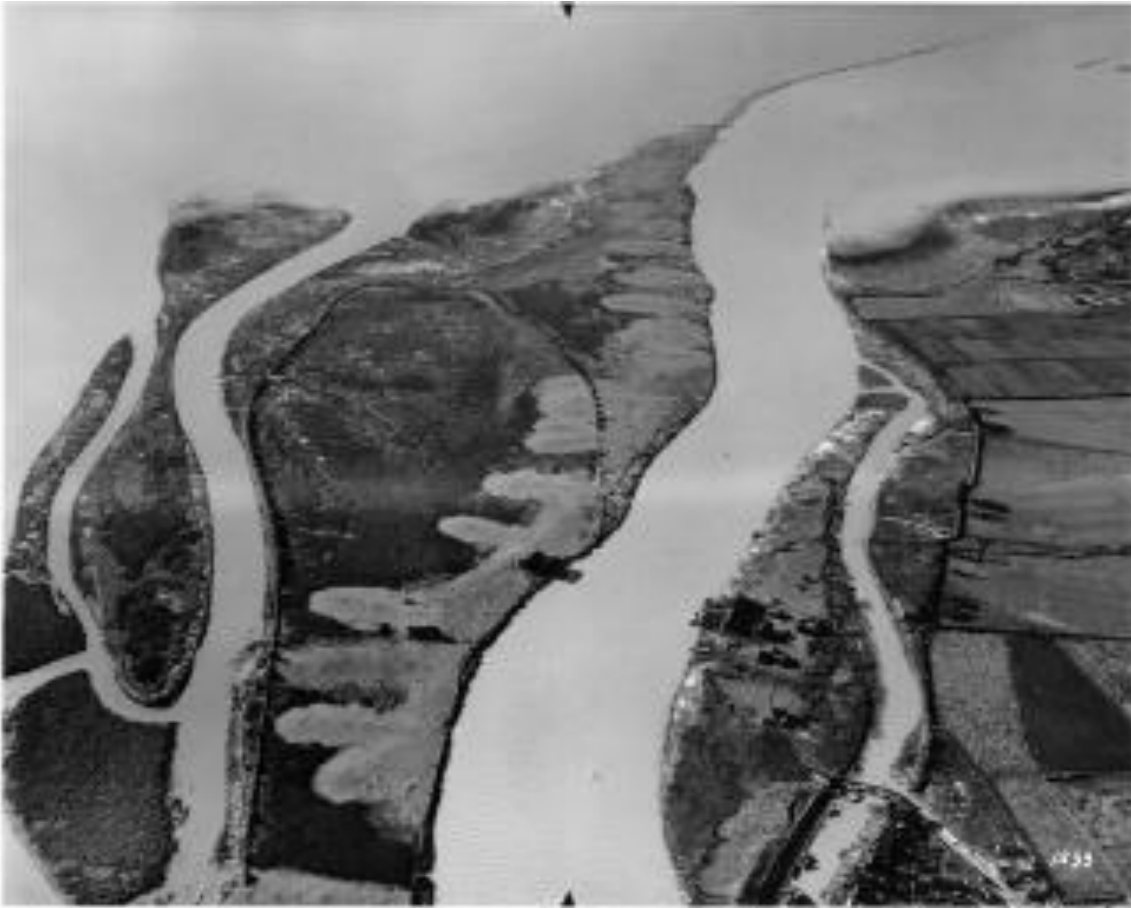
Fig. 83. Iona aerial (1930)

Fig. 83 and 84 show Iona Island in its early state with the North Arm Jetty already in place. Aside from that the island is not developed, and the southern channel is not yet filled in.

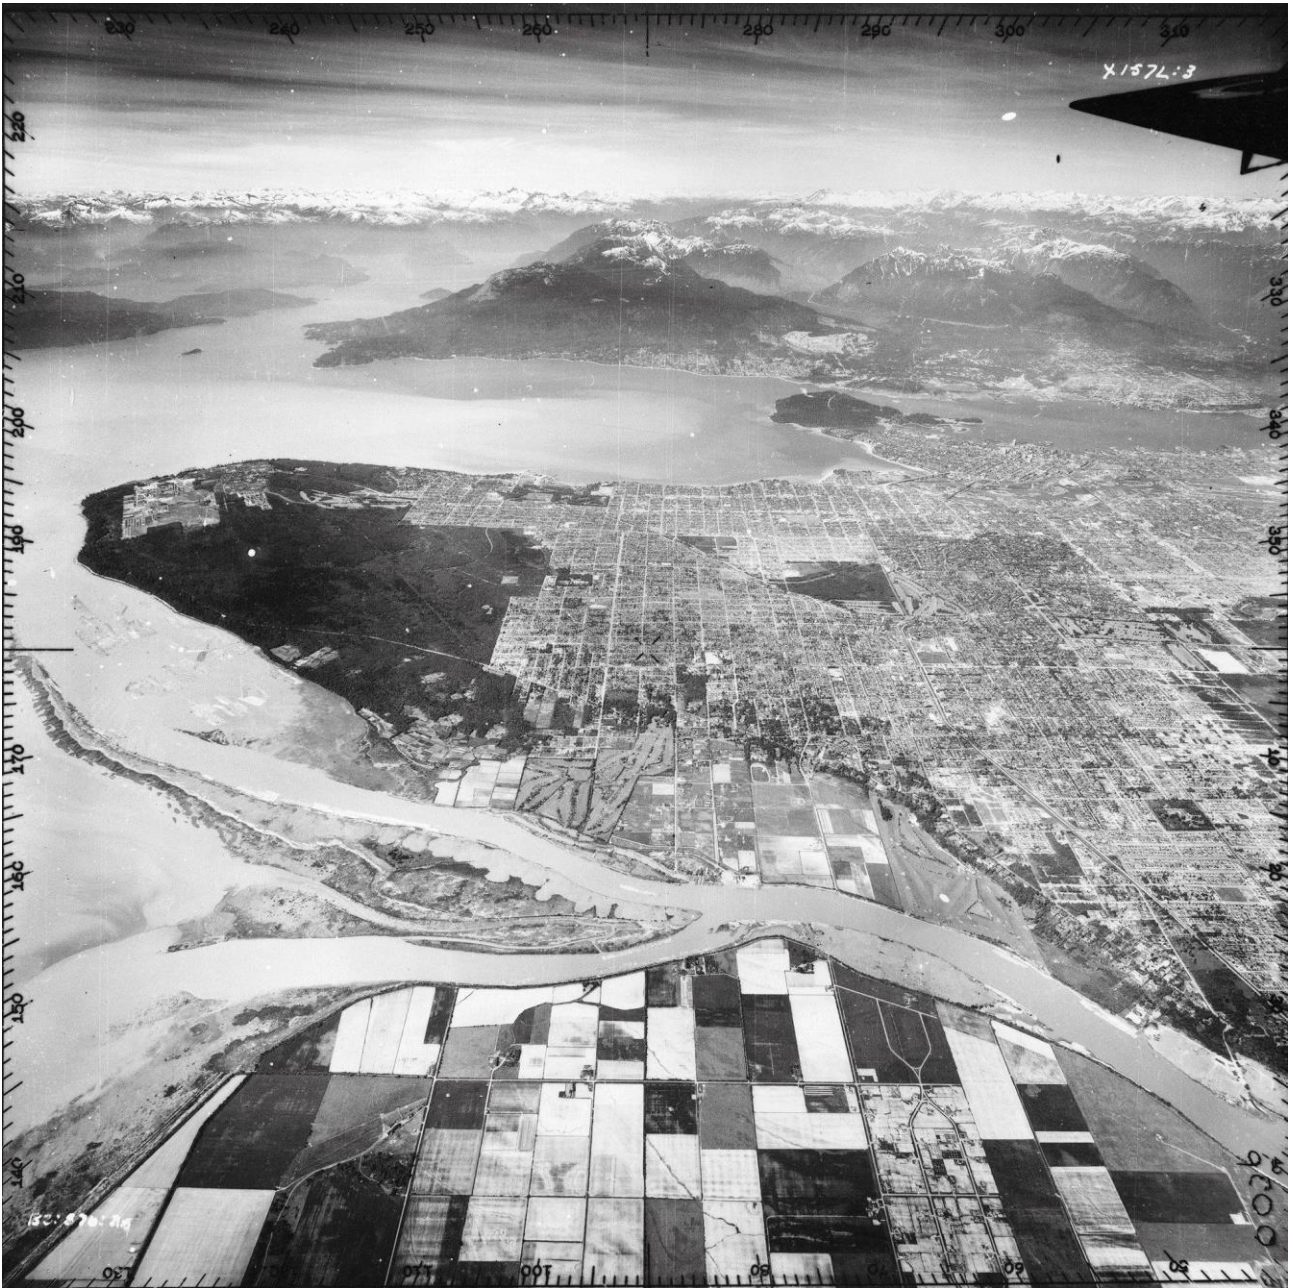
Fig. 85. Iona aerial (1948)

Fig. 85 shows Iona from a greater distance. The North Arm Jetty in its relative position to the mainland shoreline is well visible.

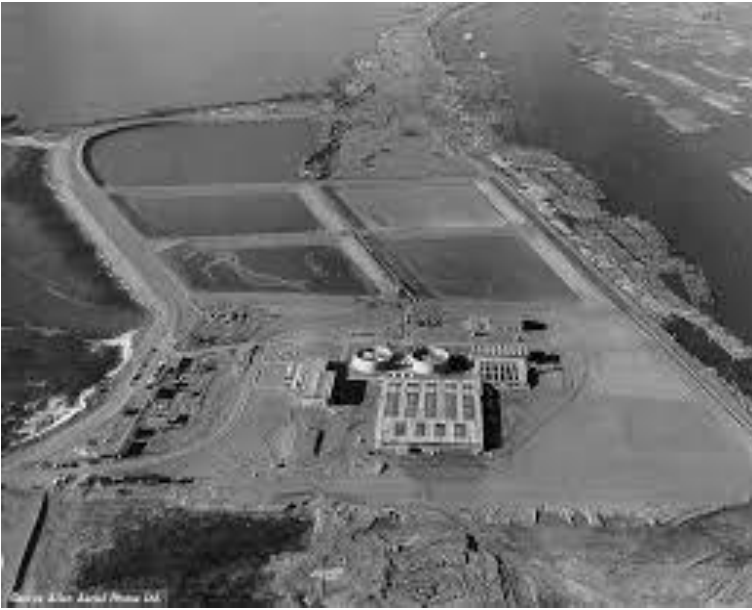
Fig. 87. Iona Island Treatment Plant

The treatment plant (see Fig. 87) and the connected jetty would resume work in the early 60s, and alongside with the erection of the plant, the Iona causeway was constructed. There-

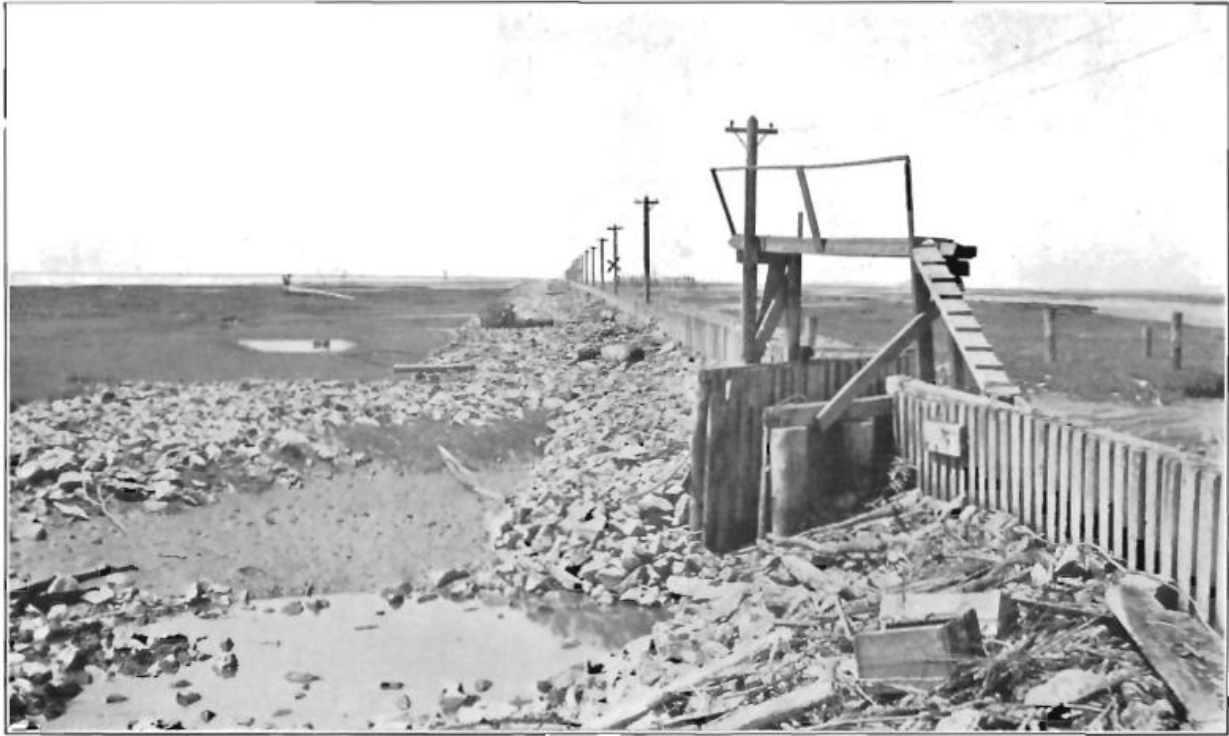
Steveston jetty and tidal flats at the mouth of Fraser river, B.C. View seaward from near inner end of jetty. (Page 6.)

The photograph was taken at low tide. Tidal flats are visible on the left and right side of the jetty.

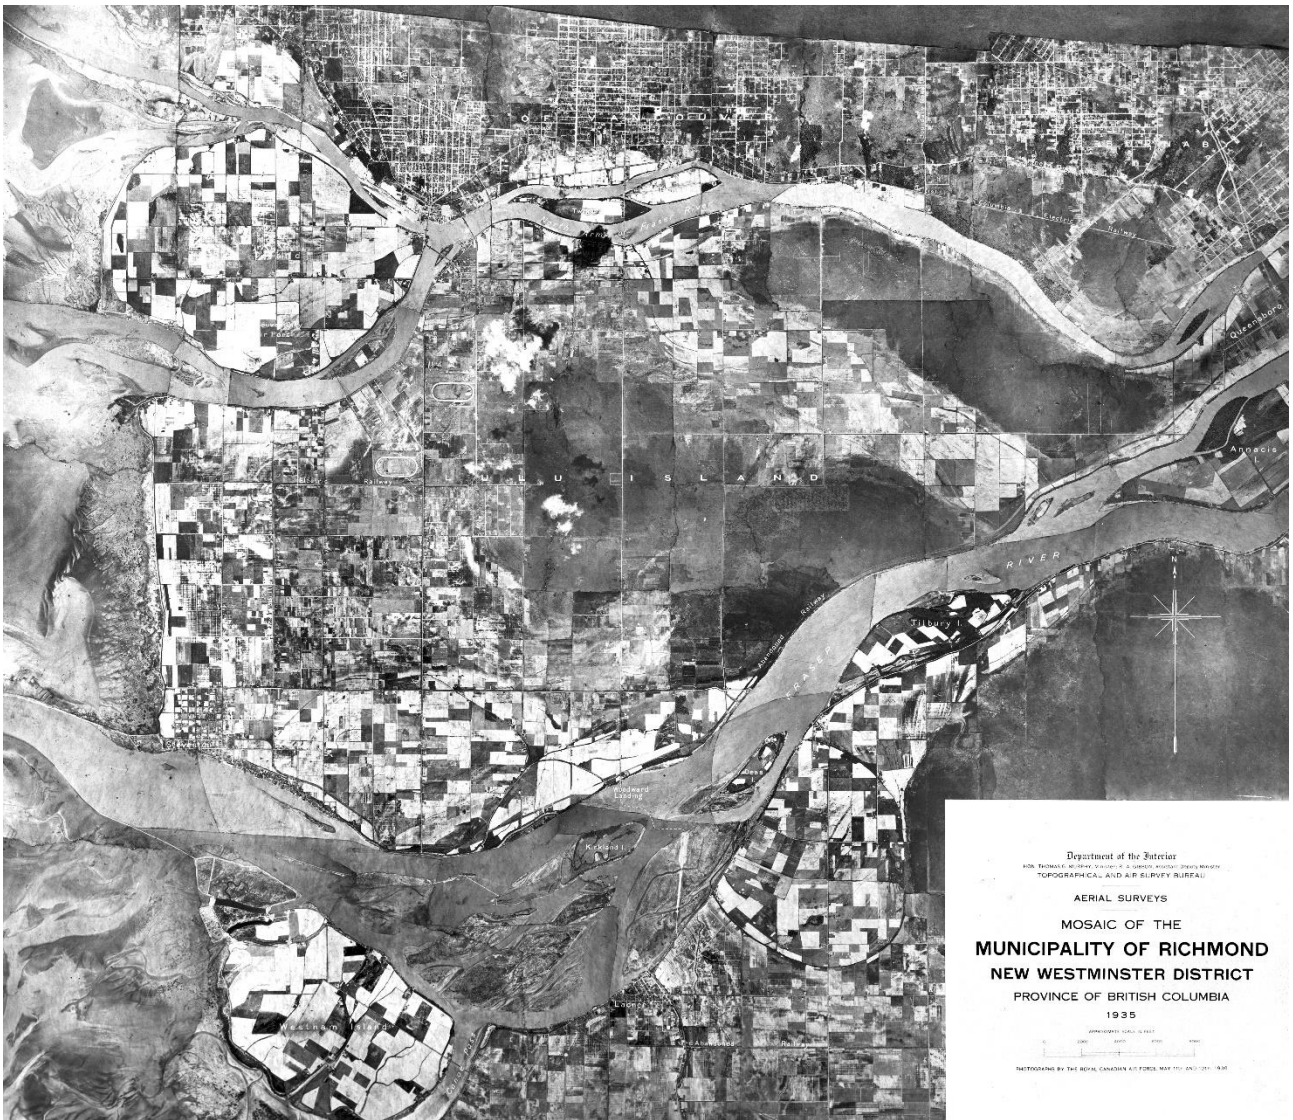
Fig. 98. Aerial mosaic of Richmond

This aerial mosaic of Richmond from 1935 shows the already extensive development on the coastal islands and the relative position of important islands discussed in this study.

- Iona Island (close to Sea Island) in the upper left corner (see also Fig. 86)
- Lulu Island with Steveston on its southwestern tip (see also Fig. 101)
- Shady Island, elongated structure located close to the Steveston shoreline (see also Fig. 102)
- Reifel Island, located across Steveston at the northwest tip of Westham Island (see Fig. 106).
- Westham Island, located below Reifel Island (see also Fig. 19).

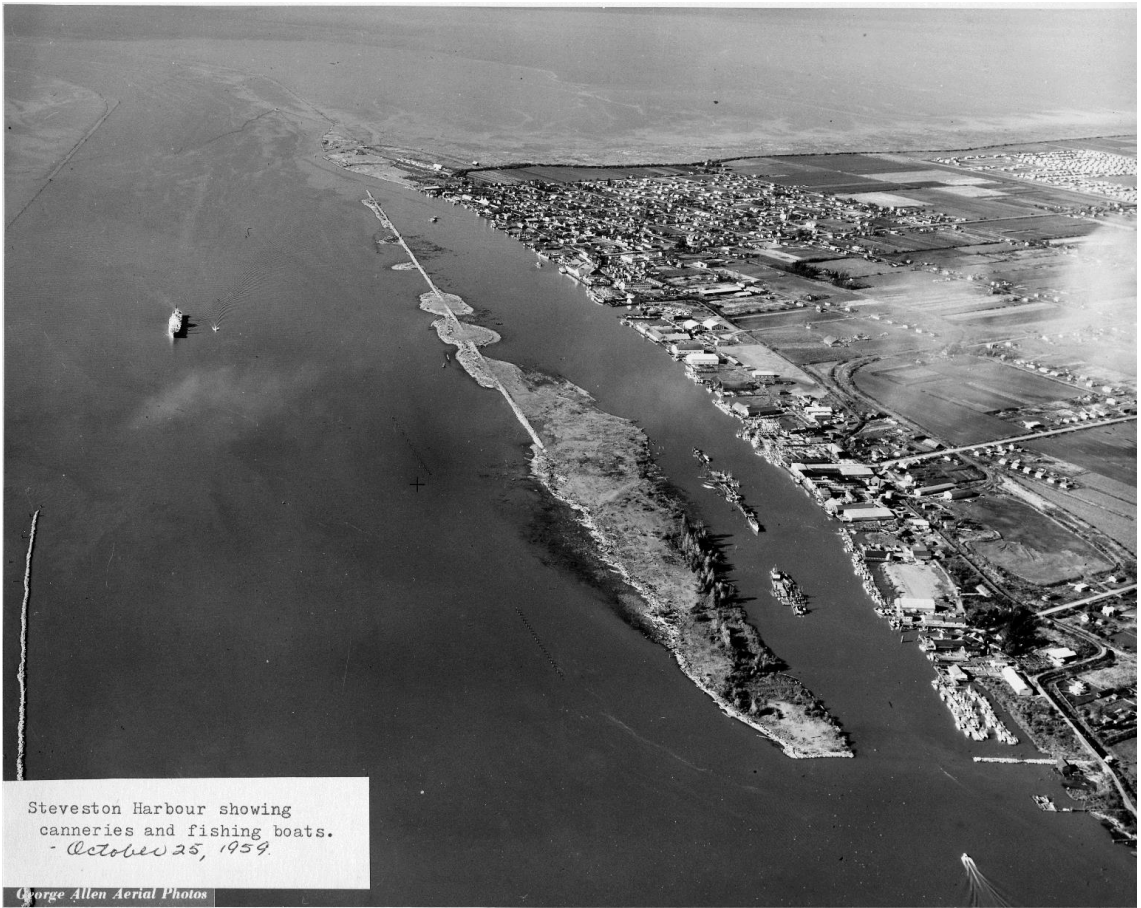
Fig. 101. Aerial of Shady Island and Steveston (1959)

This aerial shows Shady Island, likewise looking seawards, in 1967. Together with Fig.101 and Fig. 102 it is well displayed how the island, although left relatively untouched, was armored with different structures on its south-, up- and downstream side to provide calm and sheltered conditions for the Steveston waterfront.

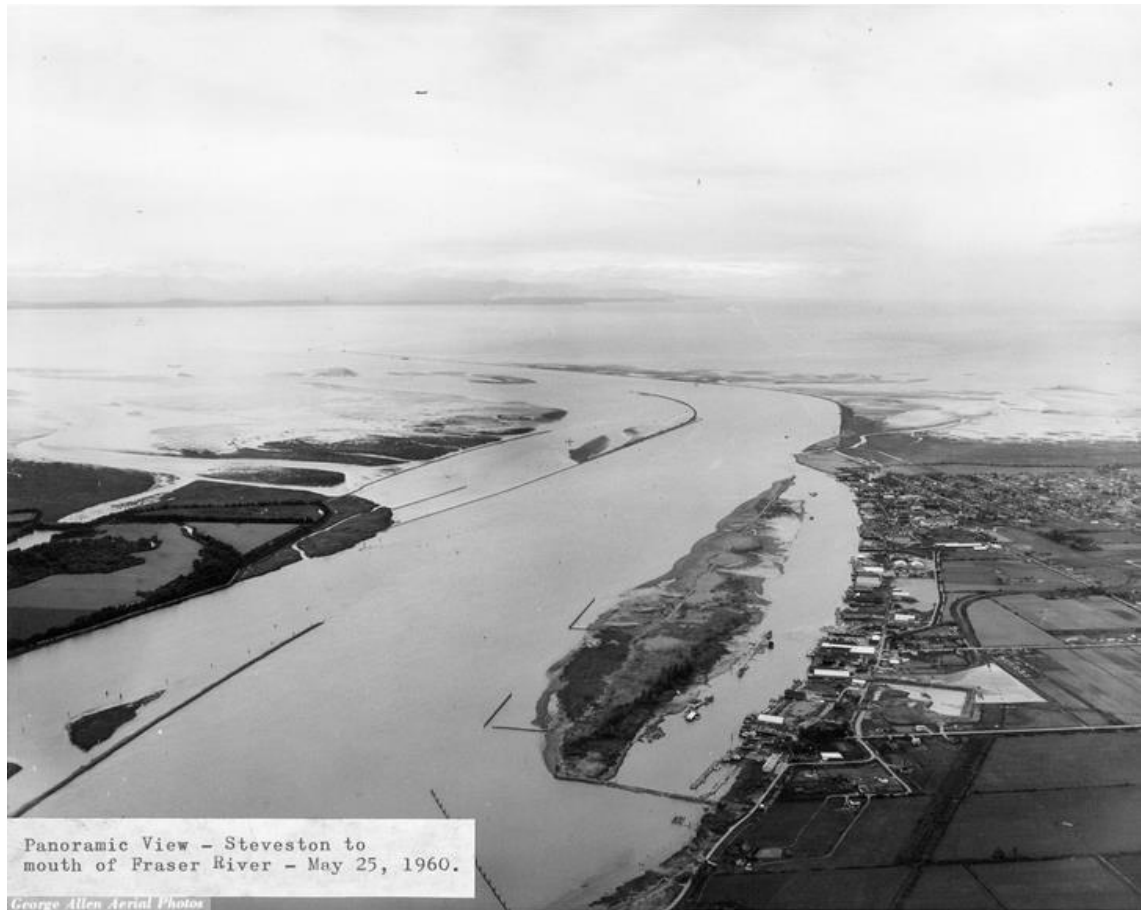
Fig. 102. Aerial of Shady Island and the jetties (1960)

While the Steveston South Jetty No.1 was also constructed in the 30s, it did not stand the test of time and had to be replaced with another, more sturdy structure - the Jetty No.2. ("Steveston South Jetty No. 2" 2014). The second jetty was put in place in the early 50s and constructed as an elongation of the Albion Training wall, which stretches towards the Strait of Georgia from Reifel Island.

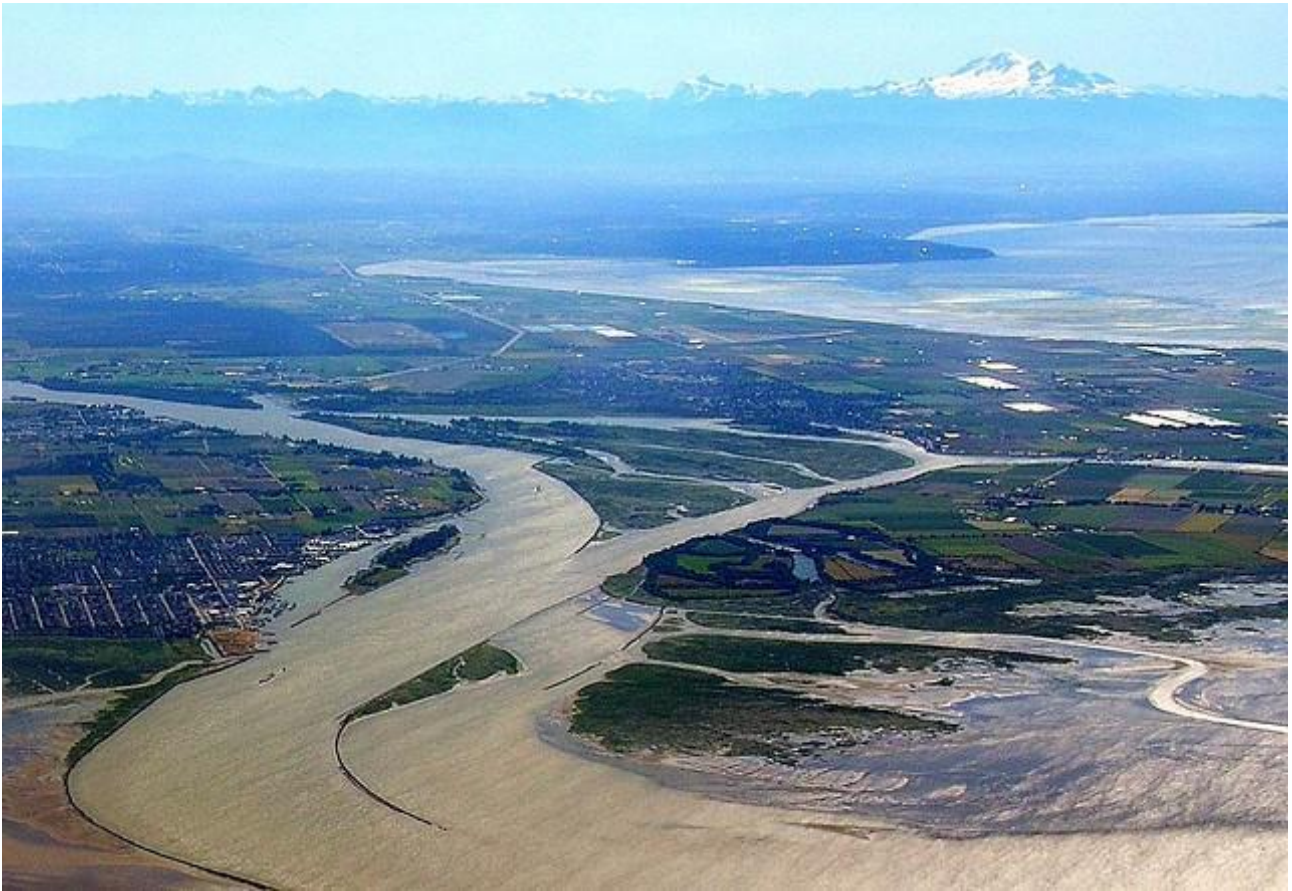
Fig. 104. Lower Fraser River today

This aerial (Fig. 104) shows Garry Point and the jetty environment at the mouth of the Fraser River south arm in its current state. The Steveston jetty extends from Garry Point on the bottom left part of the image. Sediment and marsh conditions are well visible.

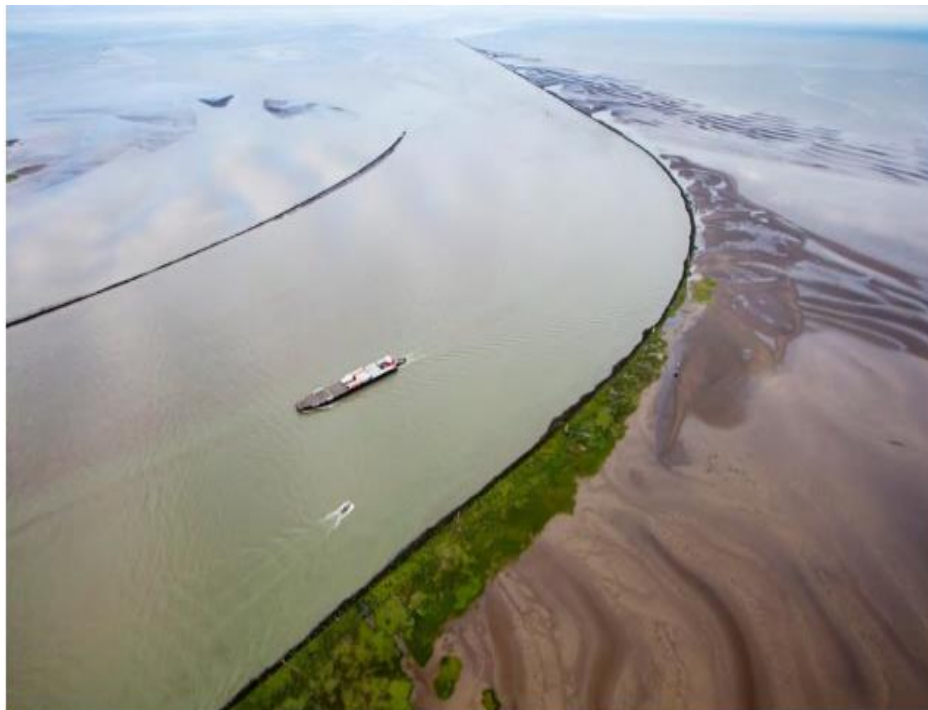
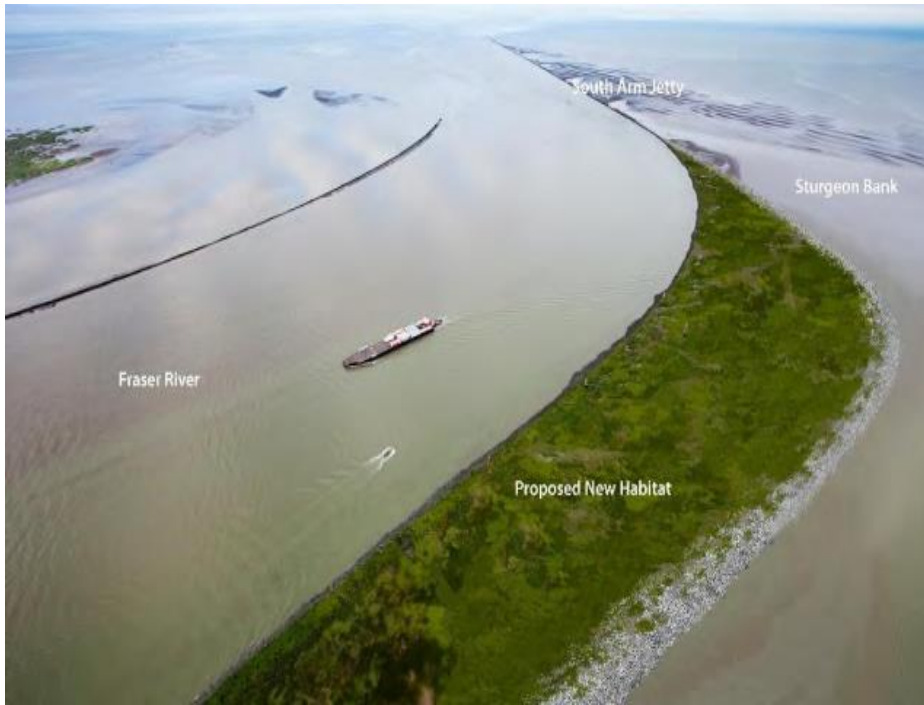
Placed amid the crucial off-coast areas Sturgeon and Roberts Bank, the northern jetty - recognizing the immense environmental impact of alike transformations - was in later years subject to reconstruction. Several sections of the structure were replaced with meshed steel wire, to allow free movement of sea life (“Steveston North Jetty” 2014). In addition, sediment disposal on the northern side of the jetty favored marsh development alongside the structure.

The pictures above show the site discussed. The first picture displays the current condition of the marshland while the second picture (simulated) shows the development goal of the project - further 43ha of sandflat converted into a highly productive marsh.
