BANK STABILIZATION FOR FLOOD RESILIENCE AND HEALTHIER HABITATS IN BRITISH COLUMBIA

A literature review and practitioner workshop summary report.

Prepared by: Charlotte Milne, UBC Sustainability Scholar 2024

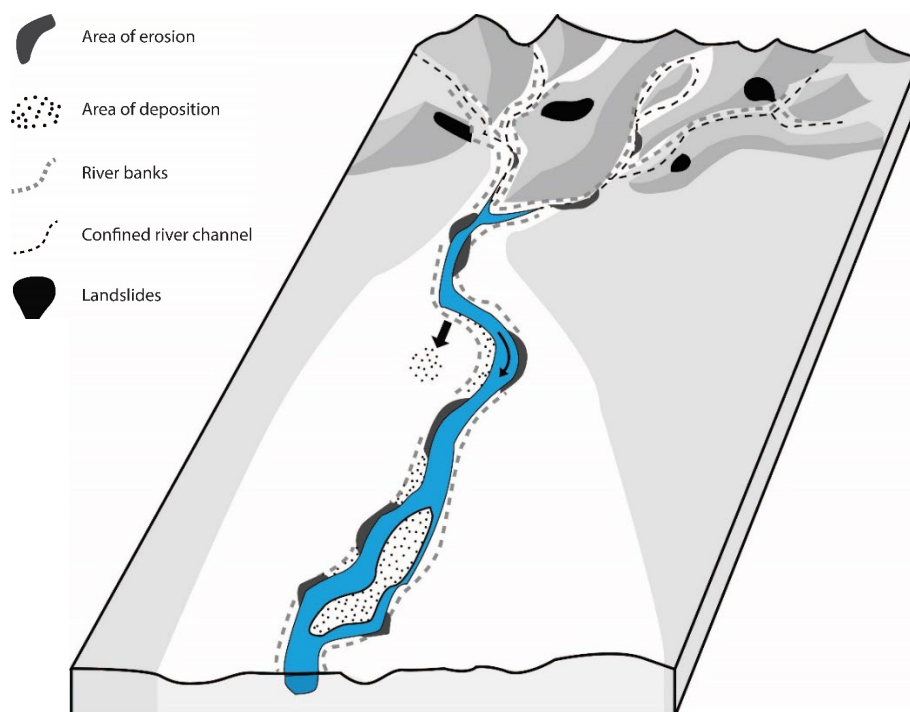
Figure 2. Diagram of the areas where erosion and deposition may be expected throughout a natural river system. This figure has been adapted from Florsheim et al. (2008).

Bank erosion is an ongoing and natural process in all rivers, with many important and significant benefits (Florsheim et al., 2008; Piégay et al., 2005). Rivers undergo erosion of their banks and bed to maintain an approximate state of equilibrium as fluctuations occur in both water and sediment supply (Pfeiffer et al., 2017). In upper reaches, there may be considerable down cutting with erosion of the riverbed, while downstream erosion of the riverbanks and lateral migration of the river channel becomes more prominent (Das et al., 2014; Florsheim et al., 2008). *Figure 2* displays the areas of the potential erosion that can be expected throughout a typical river system.

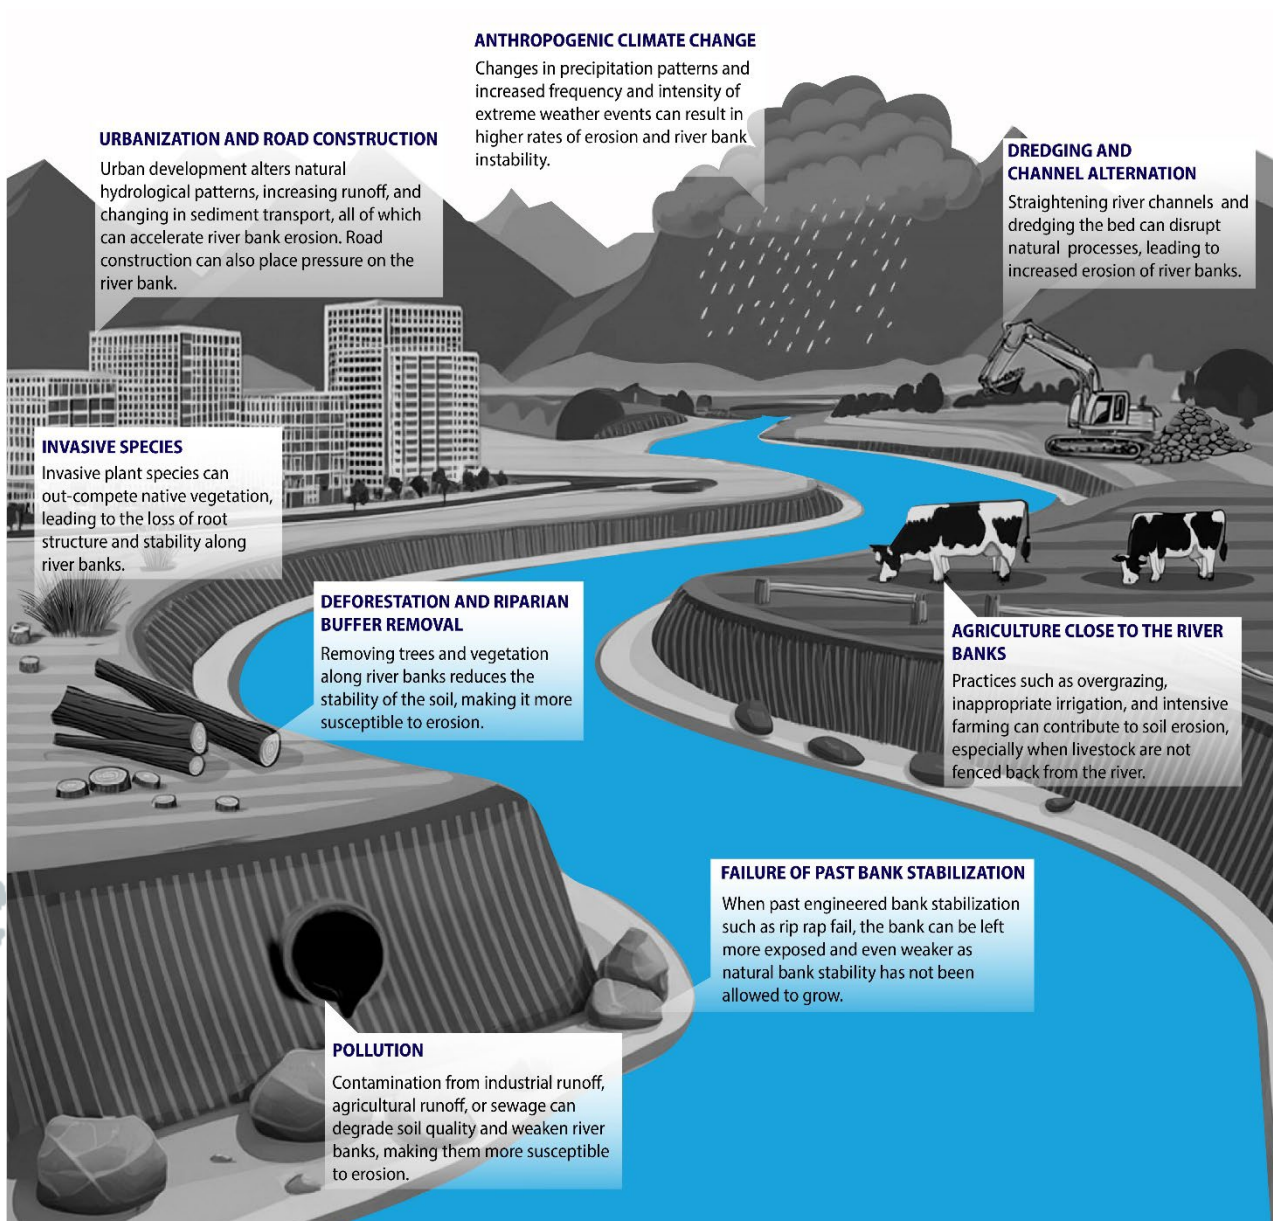
Figure 3. Anthropogenic factors which can exacerbate riverbank erosion beyond natural rates.

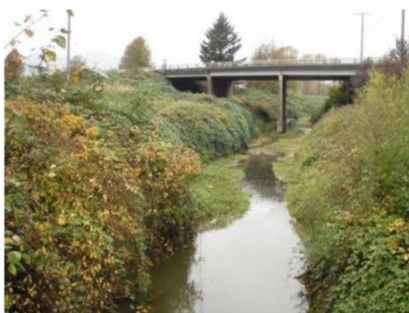
PICTURE 1

Original steep bank with vegetation that was not helping stabilization.

Steep slopes lead to an elevated risk of erosion, so a key stabilization tool is to decrease slopes to a more stable 2:1 or 3:1 profile.

- This was undertaken in a Chilliwack Creek shown in Pictures 1-3.
- Originally there was a steep slope, and while there was vegetation it was mainly Blackberry and invasives whose roots were doing little stabilization work.
- Using an excavator, the slope profile was decreased, and everything was stripped back except any large wood.
- Burlap sacking also provided temporary erosion and weed barrier as revegetation with native plants was undertaken.
- Ten years later the large trees are growing successfully on the upper slopes and erosion has decreased, protecting the farm that lies next to the river.

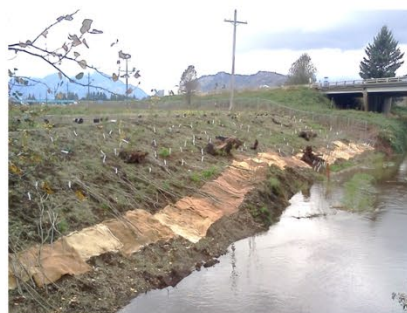
PICTURE 2

Bank immediately after excavation, slope has been significantly decreased.

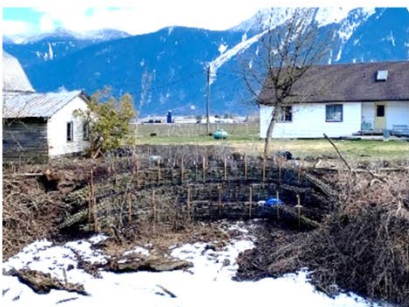
PICTURE 1

Highly eroded bank with the early wattle fencing being put in place.

- Severe erosion was threatening a farm and its buildings, so bioengineering was implemented to increase bank strength.
- Soil that had been lost during erosion needed to be replaced, and then wattle fences were created along the bank.
- Metal fences were introduced as a temporary measure during the high river flow months to give the vegetation time to grow.
- After ~one year of growth, the bank is highly vegetated, and the farm is better protected.

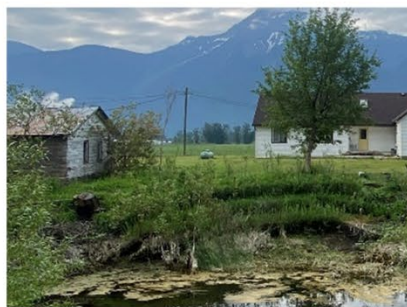
PICTURE 2

The bioengineering in its initial growth phase, supported by metal fencing.

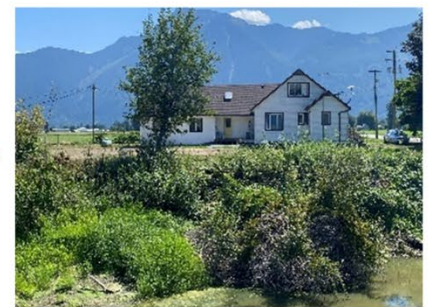
PICTURE 3

The bank ~1 year later with significant vegetation growth.

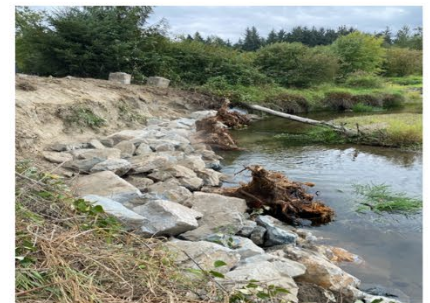
PICTURE 1

LWD amongst riprap.

- Large woody debris (LWD) can be installed instream at the toe of riprap, decreasing erosion while increasing bank complexity and habitat potential.
- Soil wraps are a medium that can be driven into banks, drastically decreasing erosion, while allowing for vegetation growth through the material.
- Methods work best when combined with decreased slope.
- While these methods may be more labour intensive than riprap alone, they result in far less environmental or cultural impact.

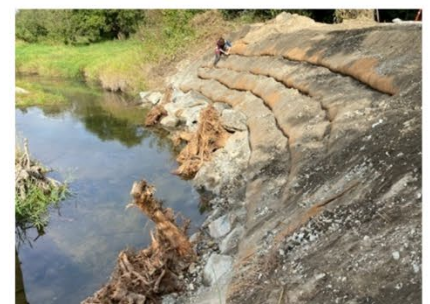
PICTURE 2

Soil wraps that allow plant growth through the material.

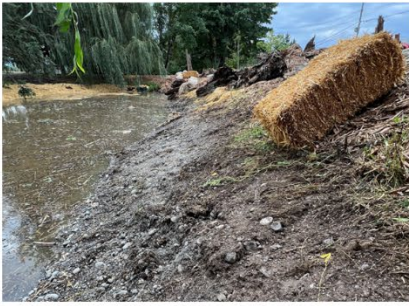
**PICTURE 1**

Eroded bank with straw prior to spreading, seeds have been spread.

- S.A.Y. Lands is using straw and hand-spread seeds on banks, encourage rapid plant growth.
- The method is cost effective, with the common seed types being incredibly cheap, while the straw itself can be old and otherwise unusable.
- The method is being applied to steeper and shallower slopes.
- Rapid growth of Rye seeds provides almost immediate slope stabilization improvements, with tough roots that are difficult to remove.
- In the presented site, significant seed growth occurred within only 8 days, helped by the protective and nutrient-rich straw barrier.

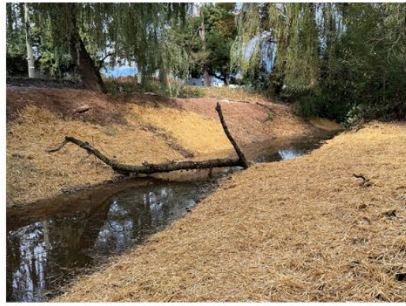
**PICTURE 2**

The bank after straw coverage.

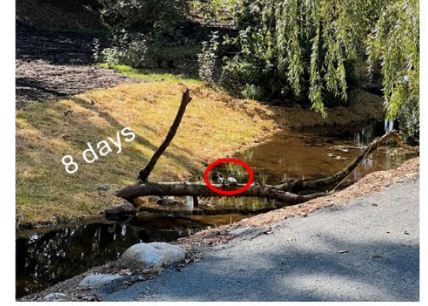
**PICTURE 3**

The bank 8 days later, with visible plant growth and animals gathering.

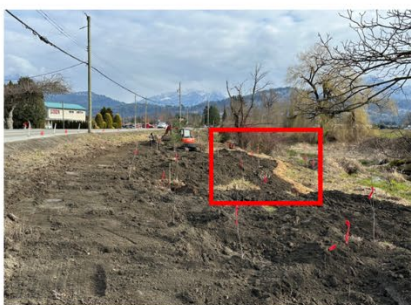
**PICTURE 1**

Creation of a wood mulch berm, prior to the spreading of additional mulch over the top surface.

- Wood mulch is being used in S.A.Y. lands projects to both build up berms, and to layer overtop a wider bank area.
- The method provides a protective barrier against erosion, while also providing beneficial bacteria and soil nutrients for revegetation efforts.
- The process involves the creation of an initial berm, building up the protective barrier and allowing sediment retention.
- A secondary layer of mulch is then draped over top of the area, this both locks the berm securely into the bank, and provides an ideal substrate for the staking of plants across a wide bank area.

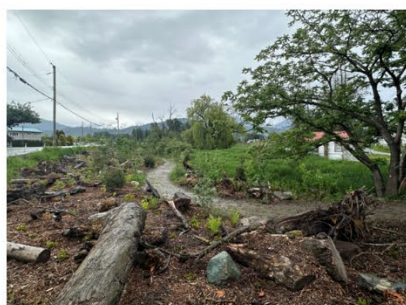
**PICTURE 2**

Vegetation growth in the mulched area following direct staking.

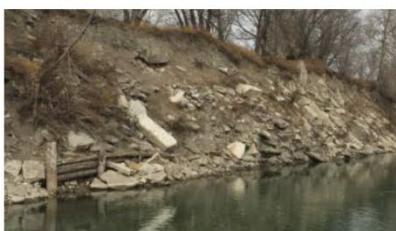
PICTURE 1

Site 1 bank in 2017, prior to works.

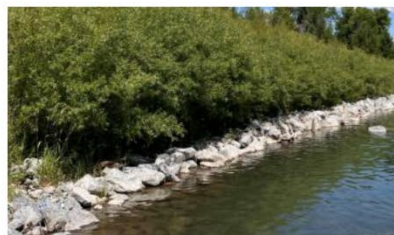
PICTURE 2

Site 1 in 2023, following works.

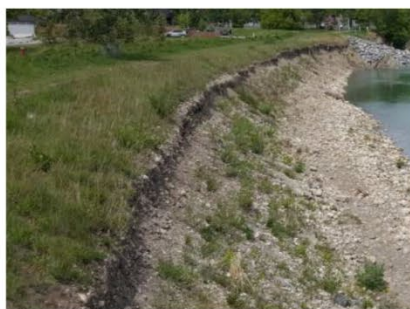
PICTURE 1
Site 2 bank in 2016, prior to works.

1. Box fascine
2. Brush mattresses
3. Hedge brush layers
4. High density live staking

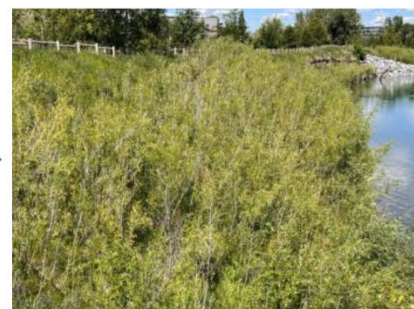
PICTURE 2
Site 2 in 2023, following works.

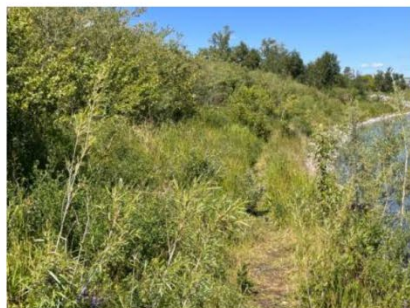
PICTURE 1
Site 4 bank in 2016, prior to works.

1. Soil filled riprap with shrub plantings
2. Void filled riprap with plug plantings
3. Void filled riprap with live cut & other plantings (joint)

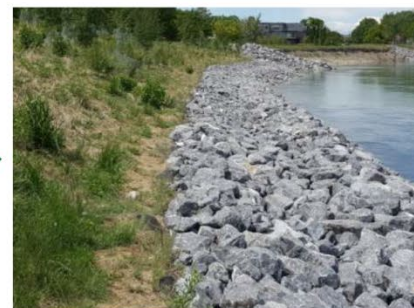
PICTURE 2
Site 4 in 2023, following works.
