THE UNIVERSITY OF BRITISH COLUMBIA

MECH 456

Biodiesel Engine Compatibility Study

Submitted:
April 30, 2004

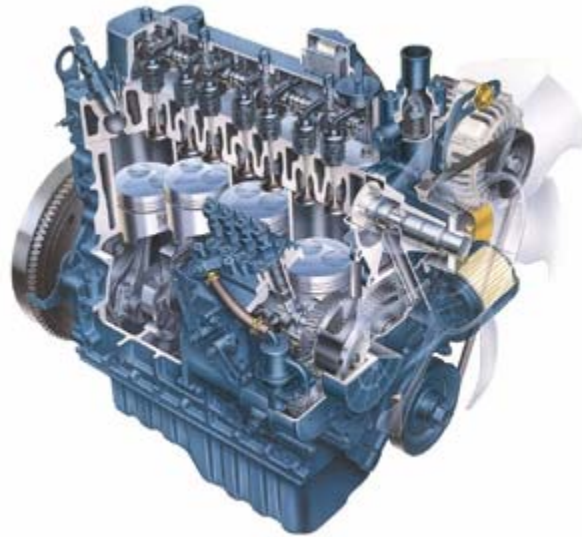
Figure 4 – Kubota Super 05 V-Series Engine

The engine selected for testing was a Kubota V1305-E 1.3L, four cylinder, liquid cooled, indirect injection diesel. The engine is rated to produce 30 hp at 2700 rpm. A goal of the Biodiesel Initiative at UBC is to have Plant Operations consume the biodiesel produced, therefore it was deemed important to pick an engine that they used. Given UBC Plant Operations uses a number of these engines in their Kubota F3060 lawn tractors, it was felt this would be a good candidate for testing UBC produced biodiesel.

A new, stripped down V1305-E, as shown above, was sent from Kubota Canada to perform testing. To this engine an air filter, muffler, and fuel filter were added. All of these parts were standard Kubota parts for the V1305 engine. The only modifications made to the engine were the removal of the cooling fan and the change of all rubber fuel lines to polyethylene lines.

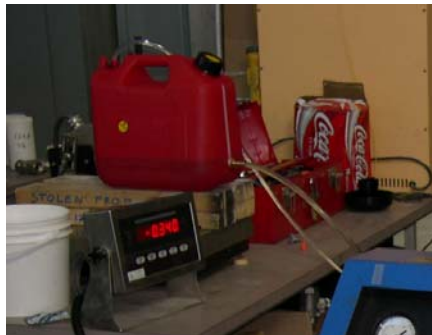
Figure 5 - Fuel System

Fuel consumption is important for these tests to enable a proper monitoring and performance evaluation of the engine. To measure fuel consumption the pail and scale method was used. This method has proven more accurate than flow meters for low flow rates and accounts for the amount of fuel returned to the tank from the injectors. The scale used in this case was an IQ Plus 355 series digital scale. A BNC plug was attached to the voltage outlet of the scale so that the Data Acquisition system (DAQ) could monitor the weight of the fuel at the same time as it recorded the torque and RPM.

The fuel system hoses were also changed to polyethylene because biodiesel has shown to be incompatible with some rubber used in fuel systems⁵. Polyethylene hoses were run from our fuel tank (pail), a modified nine liter jerry can, to our engine (see Figure 5).

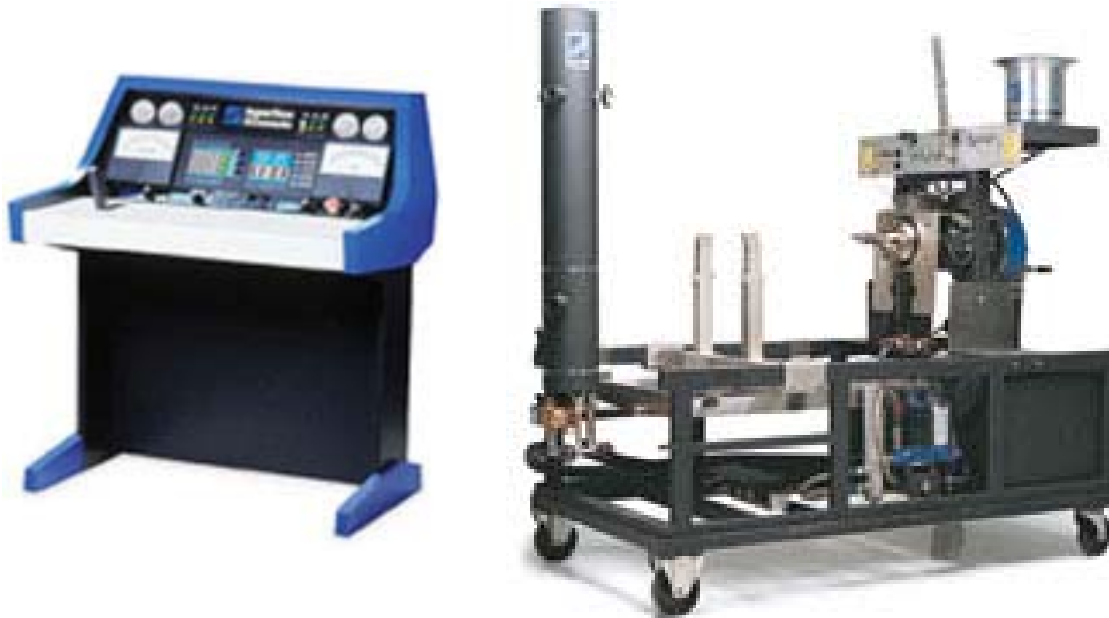
Figure 6 – Superflow Control Bench and Dynamometer

The dynamometer used for testing is a Superflow SF-901 water brake style dynamometer with a classic control bench (see Figure 6). Outputs currently available from the dynamometer are RPM, torque, and airflow. The dynamometer has the ability to output fuel flow and various temperatures and pressures, however for the scope of our testing only RPM, torque and airflow will be taken from the dynamometer. The dynamometer is rated for up to 1500 hp and as such

has more than enough capacity to handle the 30 hp Kubota engine. A representative from Superflow was contacted regarding the suitability of the SF-901 for this application and the only concern made was low RPM loading of the engine may be difficult.

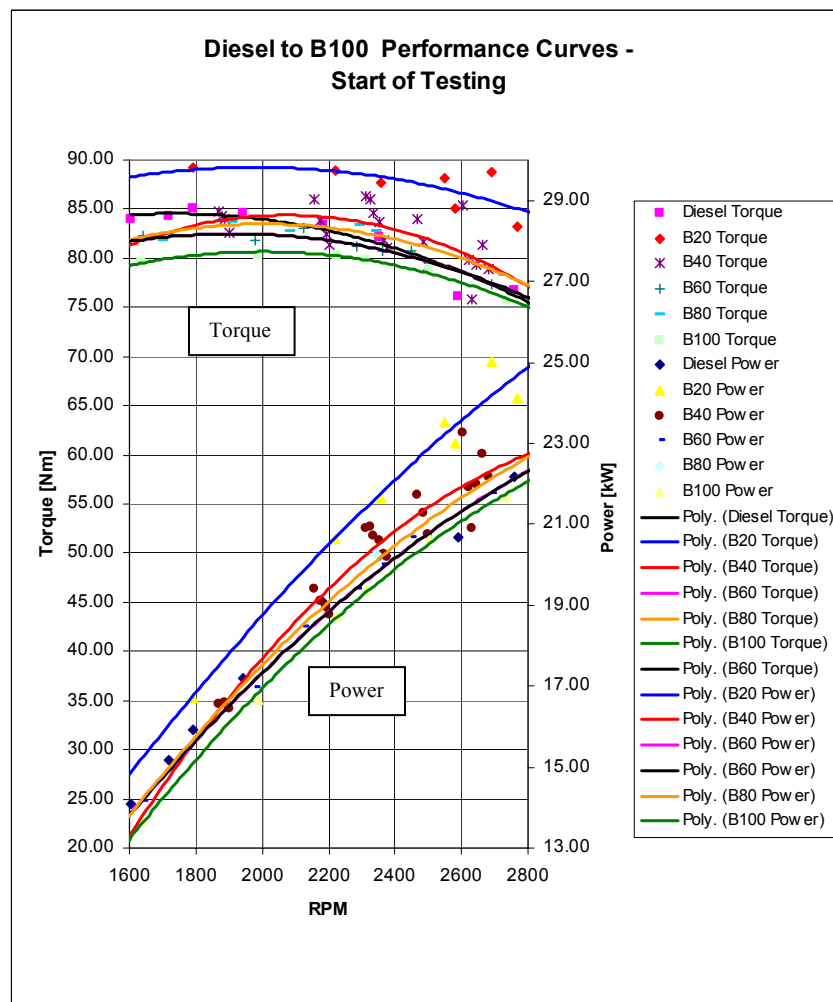
Figure 10 – Performance Curve Comparison Start of testing

From the three different tests (Performance 1, Endurance, and Performance 2) and the six different blends of fuel, a number of comparisons could be made. The following plot compares the different blends' performance curves during performance test 1.

From the above plot a few things should be noted, B20 results appear to be shifted significantly higher than the other fuels tested and the expected trend of decreasing power with increasing

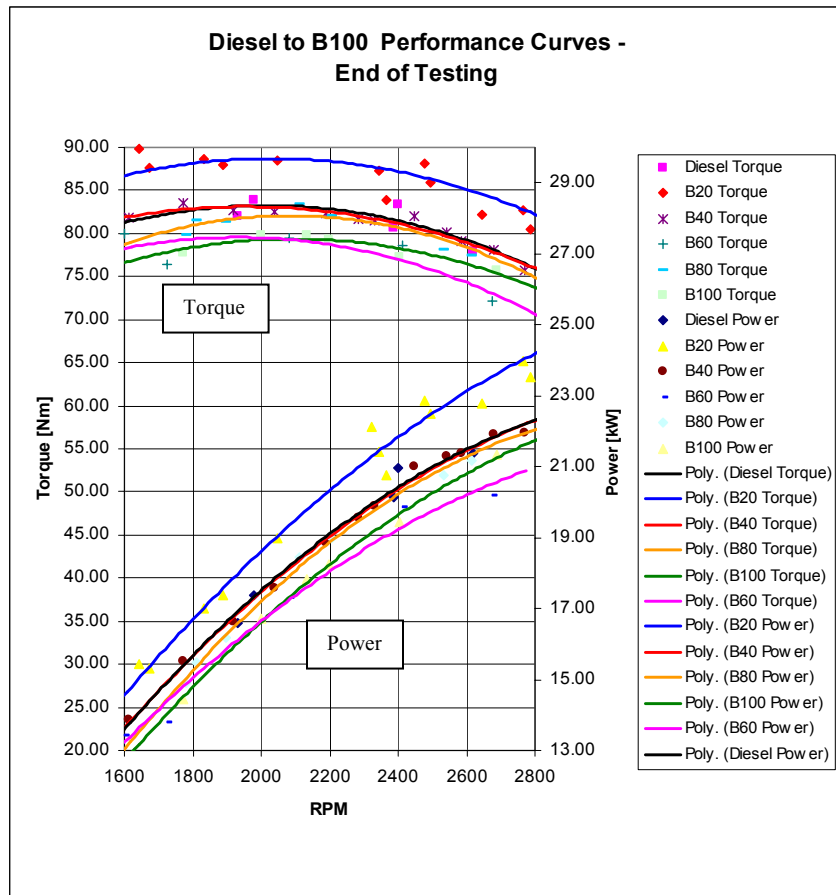
Figure 11 - Performance Curve Comparison End of testing

biodiesel content was not consistently observed. Both these issues require further investigation. A comparison of the performance curves obtained at the end of testing yield similar results to the first curves. A plot comparing the second performance curves from the various fuel blends can be seen below.

Again B20 was shifted significantly higher than the rest of the blends and the trend of decreasing power with increasing biodiesel content was not consistently observed.

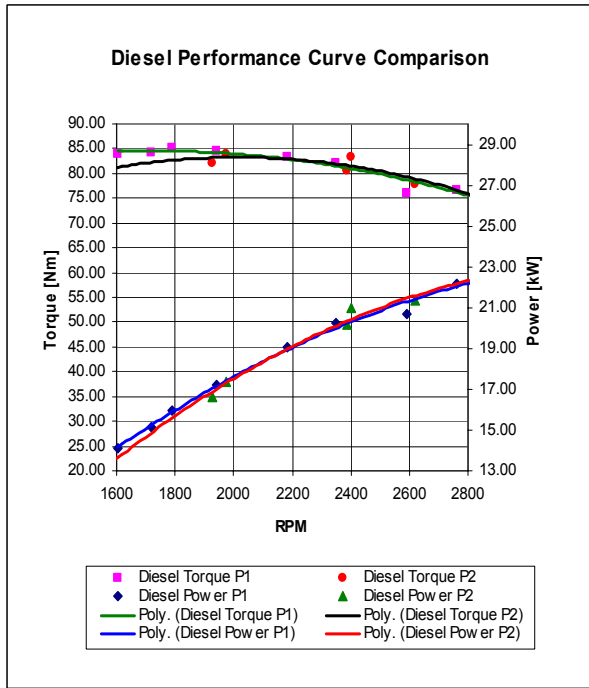
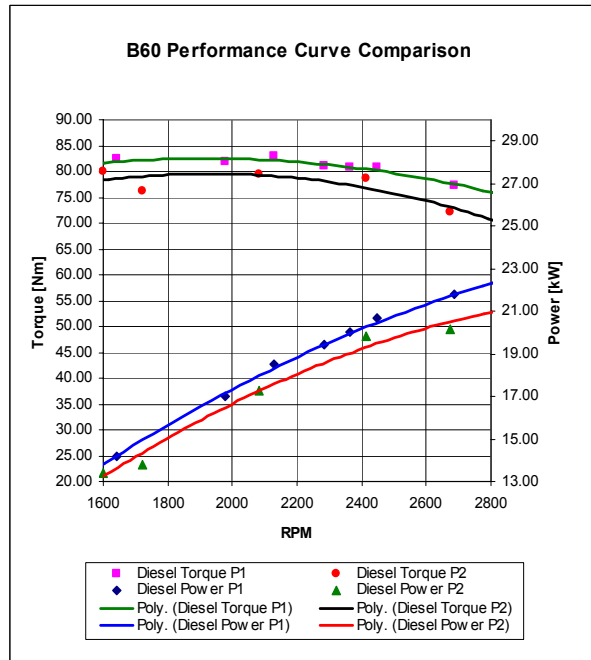
Another comparison of interest is the start of testing (P1) and end of testing performance curves (P2) of the individual fuel blends. From this comparison degradation of engine performance, if present, may be shown. The before and after comparisons of Diesel, B20, B40, B60, B80 and B100 follow.

Of the above plots, the only blend that showed a significant amount of change from start to finish was B60. Even with this case the difference between start and finish was less than 2 kW change in power output. However, this does not follow the trend of minimal change (less than 1 kW) in performance of the rest of the fuel blends, most importantly the higher blends B80 and B100.
