UBC Social, Ecological, Economic Development Studies (SEEDS) Student Report

**The ground beneath us: managing soil at UBC for improved drainage and reduced compaction**

Sustainable Soil Management, SOIL 502

July 14, 2010

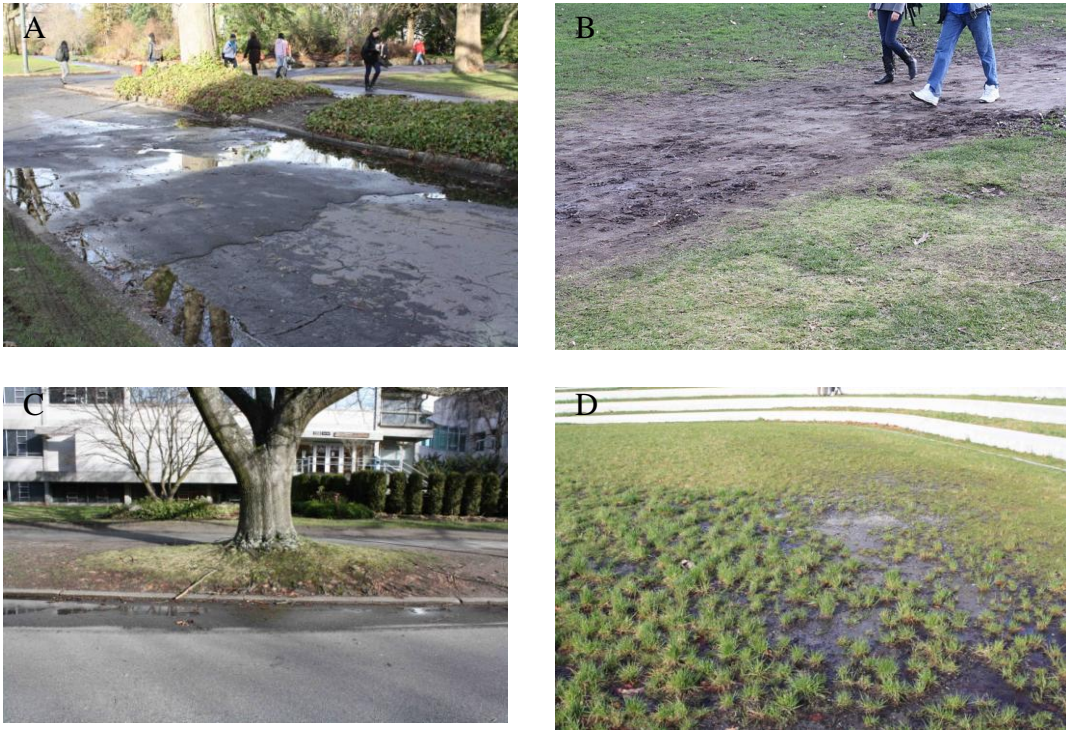
Upon inspection, soils along Main Mall were visibly degraded. Pedestrian walkways were poorly drained (Figure 1A), poor landscape design led to severely compacted and poorly drained improvised walkways (Figure 1B), severe compaction occurred around ornamental trees (Figure 1C), and poor drainage was evident in the playing field ('bowl,' Figure 1D). Poorly drained areas were often centred around areas of compaction. Compaction contributes to poor drainage by reducing porosity (increasing bulk density) and is caused primarily through foot traffic and maintenance vehicles driving over soil. Additionally, higher water content increases severity of compaction (Brady and Weil, 2002). Ultimately, mechanisms of soil degradation at UBC are human and vehicle traffic and inappropriate landscape design.

**Figure 1:** Soil landscapes along Main Mall. A) Poor drainage, B) Improvised path and compaction, C) Compaction around ornamental trees, D) poor drainage in playing field.

Compaction seems to be the main challenge for UBC soils, and remediation should focus on addressing this aspect of soil quality. Reducing stress is the first step to remediation: proper routing of pedestrian and vehicle traffic away from soil and prevention of corner cutting through use of corner fences or hedges. The UBC Public Realm Plan proposes to address this issue by restricting vehicle and redesigning Mail Mall with a pedestrian focus (UBC, 2009). Some areas of severe compaction, such as around the Oak trees along Main Mall, require more drastic approaches for remediation. Solutions to these compaction problems may include (Kuser, 2007):

- Radial trenching. Trenches are dug around a tree trunk and filled with soil and organic material to deliver nutrients.
- Mulch Applications. Application and maintenance of a 10 cm mulch layer that will slowly rebuild a healthy surface soil.
- Compressed air treatment. Injection of compressed air or water to create fractures and decrease bulk density.
- Mechanical breakup. Tillage of soil with equipment (such as a subsoiler).
- Soil amendments. Rotary tillage of low-density supplements into compact soil.

Ultimately, the soil on UBC campus should be managed for its intended use. Large areas of lawn should expect to be areas of recreation and should be managed to meet this need. Proper aspects of turf management should then be applied, such as having soil depth >50 cm to improve drainage, avoidance of surface depressions, prevention of thatch build-up and subsurface drainage where appropriate (French, 1986). Also, given that most students are on campus during the wet winter, there should be adequate drainage to prevent further compaction. Soil depth will alleviate this issue, but subsurface drainage should be installed if the soil is not deep enough to prevent surface pooling.
