# OPERATIONAL PERFORMANCE OF CROSS LAMINATED TIMBER : **BROCK COMMONS TALLWOOD HOUSE**

SEPTEMBER 2020

This report describes the performance of the mass timber structure in Tallwood House, between September 2017 and August 2019, based on measurements of the moisture content in the prefabricated CLT floor panels and the displacement of the vertical structural system. It is intended to initiate discussions on the performance of mass timber structure elements during building occupancy and lead to further research that can explore the influential factors.

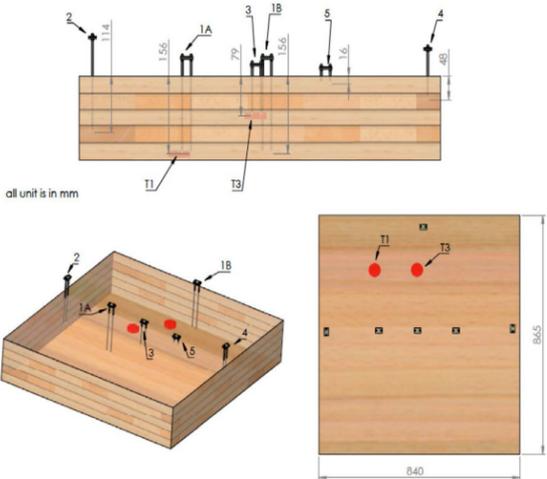
Figure 1: Location of the moisture content and temperature sensors within a CLT panel.

Since wood products can be susceptible to moisture damage, tracking moisture levels during construction and occupancy is valuable in determining appropriate water protection strategies. In order to study the moisture content of the CLT floor panels in Tallwood House, multiple moisture sensors were installed in select panels during their fabrication. Each monitored CLT floor panel has six moisture sensors (MC1A, MC1B, MC2, MC3, MC4, MC5) to measure moisture content at different layers, as well as two temperature sensors (T1 and T3) at different depths in the CLT panel, as shown in Figure 1.

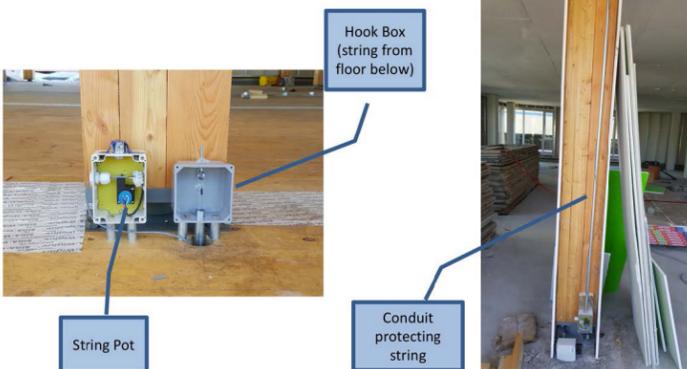
Figure 2: Arrangement of the string pot sensors along the columns.

In Tallwood House, string pot sensors were installed to monitor the vertical movement of the mass timber columns. These sensors were assembled by connecting a no-stretch cable from the bottom of one floor to the top of the next floor above, see Figure 2. The displacement of each GLT or PSL column is measured (in millimeters) through cable movement by the sensor on the lower floor. The sensor assembly was repeated on one line of exterior columns continuously through all the 18 floors, allowing for the possibility of floor-to-floor comparison. Like the moisture data, the string-pot sensors are continually accessed through remote monitoring.

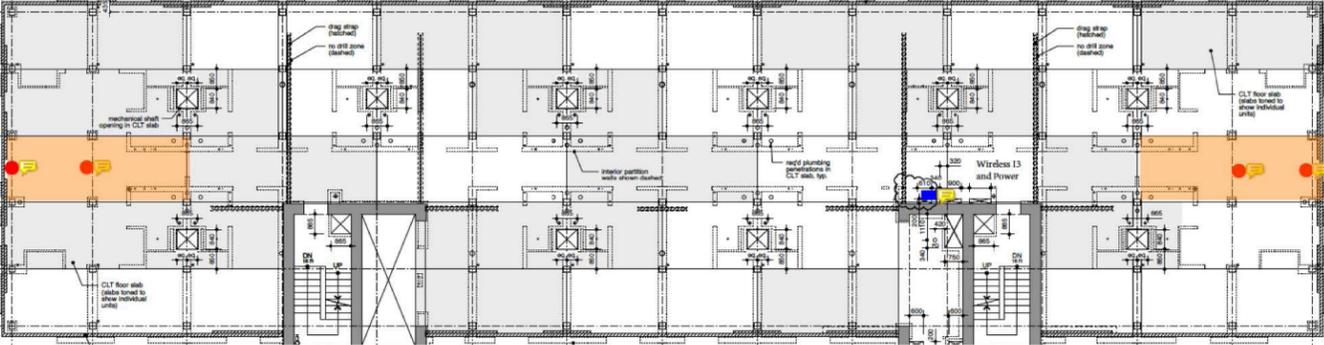
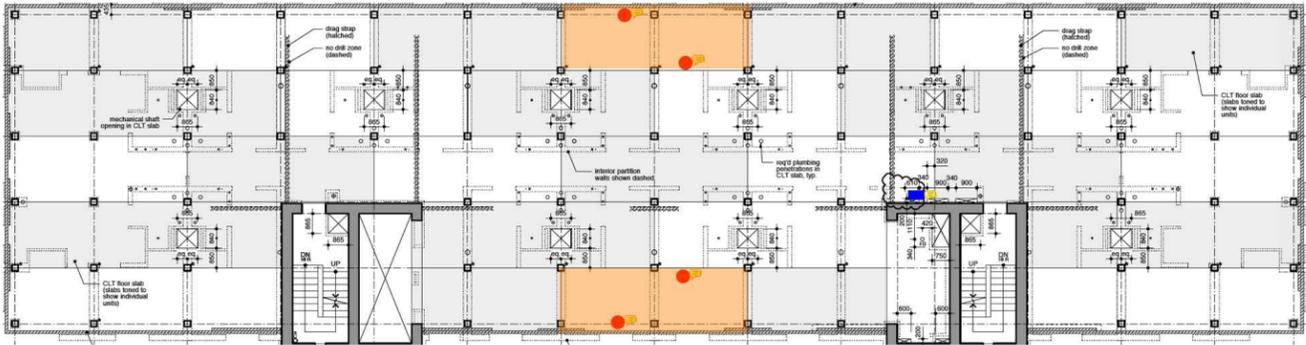
Figure 3 : Location of the moisture content and temperature sensors installed CLT panels on each floor. (LEFT: East-West moisture monitoring sensors, RIGHT: North-South moisture monitoring sensors)

The floor sensors were positioned on alternate floors, see Figure 3, with data from panels on Floor 4, 8, 12, 16 in North-South locations, and data from Floor 3, 6, 10, 14 data in East-West locations. The data acquisition systems are continually accessed through remote monitoring.

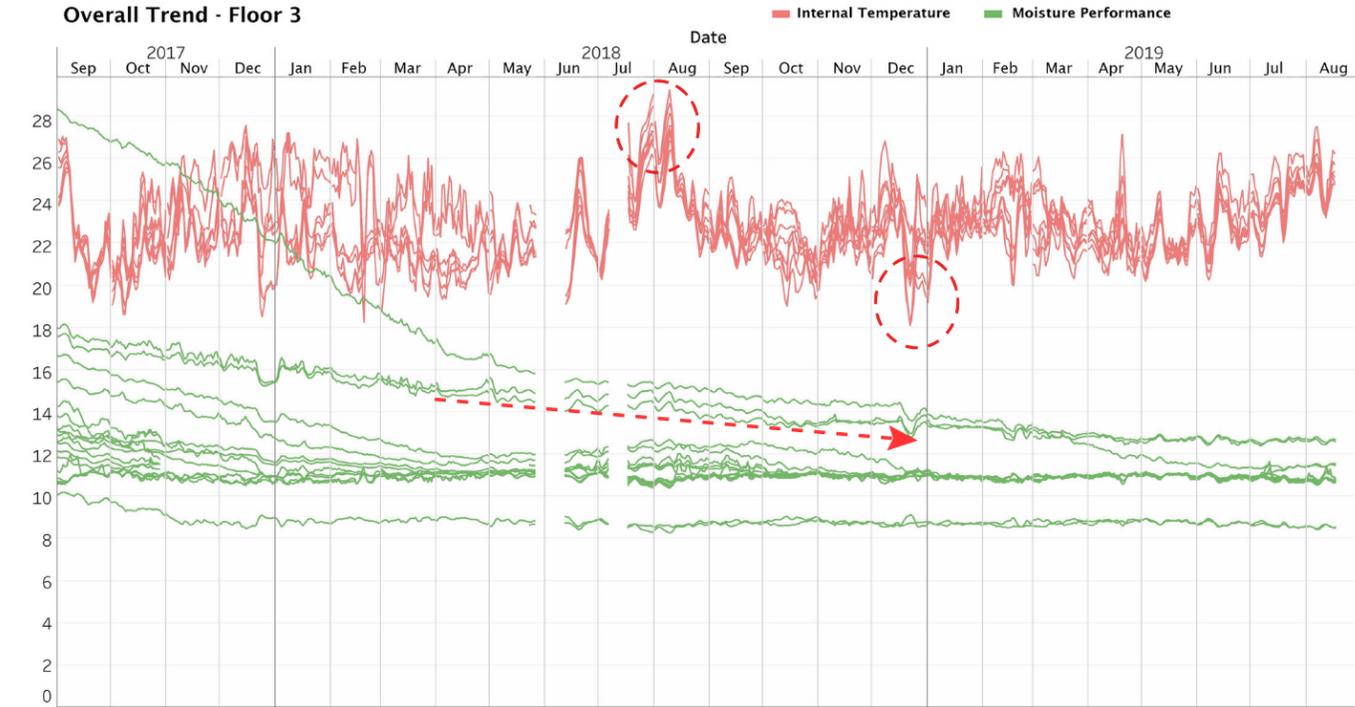
Figure 4: Overall Trend - Floor 3.  
The moisture content and internal temperature of the CLT panels plotted against the period from September 1, 2017, to August 31, 2019 for sensors at Floor 3, sourced from East-West locations.

As seen in the graphs, the average moisture content (MC) from the CLT panels was about 10-20%, consistent across the floor locations. Moisture sensors on Floor 3 showed a diminishing trend from a range of 12-18% MC during initial months of occupancy to a range of 8-15% MC after two years in use, illustrating the drying of the CLT panels over the time. The moisture levels did not show any substantial spike or drop at any point during the monitored period, and a similar drying pattern as observed in the data from other floors.

The temperature data measurements indicated a visible variation with the internal temperature of the CLT panels on Floor 3, between 18 and 30 degrees Celsius with the highest temperature during the summer months and lowest during winter months. Similar trends were observed for the other floors, although the lowest spike in temperature on the higher floors reached 14 degrees Celsius.

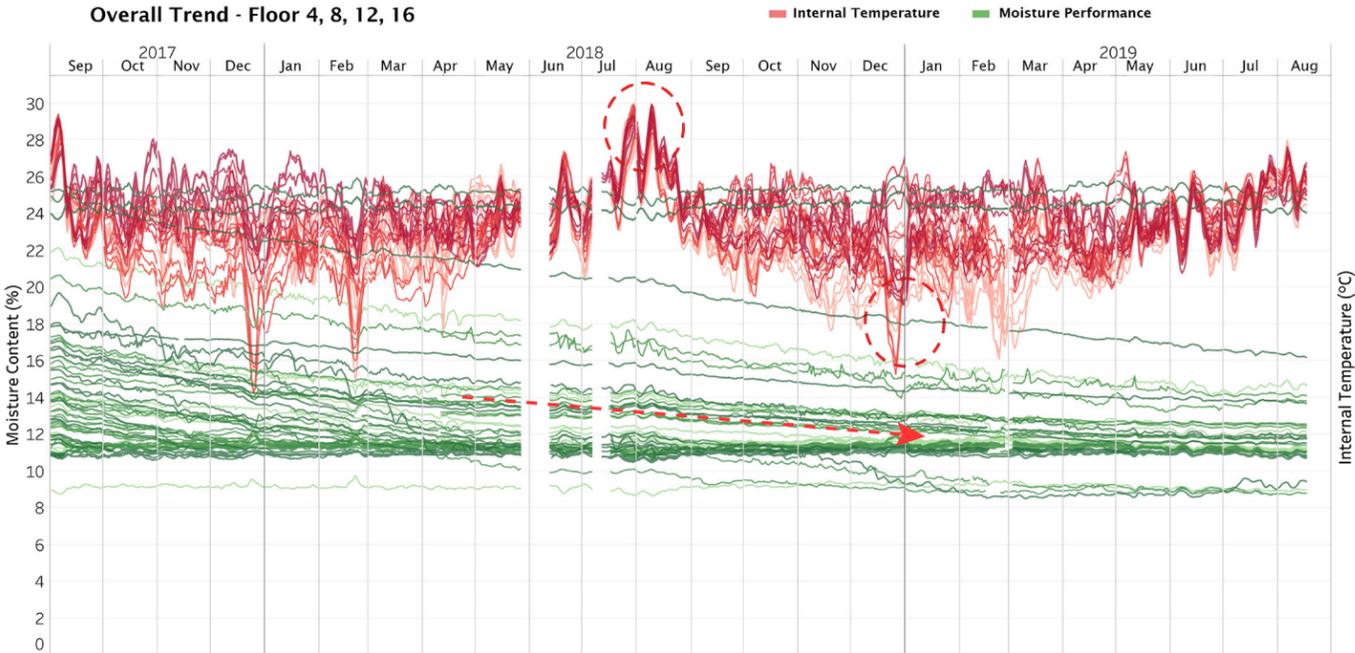
Figure 5: Overall Trend - Floor 4, 8, 12, 16.  
The moisture content and internal temperature of the CLT panels plotted against the period from September 1, 2017, to August 31, 2019 for sensors at Floor 4, 8, 12, 16 that were sourced from North-South locations.

To understand the trends in the moisture content and the internal temperature of the CLT panels, daily data was plotted over the period between September 2017 and August 2019. In the graphs, the days were used as the x-axis and the corresponding moisture and temperature values for every day was plotted as the y-axis to review the trend with time. Figure X (left) presents the moisture data from one of the floors (Floor 3) in the Tallwood House, sourced from sensors in the East-West locations. Figure X (right) presents the moisture data from multiple floors (Floor 4,8,12,16), sourced from the North-South locations.

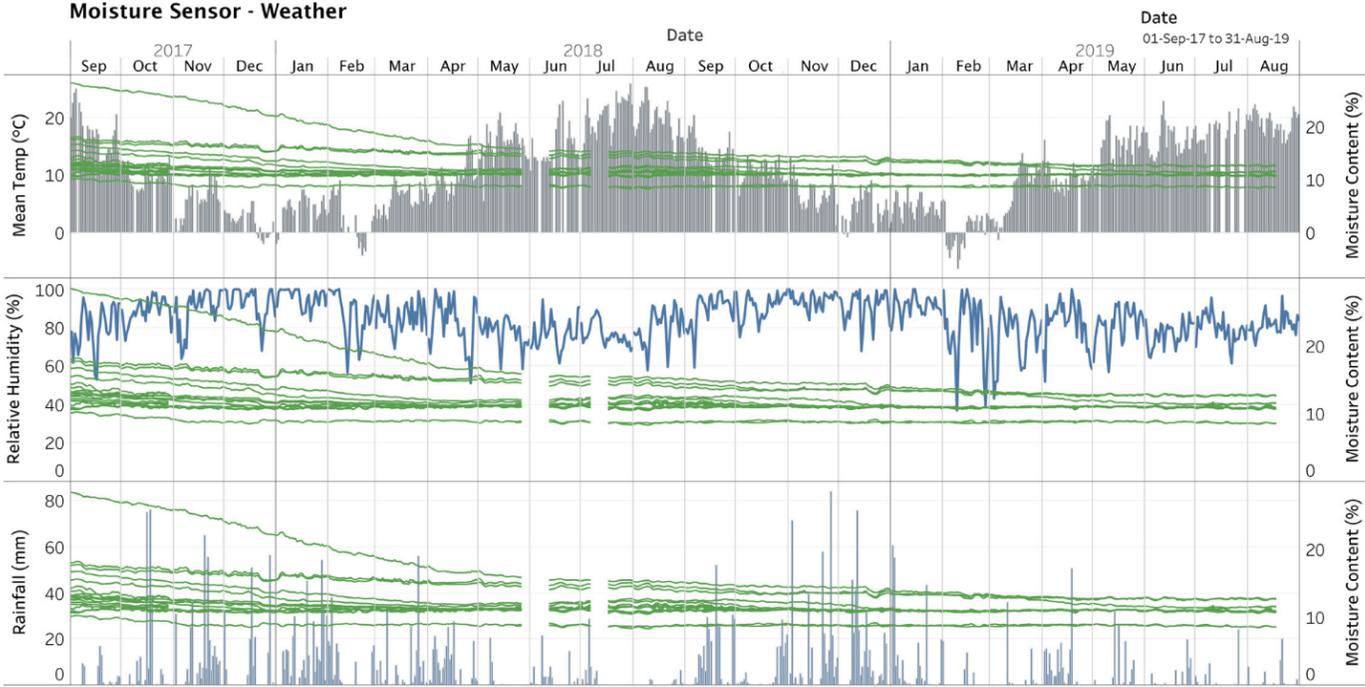
Figure 6: Moisture Sensor - Weather. The moisture content of the CLT panels in Floor 3 and its relation to external climate conditions (X-axis - Days from September 1, 2017, to August 31, 2019; Dual Y-axis- Left: Climate conditions and Right: Moisture content values in %)

The analysis did not show any correlation between the overall drying trend in the moisture content of the CLT panel and the external climate conditions (at least the three used above). However, a small correlation was observed between the variations of the internal temperature of the panels with the outside temperature, with increased CLT temperature during the hotter periods in July/August. A few spikes in internal CLT temperature also occurred during certain days with high rainfall. No correlation was observed between the internal temperature of the CLT panels and relative humidity.

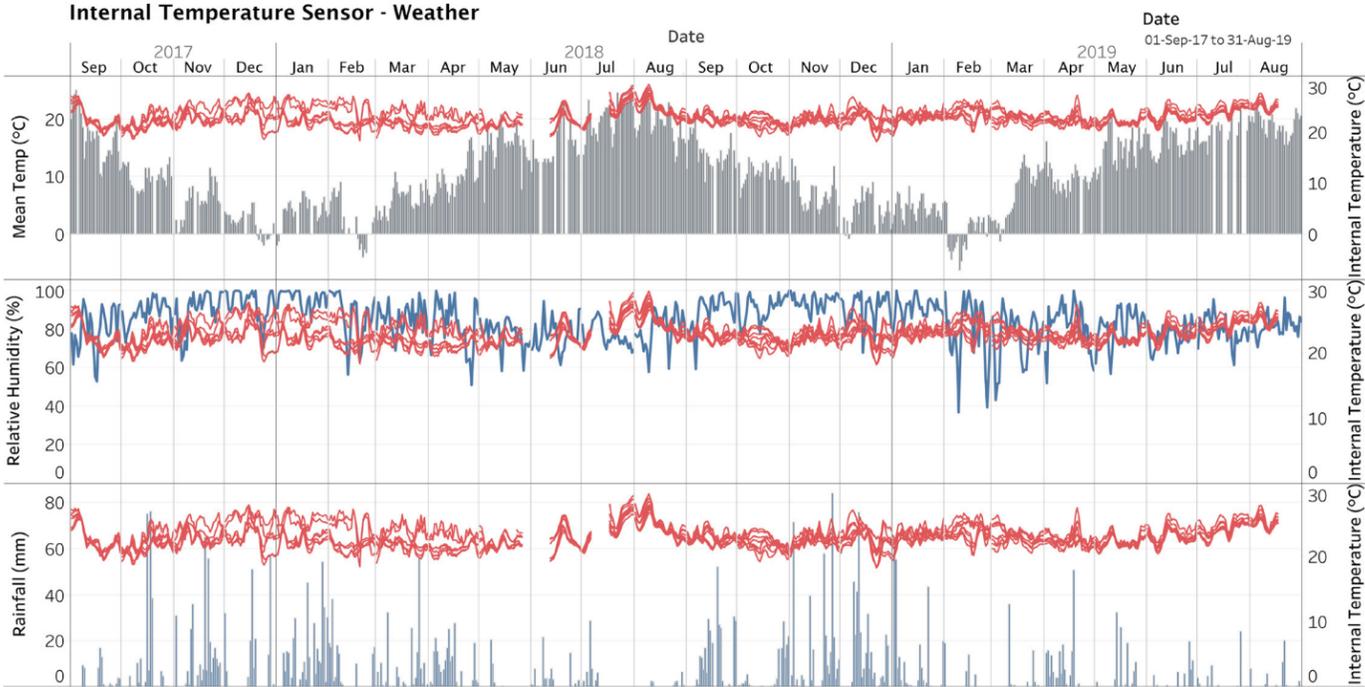
Figure 7: Internal Temperature Sensor - Weather. The internal temperature of the CLT panels in Floor 3 and its relation to external climate conditions. (X-axis - Days from September 1, 2017, to August 31, 2019; Dual Y-axis- Left: Climate conditions and Right: Internal Temperature values in °C)

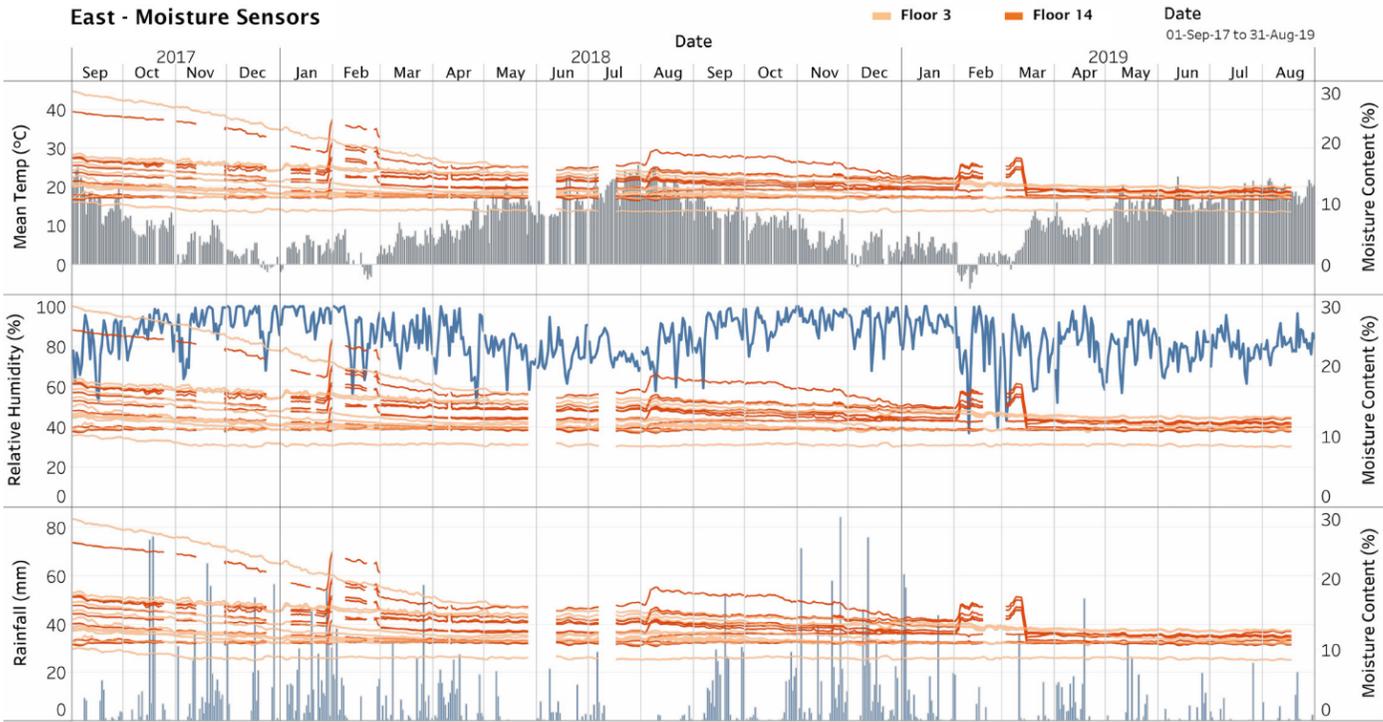
Figure 8: East - Moisture Sensors.  
The moisture content of the CLT panels and its relation to the floor height, by comparing the data from the sensors at Floor 3 and Floor 14 in the East.  
(X-axis - Days from September 1, 2017, to August 31, 2019;  
Dual Y-axis- Left: Climate conditions and Right: Moisture content values in %)

This study showed that the moisture content of the CLT panels was slightly higher on the upper floors: the sensors on Floor 14 showed 3-5% higher MC compared to Floor 3. Both Floor 3 and Floor 4 had a similar drying trend, although there was greater variations on Floor 14 than Floor 3, and greater variation in the East sensor than the West sensor, including a small spike in winter 2019 in the moisture content of the east sensors. The overall trend in moisture content in all the floors did not seem to be affected due to external climate conditions.

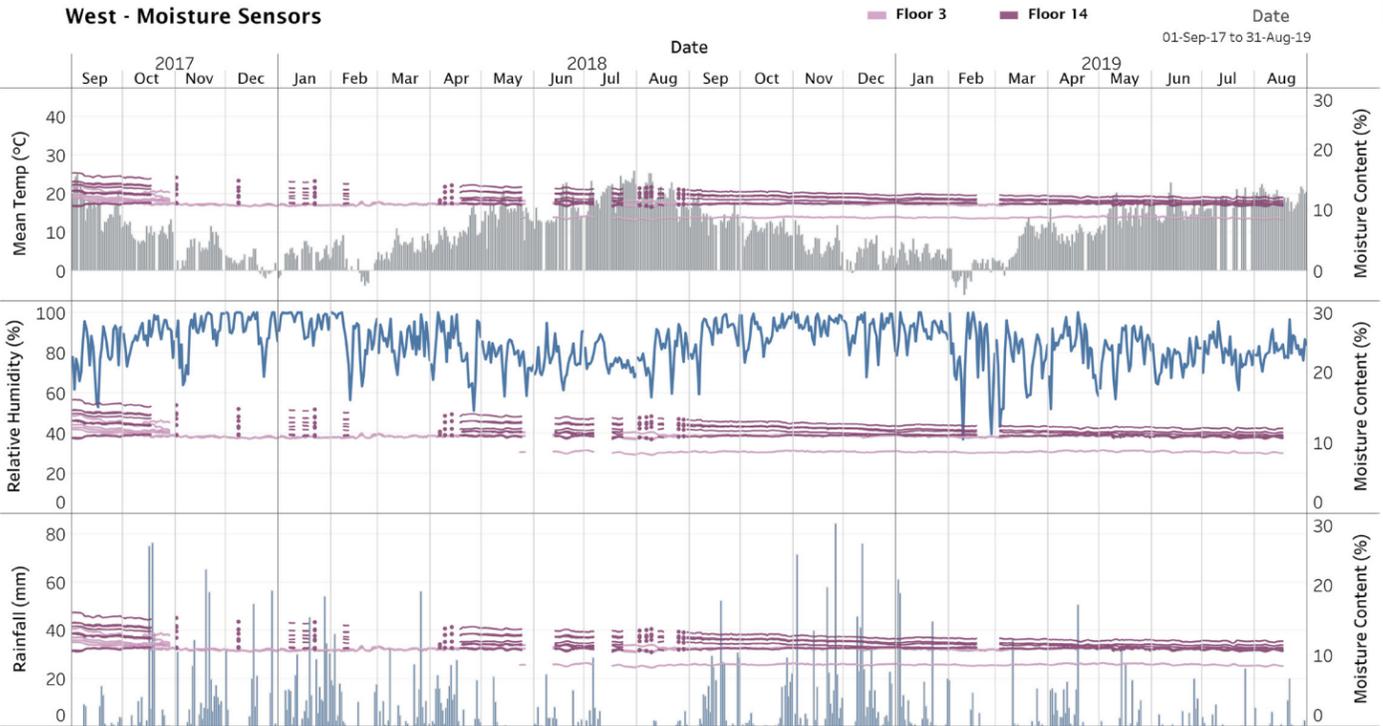
Figure 9: West - Moisture Sensors.  
The moisture content of the CLT panels and its relation to the floor height, by comparing the data from the sensors at Floor 3 and Floor 14 in the West.  
(X-axis - Days from September 1, 2017, to August 31, 2019;  
Dual Y-axis- Left: Climate conditions and Right: Moisture content values in %)

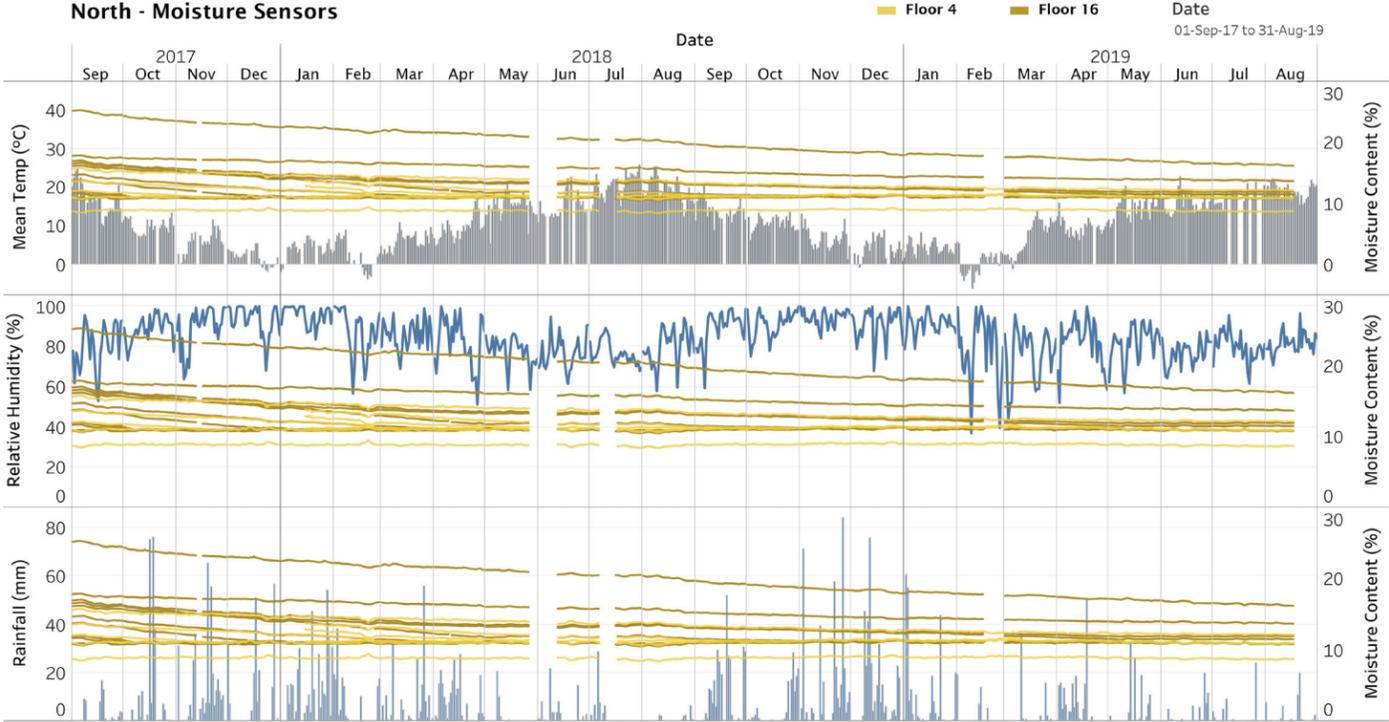
Figure 10: North - Moisture Sensors.  
The moisture content of the CLT panels and its relation to the floor height, by comparing the data from the sensors at Floor 4 and Floor 16 in the North.  
(X-axis - Days from September 1, 2017, to August 31, 2019;  
Dual Y-axis- Left: Climate conditions and Right: Moisture content values in %)

As noted on the previous page, the moisture content of the CLT panels was slightly higher on the upper floors: the sensors on Floor 16 showed 10-15% higher MC compared to Floor 4. This is a notable larger variation than between Floor 3 and 14. It should be noted that the sensors on Floor 16, position on the North and South of the building, are both a different orientation and two floors higher than the highest East-West sensors. Either orientation or additional height could be factor in the variation. Floor 16 also showed moisture data from the South location that did not follow the drying trend and maintained a consistent and higher moisture content than the other floors.

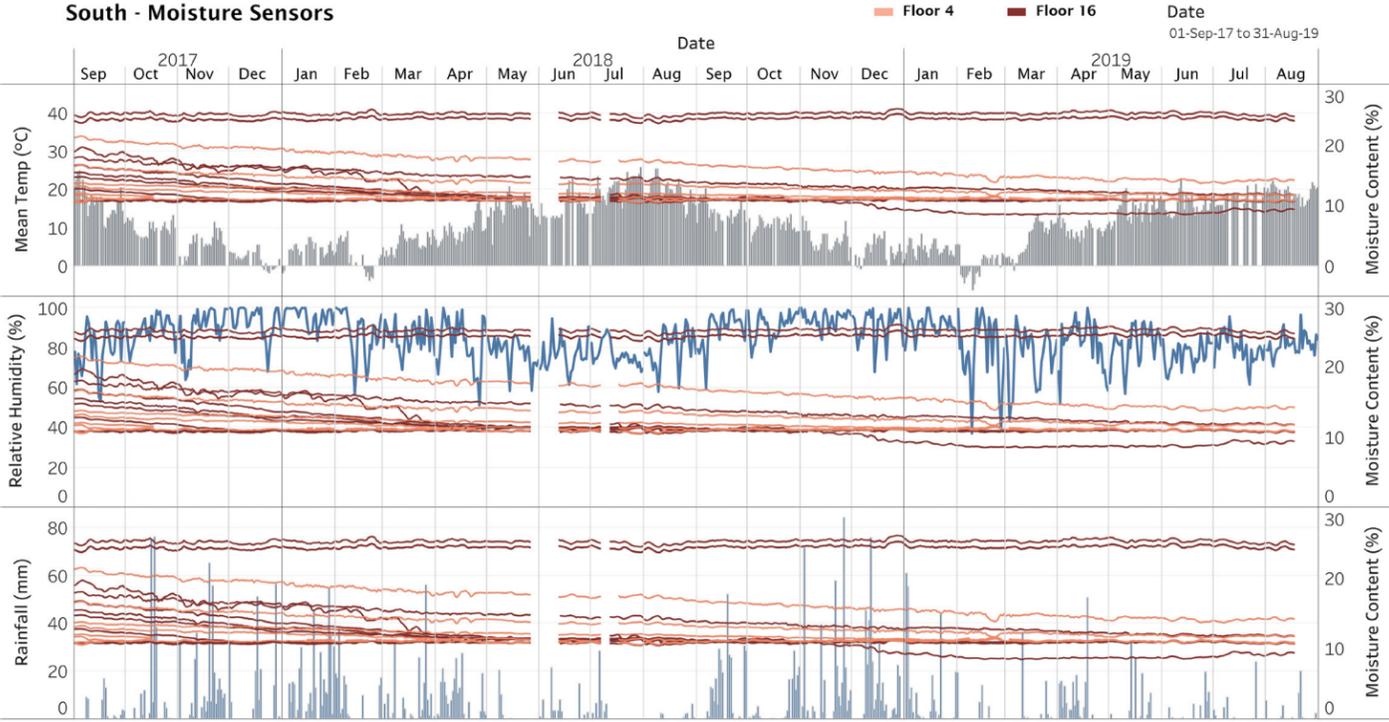
Figure 11: South - Moisture Sensors.  
The moisture content of the CLT panels and its relation to the floor height, by comparing the data from the sensors at Floor 4 and Floor 16 in the South.  
(X-axis - Days from September 1, 2017, to August 31, 2019;  
Dual Y-axis- Left: Climate conditions and Right: Moisture content values in %)

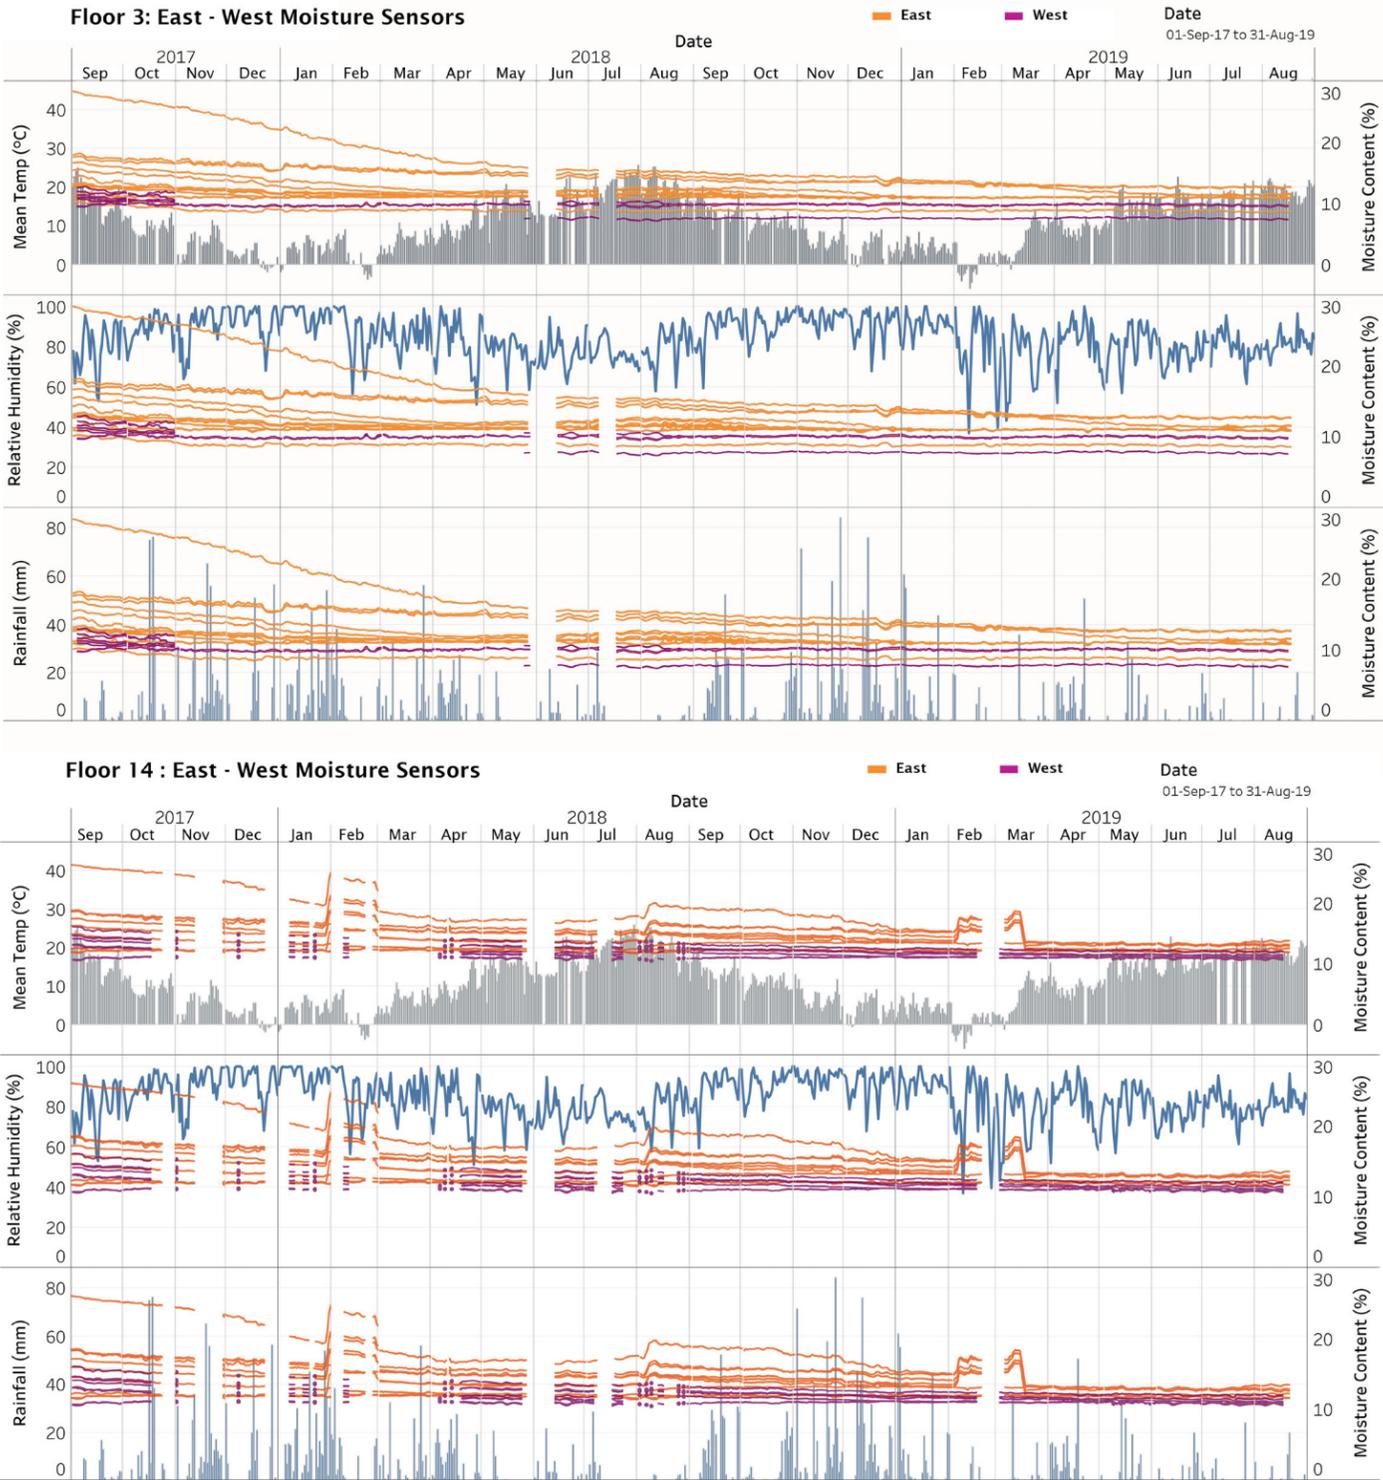
Figure 12: Floor 3: East - West Moisture Sensors. The moisture content of the CLT panels and its relation to the orientation, by comparing the data from the East and the West sensors at Floor 3. (X-axis - Days from September 1, 2017, to August 31, 2019; Dual Y-axis- Left: Climate conditions and Right: Moisture content values in %)

Figure 13: Floor 14: East - West Moisture Sensors. The moisture content of the CLT panels and its relation to the orientation, by comparing the data from the East and the West sensors at Floor 14. (X-axis - Days from September 1, 2017, to August 31, 2019; Dual Y-axis- Left: Climate conditions and Right: Moisture content values in %)

This study showed that the moisture content in the East oriented panels was 3-5% higher than the West oriented panels, on both Floor 3 and Floor 14. Floor 3 sensors in the East orientation showed a larger decrease in the first year and then a steady drying trend in the next two years. Floor 14 sensors in the East orientation showed a larger moisture decrease in the first year, but also a fluctuation in moisture content in 2018 and a small spike in winter of 2019. The data from the West-orientated sensors on both floors was more consistent and stable.

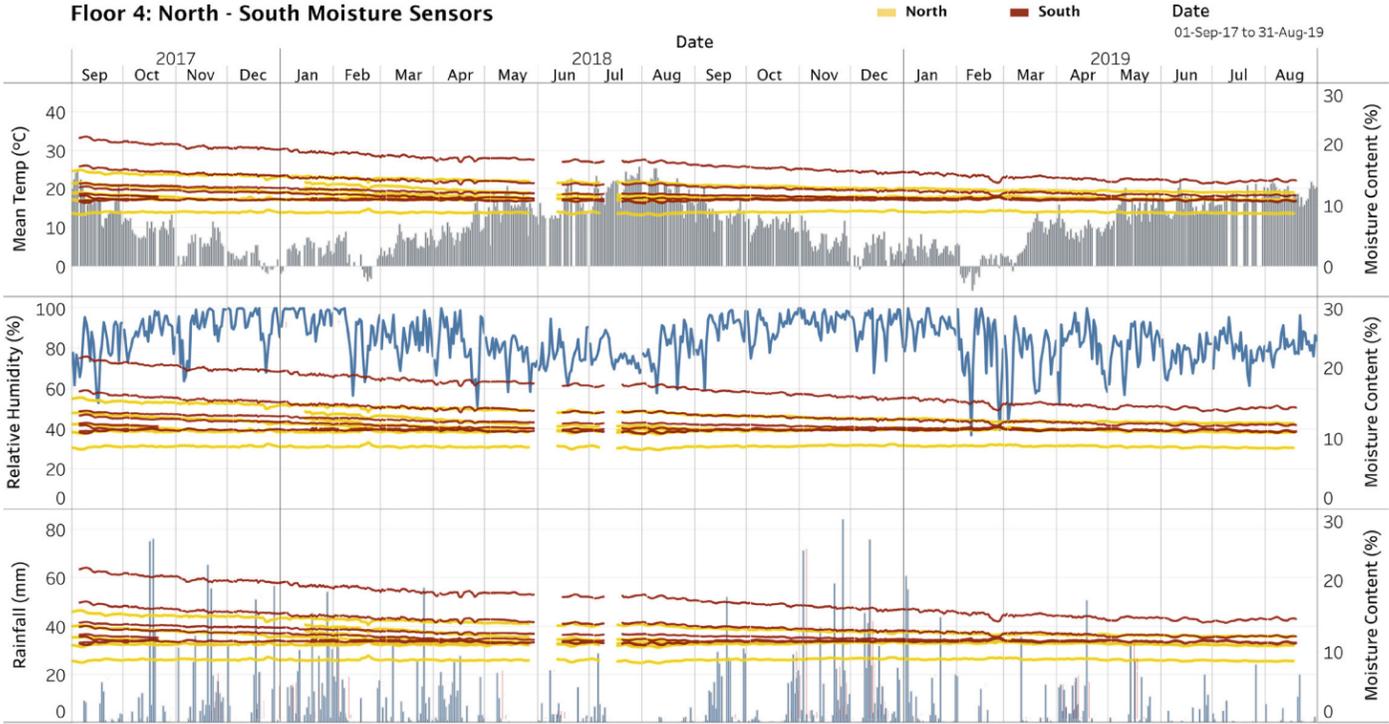
Figure 14: Floor 4: North-South Moisture Sensors. The moisture content of the CLT panels and its relation to the orientation, by comparing the data from the North and the South sensors at Floor 4. (X-axis - Days from September 1, 2017, to August 31, 2019; Dual Y-axis- Left: Climate conditions and Right: Moisture content values in %)

The study showed the moisture content in the South oriented panels was 1-3% higher than the North-oriented panels, on both Floor 4 and Floor 16, a smaller difference than the East-West sensors on Floors 2 and 14. Some sensors in the South location on Floor 16 maintained a consistent and higher moisture content, while the sensors in the North location followed the drying trend. On both Floors, the data from the North and South oriented sensors was generally more consistent than data from the East and West-oriented sensors, with no major spike or fluctuations. For all floors and orientations, the moisture content had no clear correlation with any of the climate data.

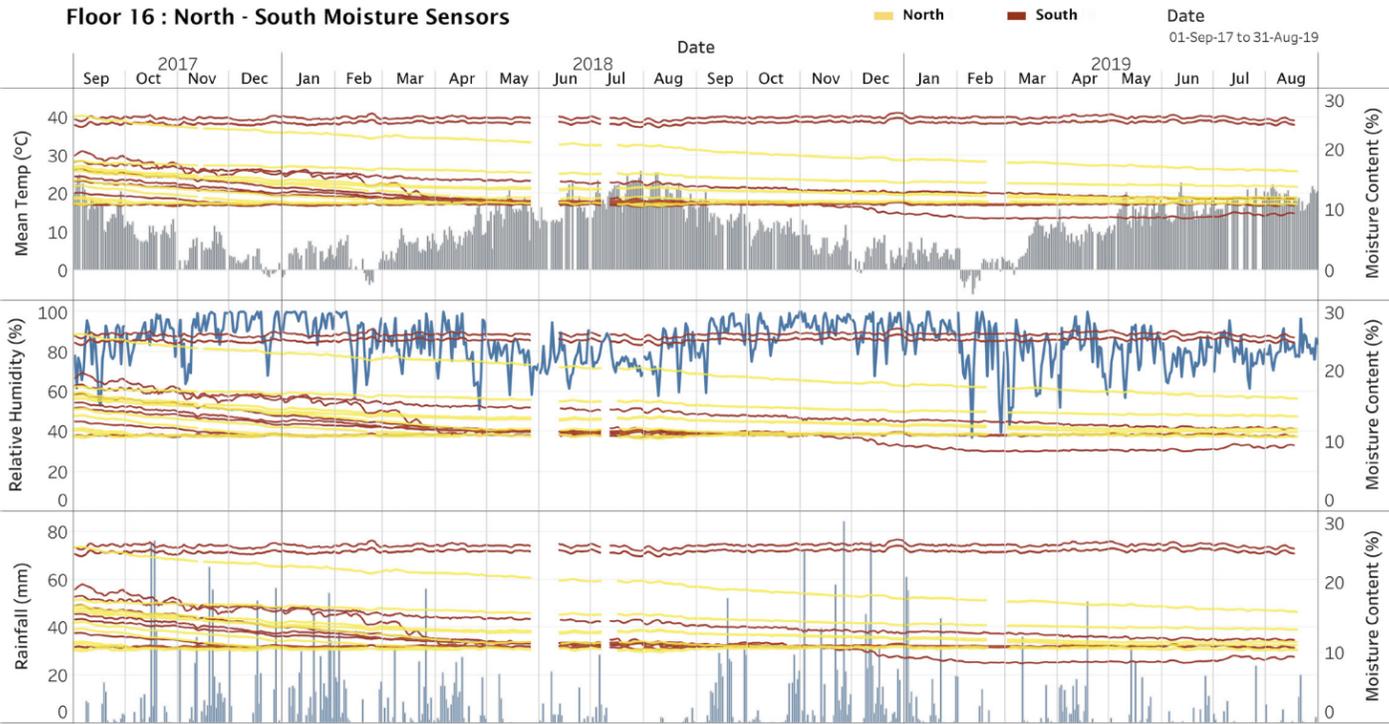
Figure 15: Floor 16: North-South Moisture Sensors. The moisture content of the CLT panels and its relation to the orientation, by comparing the data from the North and the South sensors at Floor 16. (X-axis - Days from September 1, 2017, to August 31, 2019; Dual Y-axis- Left: Climate conditions and Right: Moisture content values in %)

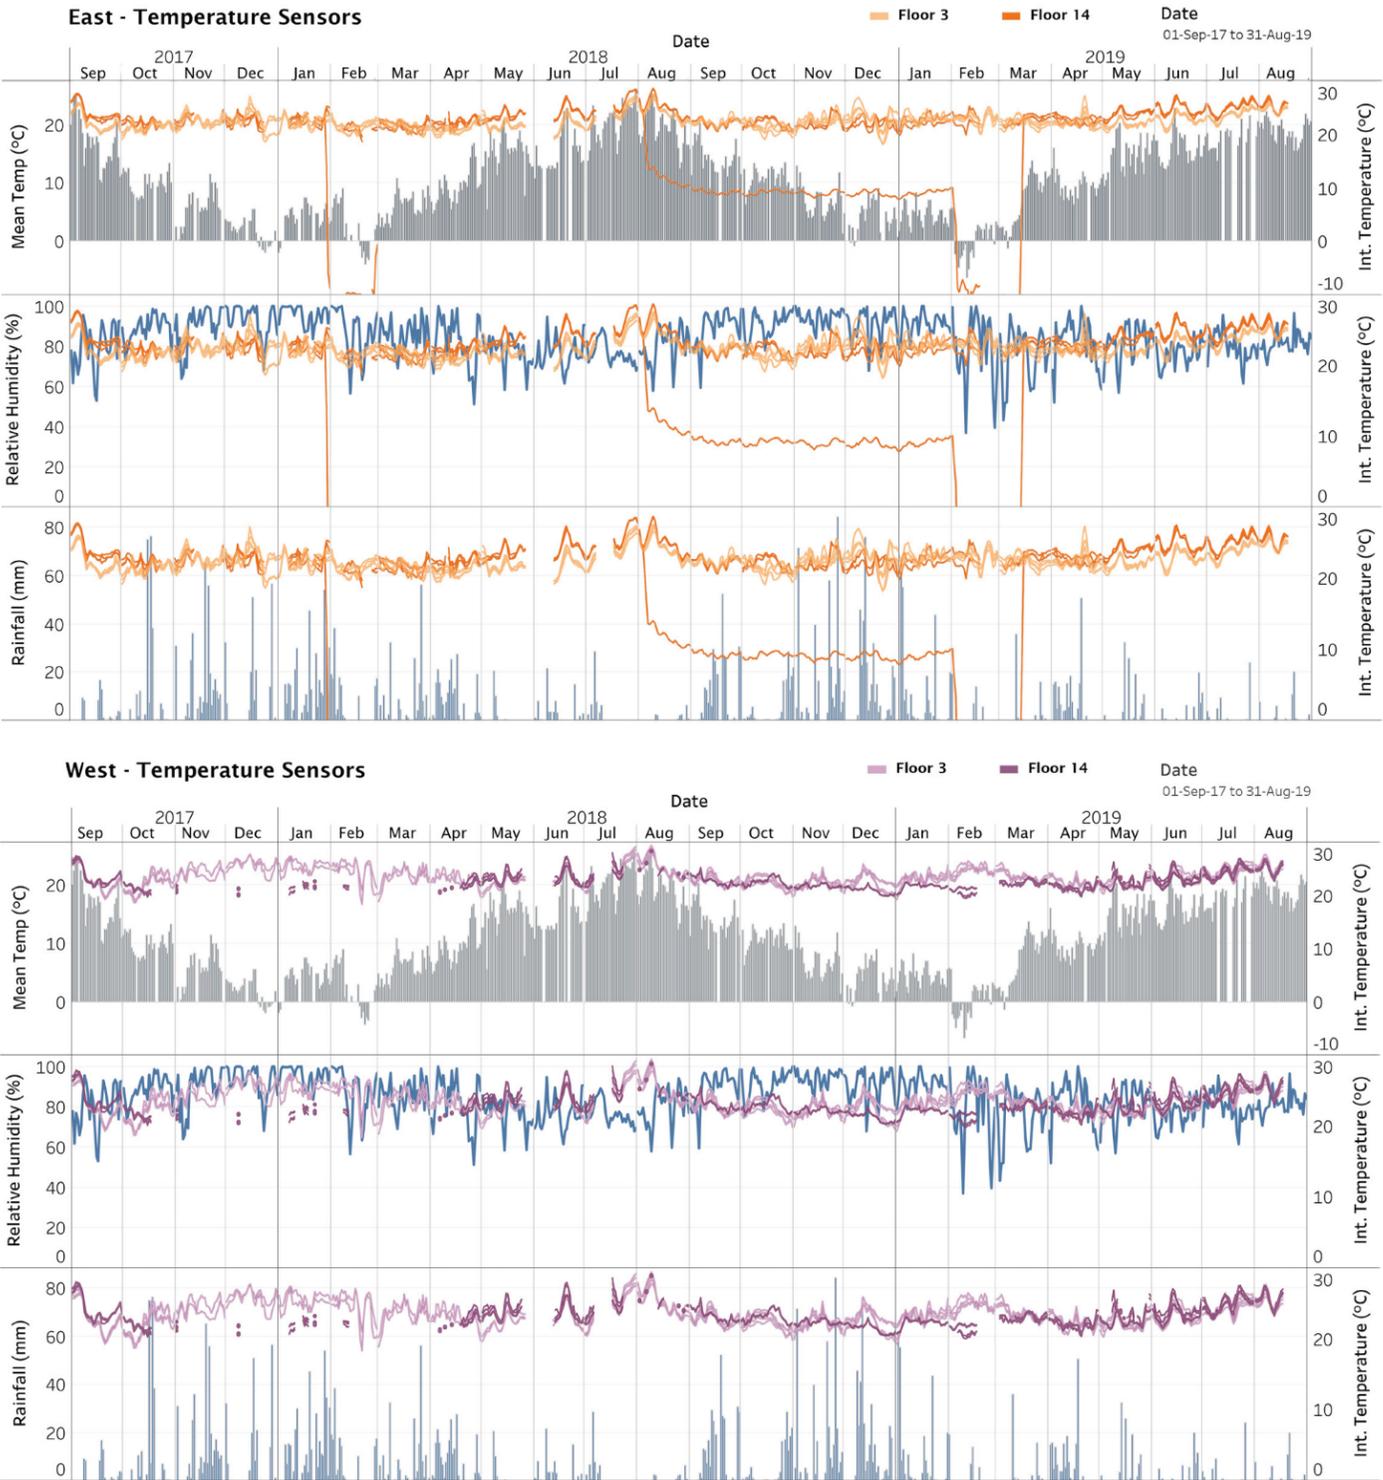
Figure 16: East - Temperature Sensors.  
The internal temperature of the CLT panels and its relation to the floor height, by comparing the data from the sensors at Floor 3 and Floor 14 in the East.  
(X-axis - Days from September 1, 2017, to August 31, 2019;  
Dual Y-axis- Left: Climate conditions and Right: Internal Temperature values in °C)

Figure 17: West - Temperature Sensors.  
The internal temperature of the CLT panels and its relation to the floor height, by comparing the data from the sensors at Floor 3 and Floor 14 in the West.  
(X-axis - Days from September 1, 2017, to August 31, 2019;  
Dual Y-axis- Left: Climate conditions and Right: Internal Temperature values in °C)

This study showed that the internal temperature of the CLT panels varied with the external mean daily temperature for both the East and West oriented sensors on both Floor 3 and Floor 14. Specifically the internal temperature of the CLT panels increased when the external temperatures was high in the summer months. On both floors, there were also some spikes of internal temperature that seems to be connected to days of high rainfall, but the correlation is not consistent. The internal temperatures of the CLT panels in the East and West locations, were very similar between the lower and upper floors throughout the year.

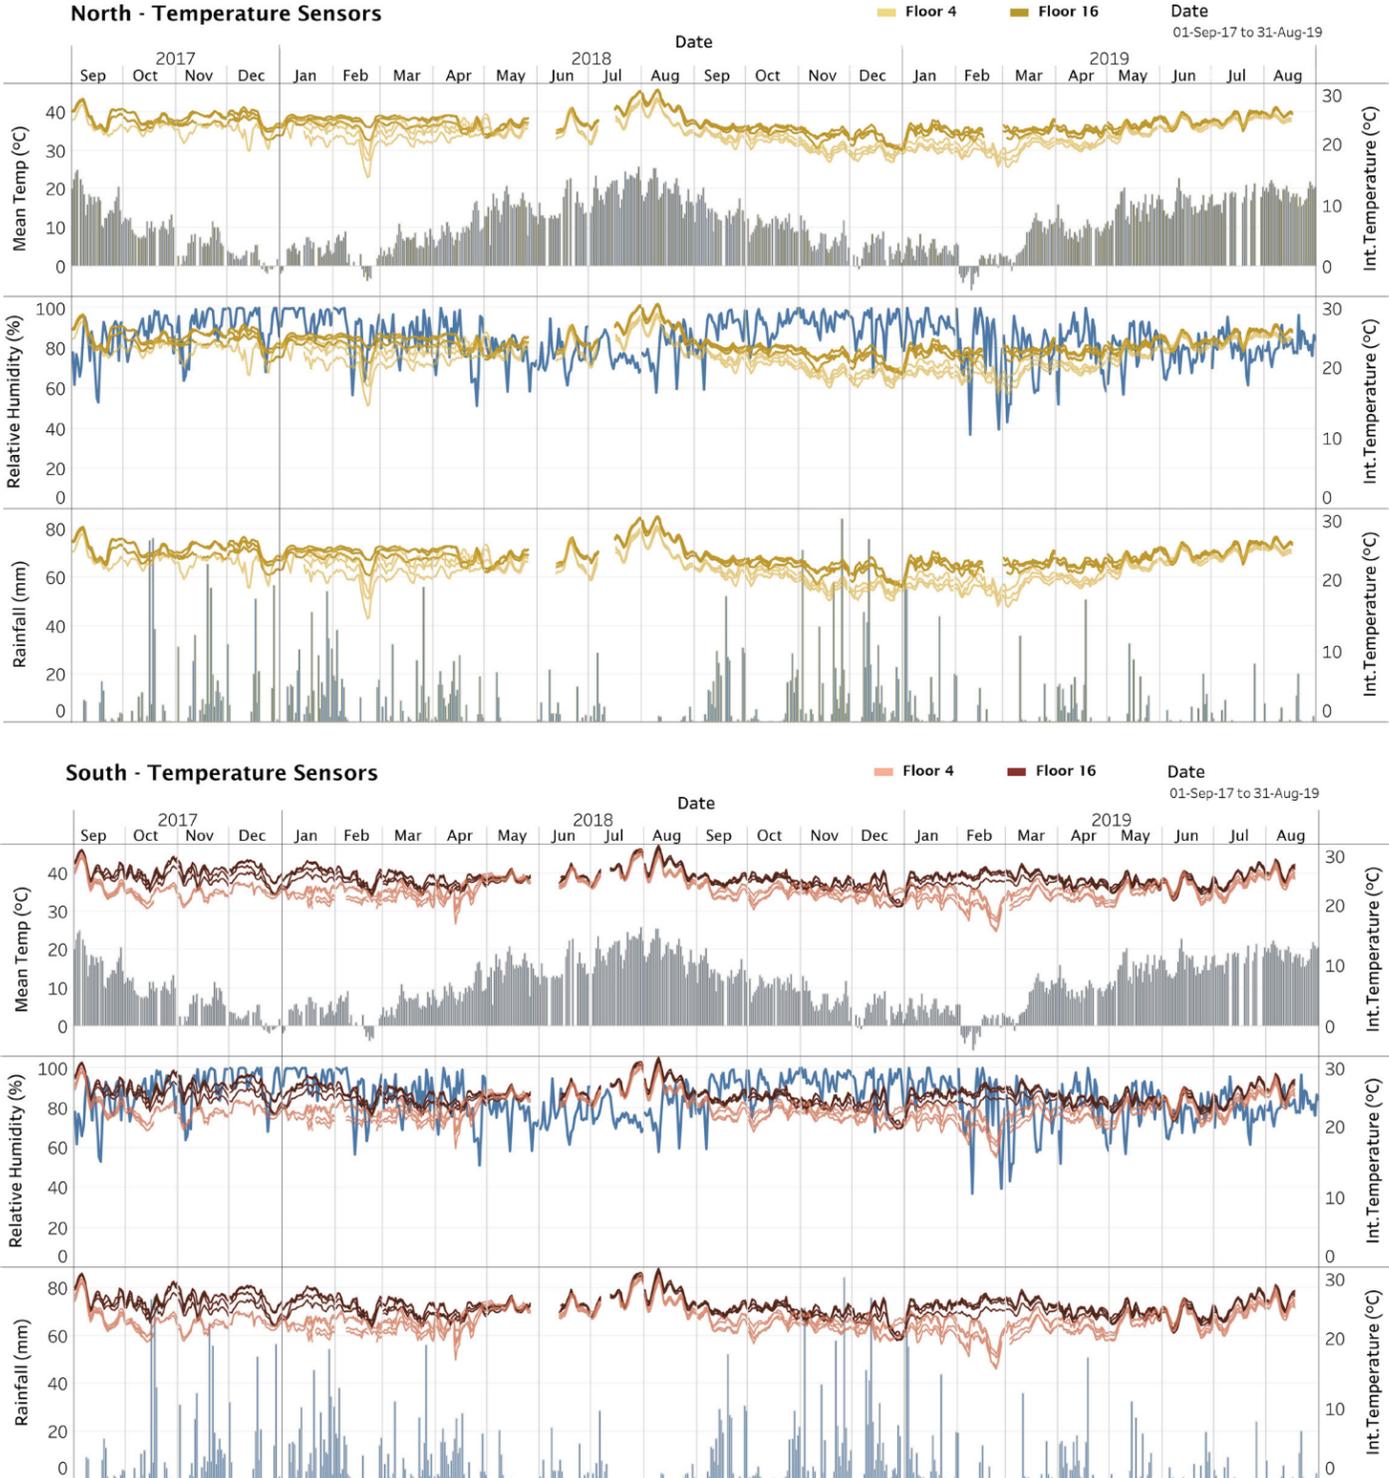
Figure 18: North - Temperature Sensors.  
The internal temperature of the CLT panels and its relation to the floor height, by comparing the data from the sensors at Floor 4 and Floor 16 in the North.  
(X-axis - Days from September 1, 2017, to August 31, 2019;  
Dual Y-axis- Left: Climate conditions and Right: Internal Temperature values in °C)

Figure 19: South - Temperature Sensors.  
The internal temperature of the CLT panels and its relation to the floor height, by comparing the data from the sensors at Floor 4 and Floor 16 in the South.  
(X-axis - Days from September 1, 2017, to August 31, 2019;  
Dual Y-axis- Left: Climate conditions and Right: Internal Temperature values in °C)

Similarly to the graphs on the previous page, the internal temperature of the CLT panels varied with the external mean daily temperature for the North and South oriented sensors on Floor 4 and Floor 16, with an increase in temperature correlating to higher external temperature in the summer. However, in both North and South locations, there was a distinct although small difference between internal temperatures on Floor 4 and Floor 16, with the sensors on Floor 16 measuring a consistently higher temperature through the years. Floor 4 also had a greater fluctuations and notably lower internal temperature than Floor 16 during the winter months.

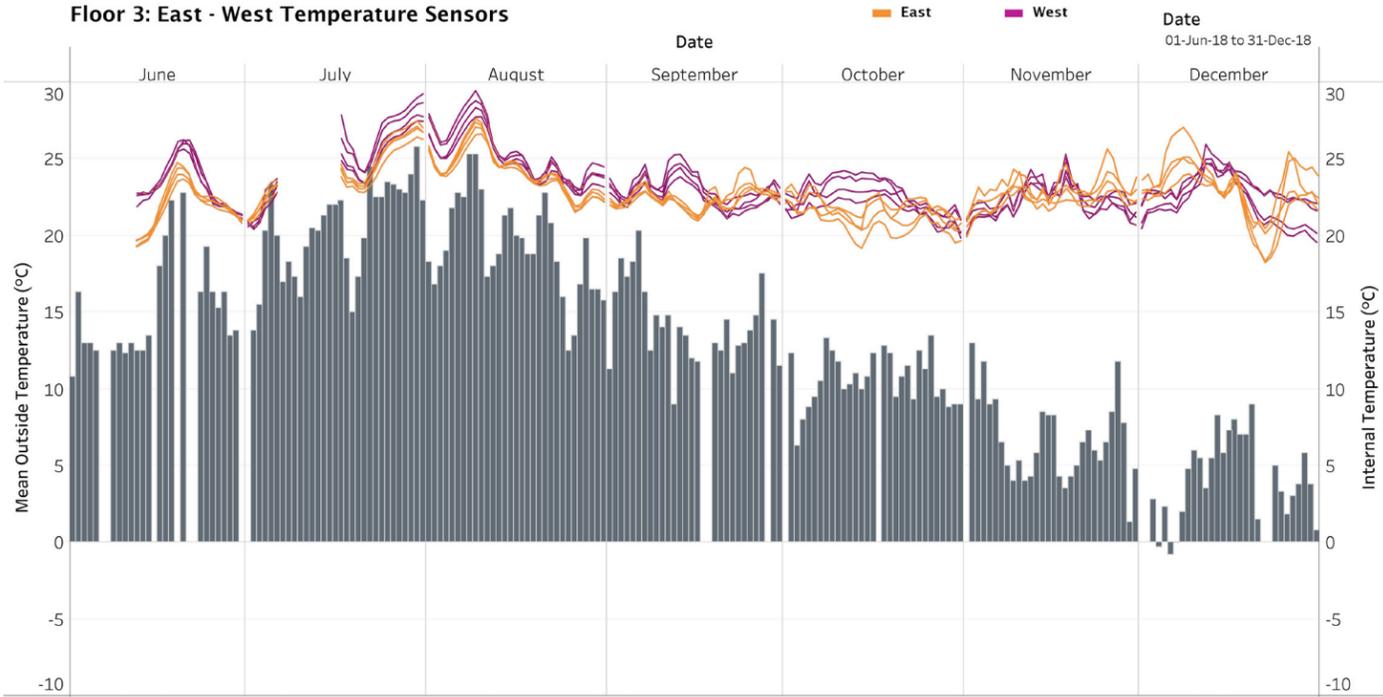
Figure 20 : Floor 3: East - West Temperature Sensors. The internal temperature of the CLT panels against the average outside temperature, comparing the measured values in Floor 3 in East-West locations.  
(X-axis - Days from June 1, 2018, to December 31, 2018;  
Dual Y-axis- Left: Outside temperature in °C and Right: Internal temperature in °C)

On both Floor 3 and Floor 14, the higher internal temperature measurements of the CLT panels correlated to higher outside air temperature in June, July and August, although the internal temperature generally remained steady when the external temperatures dropped in November and December. During the summer months, the West-oriented sensors on Floor 3 measured slightly higher temperatures than the East-oriented sensors. No similar variation was measured on Floor 14, however, there were greater fluctuations in the data from the East-oriented sensor than the West-oriented sensors on Floor 14.
