# OPERATIONAL PERFORMANCE OF CROSS LAMINATED TIMBER : **BROCK COMMONS TALLWOOD HOUSE**

SEPTEMBER 2020

This report describes the performance of the mass timber structure in Tallwood House, between September 2017 and August 2019, based on measurements of the moisture content in the prefabricated CLT floor panels and the displacement of the vertical structural system. It is intended to initiate discussions on the performance of mass timber structure elements during building occupancy and lead to further research that can explore the influential factors.

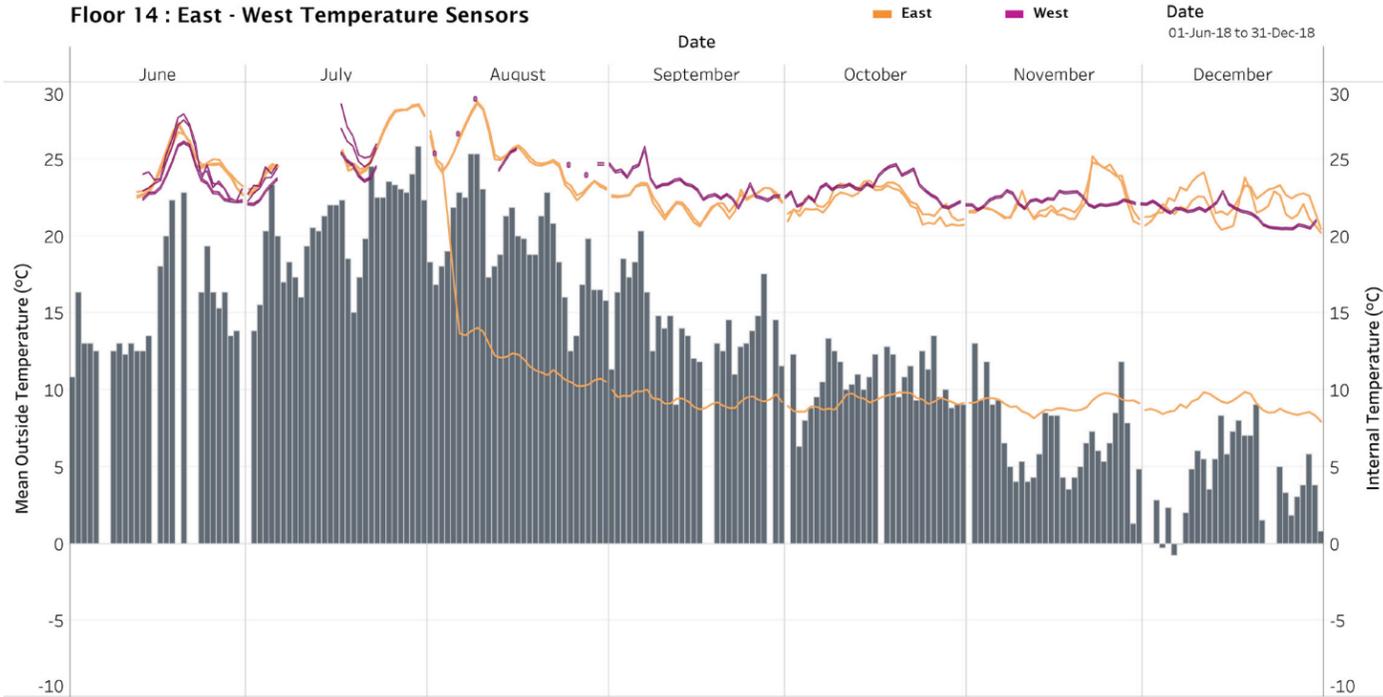
Figure 21 : Floor 14: East - West Temperature Sensors. The internal temperature of the CLT panels against the average outside temperature, comparing the measured values in Floor 14 in East-West locations  
(X-axis - Days from June 1, 2018, to December 31, 2018;  
Dual Y-axis- Left: Outside temperature in °C and Right: Internal temperature in °C)

On both Floor 3 and Floor 14, the higher internal temperature measurements of the CLT panels correlated to higher outside air temperature in June, July and August, although the internal temperature generally remained steady when the external temperatures dropped in November and December. During the summer months, the West-oriented sensors on Floor 3 measured slightly higher temperatures than the East-oriented sensors. No similar variation was measured on Floor 14, however, there were greater fluctuations in the data from the East-oriented sensor than the West-oriented sensors on Floor 14.

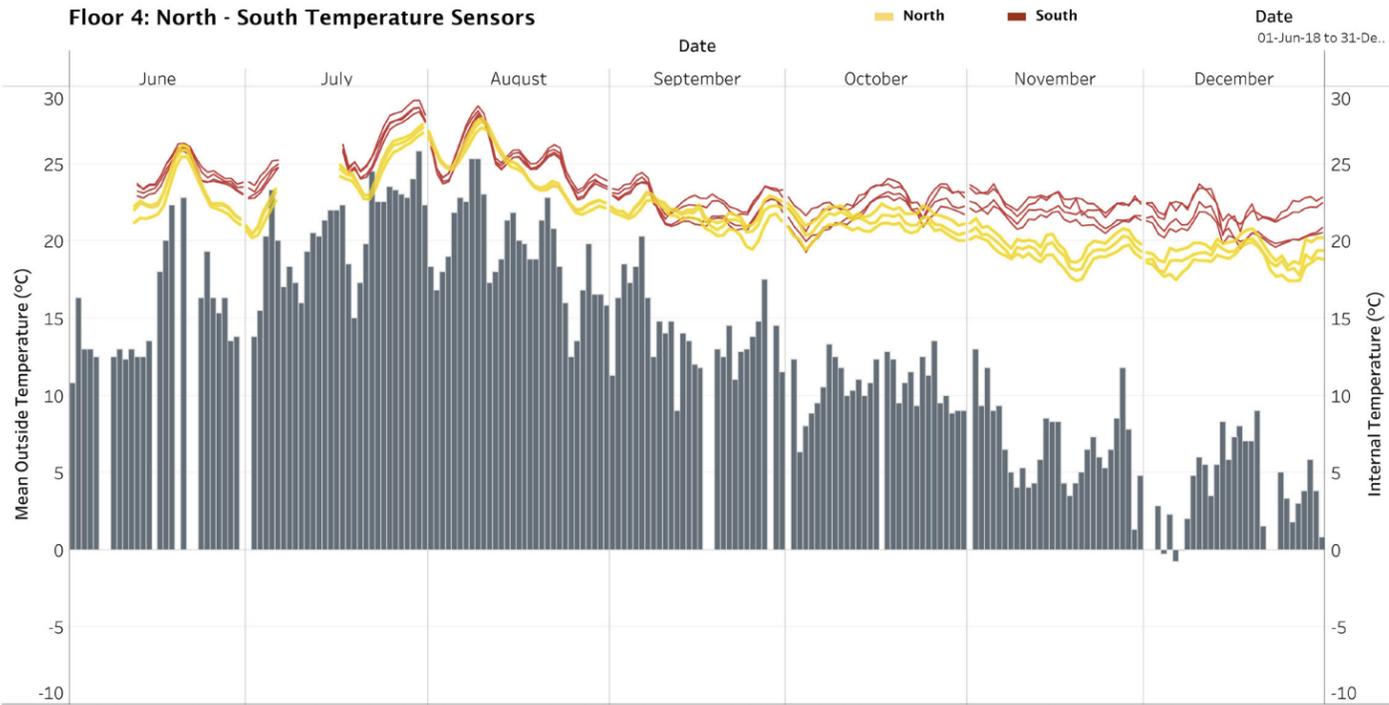
Figure 22 : Floor 4: North - South Temperature Sensors. The internal temperature of the CLT panels against the average outside temperature, comparing the measured values in Floor 4 in North-South locations. (X-axis - Days from June 1, 2018, to December 31, 2018; Dual Y-axis- Left: Outside temperature in °C and Right: Internal temperature in °C)

Similar to the previous graphs, higher internal temperature measurements of the CLT panels on both Floor 4 and Floor 16 correlated to higher outside air temperature in June, July and August. Generally, the internal temperature of the South-oriented sensors on both floors remain steady into the winter month, although there was a drop in internal temperatures on Floor 16 at the end of December correlating to the lowest external temperatures. The North-oriented sensors on both floors measure a small but consistent trend of decreasing in internal temperature from the summer to winter months. Throughout the year, the internal temperatures on the South side of the building were consistently higher than those on the North side, for both Floors, and the difference increased during October, November and December.

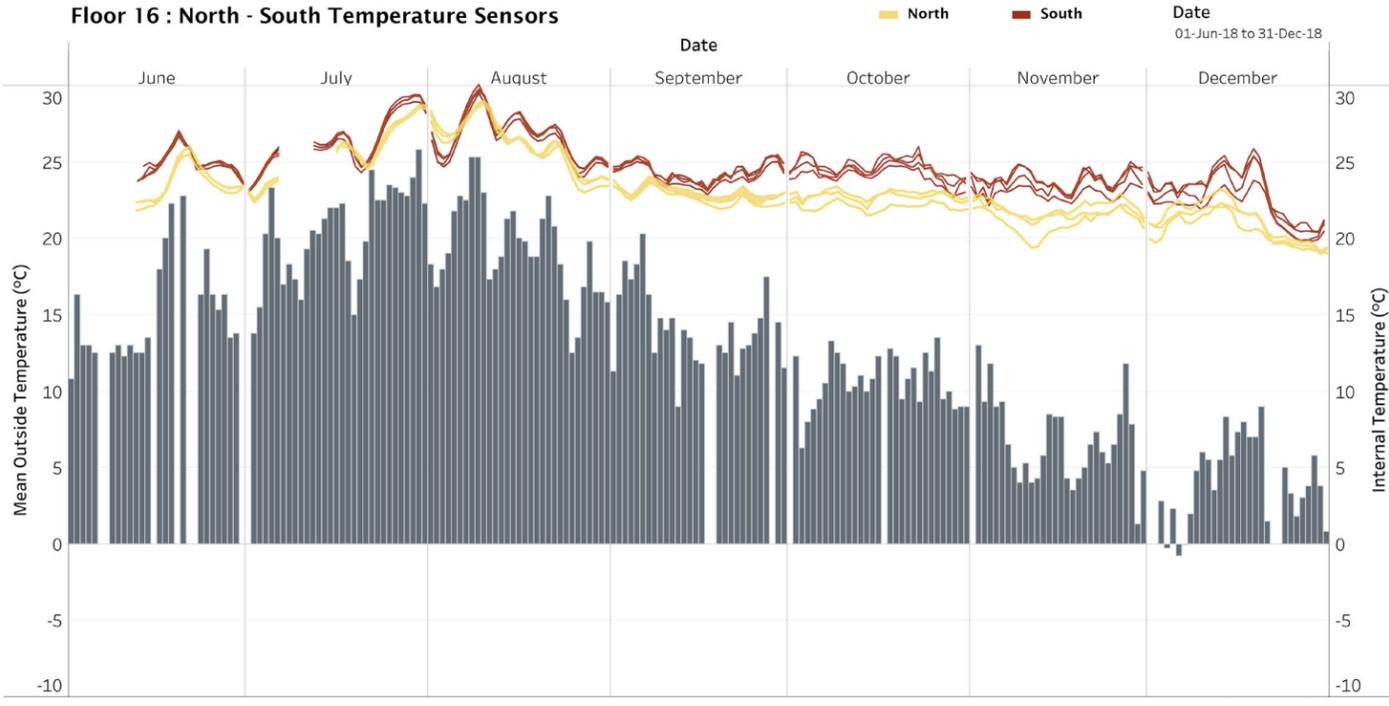
Figure 23 : Floor 16: North - South Temperature Sensors. The internal temperature of the CLT panels against the average outside temperature, comparing the measured values in Floor 16 in North-South locations. (X-axis - Days from June 1, 2018, to December 31, 2018; Dual Y-axis- Left: Outside temperature in °C and Right: Internal temperature in °C)

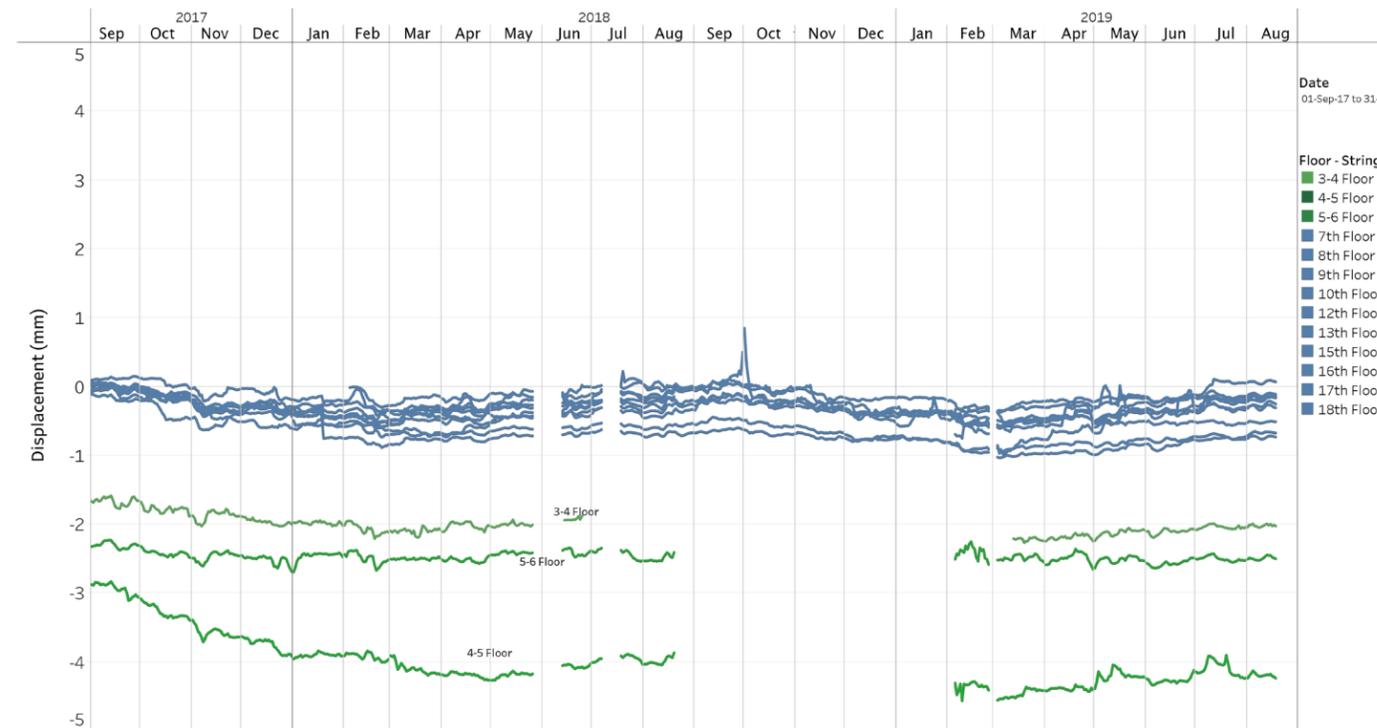
Figure 24 : Vertical movement recorded by the string pot sensors installed on each floor for the days between September 1, 2017, and August 31, 2019.

(Note : the negative values mean shortening of the panel and the positive values mean expansion of the panel.)

The study showed a vertical compression of about 0.25-1mm over the two year period on all floors above Floor 7. The vertical compression in the bottom floors was significantly greater: about 2 to 4 mm over the same period.. The highest displacement was recorded on Floor 4-5: about 4mm over two years.

Overall, there was an average shortening of about 0.8-1 mm over the total height of the building over the two year period. There seems to be a slight upward trend in the 2019 data, with the most significant displacement occurring by March 2019, and then reducing afterwards.
