Social Ecological Economic Development Studies (SEEDS) Sustainability Program

Student Research Report

# Invisible to visible: A field study investigating dirty windows and bird-friendly artwork as mitigation strategies against bird-window collisions

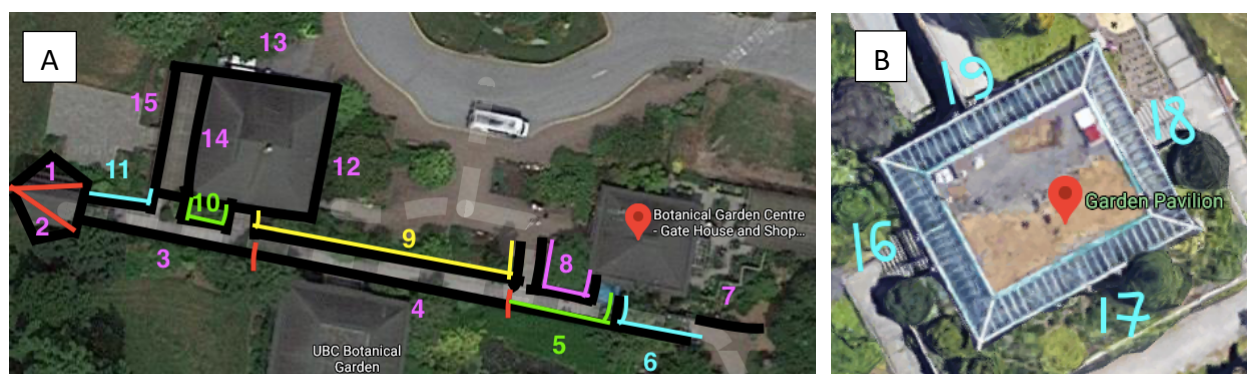
**FIGURE 1.** Map of facade locations at the Botanical Garden reception area (A) and the Botanical Garden Pavilion (B).

The study was conducted in two areas within the UBC Botanical Garden: the Botanical Garden Reception and the Botanical Garden Pavilion. The study area has a total of 19 facades within the two areas being monitored, with facades 1 to 15 located in the reception area and facades 16 to 19 at the Pavilion (see Figure 1). Facades 1 to 12 and facade 15 consist of glass panes lining the boardwalk, whereas facades 12 to 14 and facades 16 to 19 are located along buildings with glass windows or doors. Please see the appendix for images of each facade.

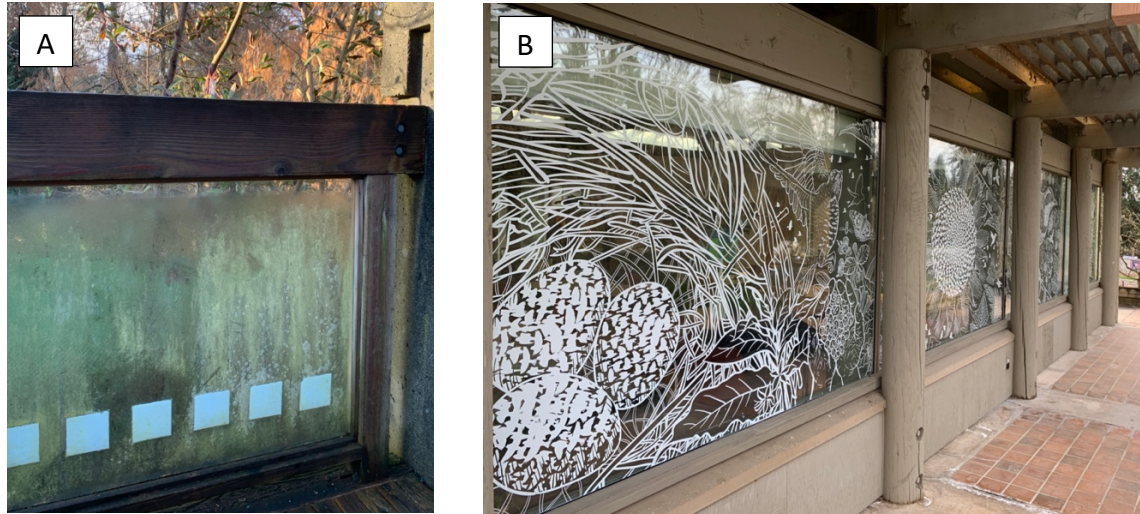
**FIGURE 4.** Two strategies at the Botanical Garden have helped to reduce bird-window collisions: dirty windows in the reception area (A) and bird-friendly artwork at the Pavilion (B).

Results from the reception area suggest that dirty windows may be an effective mitigation strategy to reduce bird-window collisions. The dirt and algal growth on the window surface that has accumulated since window cleaning was halted makes the glass less transparent and reduces the mirroring effect of glass by adding texture to the otherwise smooth and reflective surface (see Figure 4a). Even facades previously identified as collision hotspots exhibited very low collision rates in 2022. To date, very limited information on the effect of dirty windows exists, although a recent citizen-science based paper found a correlation between cleaning regimes and bird-window collisions (Żmihorski et al. 2022). Similarly, a study investigating collisions between birds and glass bus shelters reported fewer collisions at bus shelters that were dirty than those that had recently been cleaned (Zyśk-Gorczyńska et al. 2020). Not cleaning windows represents a novel approach to reducing bird-window collisions that is extremely easy and cost-effective, making it a highly accessible mitigation strategy.

Bird collisions at the Pavilion have also significantly decreased following the installation of the bird-friendly artwork in Spring 2021 (see Figure 4b), as we did not detect any evidence of collisions during the 2022 monitoring period. Bird-friendly artwork is commonly suggested to retrofit existing buildings that experience bird-window collisions, as it helps increase the visibility of windows (De Groot et al. 2021). Artwork should have high contrast to further enhance the visibility to birds (Martin 2011). Additionally, studies have found that any decals and artwork must be strategically spaced to prevent birds from believing they can fly through gaps (Brown et al. 2020). As seen in Figure 4b, the artwork at the Pavilion is dense and high contrast, which helps the window stand out.
