University of British Columbia

Student Research Report

Reducing bird-window collisions at a botanical garden: The effect of bird-friendly artwork and dirty windows

Date: 13 April 2022

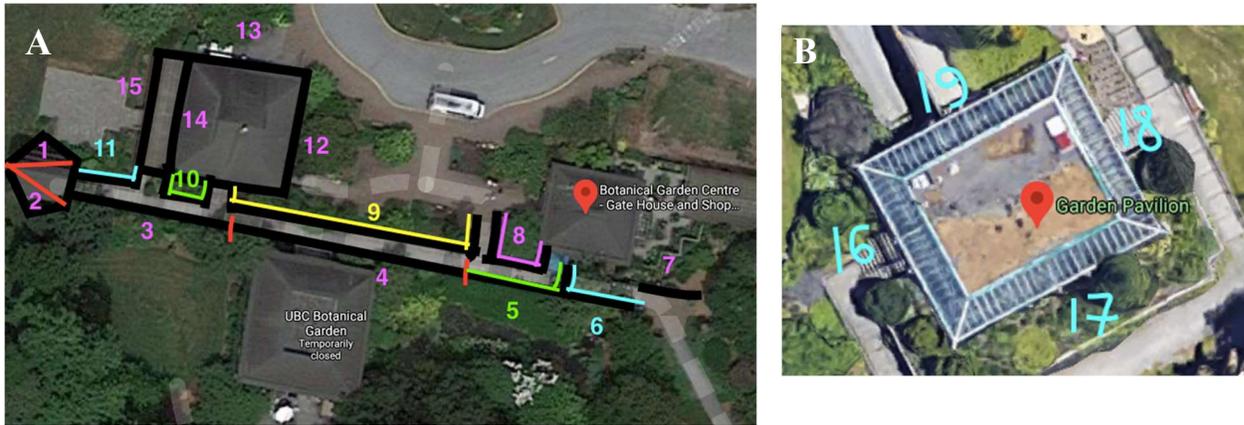
Figure 1. Satellite photographs of the Garden Centre (A) and the Pavilion (B) with labelled facades

The study location was the UBC Botanical Garden at the University of British Columbia Point Grey campus in Vancouver, BC, Canada. Two buildings were selected: the Garden Centre and the Pavilion. Facades were labelled from 1-19 with 1-15 being at the Garden Centre and 16-19 being at the Pavilion (Figure 1). Prior to the start of the study, bird-friendly artwork was applied the windows of the Pavilion (Figure 2). In addition, the glass panes at the Garden Centre had not been washed, allowing algae and dirt to build up on the surface.

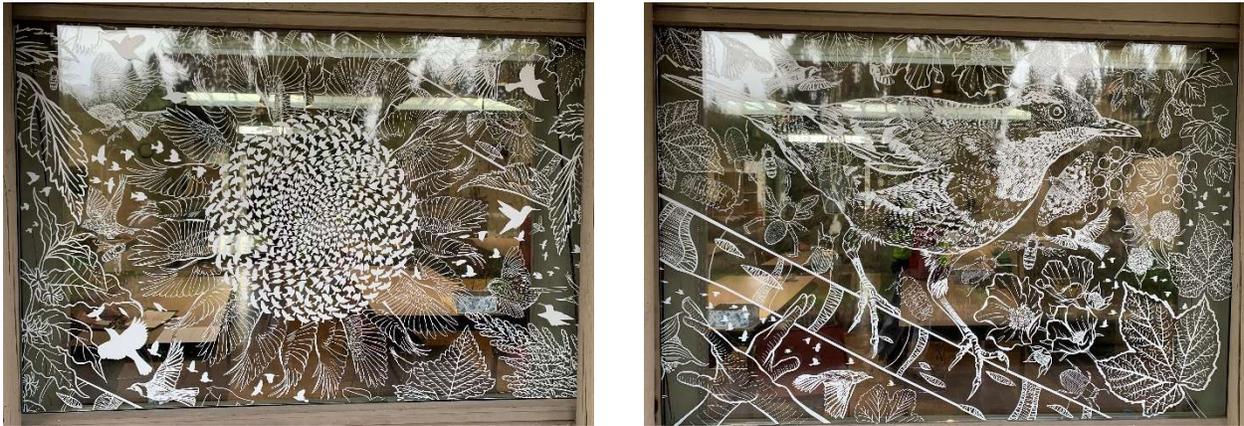
Figure 2. Artwork applied to the windows of the Pavilion at the UBC Botanical Garden

This study confirms the effectiveness of bird-friendly artwork as a bird-deterrent measure as bird collisions at the Pavilion have decreased by 100% following the application of artwork to the windows. These findings are consistent with what would be expected from the literature on pattern spacing. The maximum spacing for a pattern to be effective is 10 cm vertically and 5 cm horizontally (Rossler et al. 2015). In addition, any markings need to be at least 0.2 cm wide in order to be recognizable to birds (Rossler et al. 2015). Beyond these spacing requirements, the specifics of a pattern are less relevant. Since the artwork was designed with these spacing guidelines in mind, it fits all the requirements needed to effectively create a visual barrier for birds.
