Bird-Window Collision: A Problem at UBC Buildings (Phase 1)

Andy Chien, Carmen Leung, Gordon Cavers, Tiffany Nam

University of British Columbia

April 12, 2015

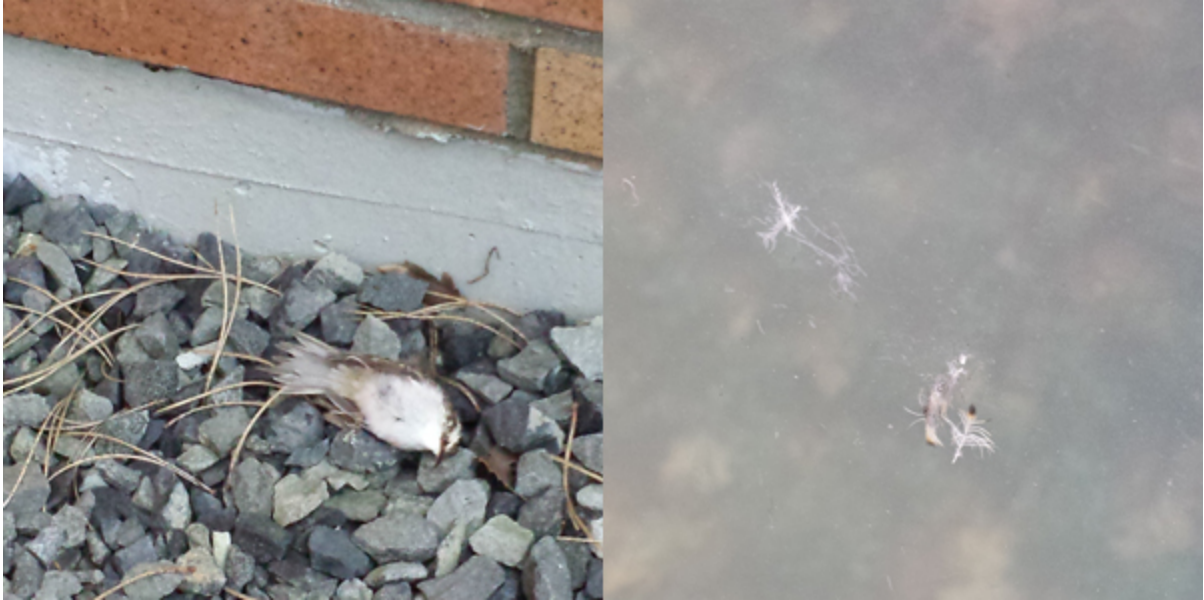
Figure 2b. Sample photo of bird collision evidence. Carcass (left) was found on Nov 18, 2014 by the S facade of Totem Residence while the small feathers stuck on windows (right) were found on Nov 25 by the same location.

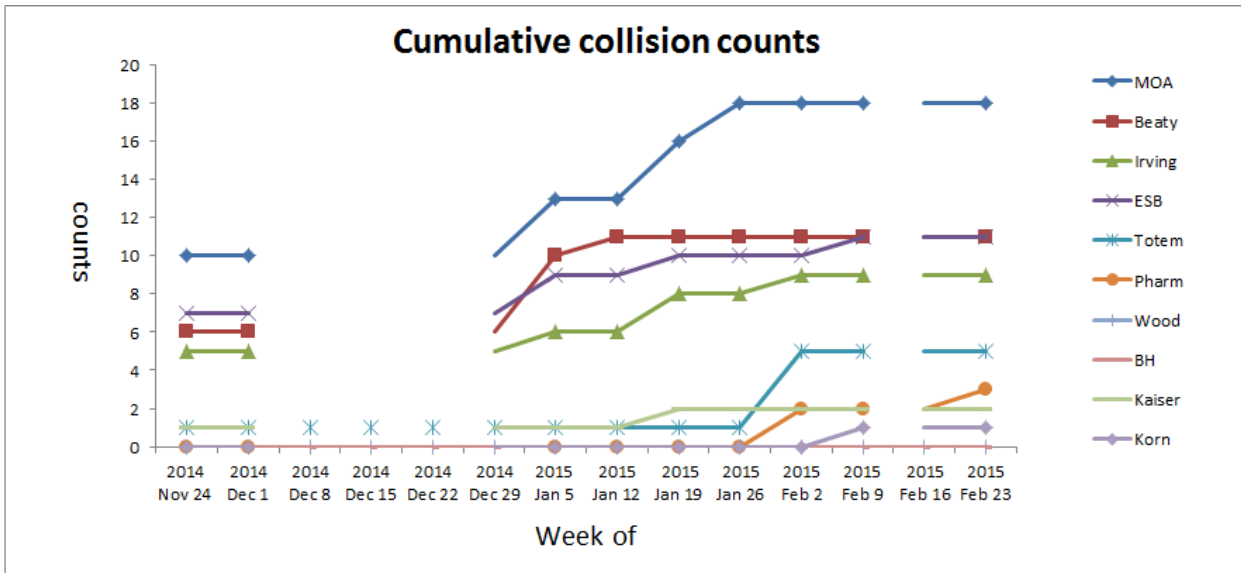
Graph I. (b) Total number of bird/window collisions for each building. Data collected on 27 days, across a fourteen-week period. The gaps represent the December exam period, holidays and reading break, when surveys were not conducted.

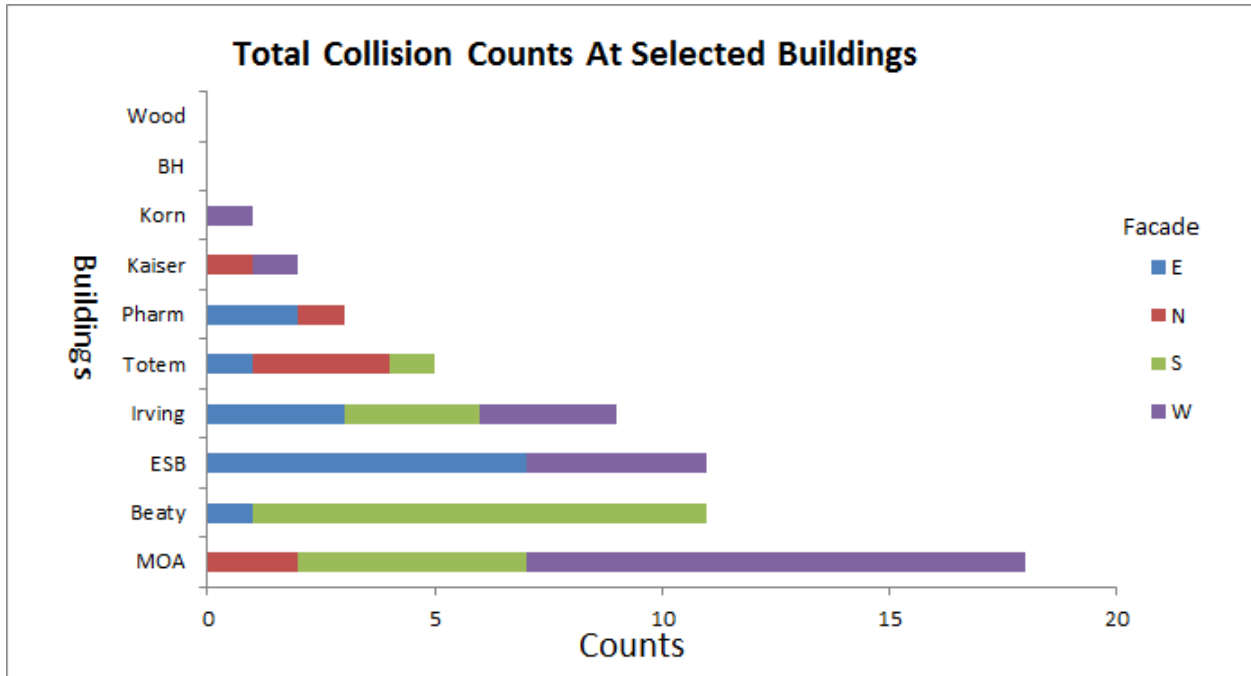
Graph II. Total recorded numbers of birds hitting windows (“collision counts”) at the ten buildings being monitored in this study. Data collected on 27 days, across a fourteen-week period at UBC Vancouver.

In total, at our ten buildings we found evidence for 60 collisions (see graph III). The museum of Anthropology(MOA) had the top collision count with 18 collisions, Beaty Biodiversity Museum (Beaty) and Earth Science Building (ESB) came in second with 11 counts each and Irving Library (Irving) came in third with 9 counts observed in 27 count days. Five out of ten buildings observed, MOA, Beaty, ESB, Irving and Totem, had collision counts more than 5 which is the number we defined to be a problem. These problematic buildings have many things in common. First is that they all have large and mostly clear windows. Second is that there are large open space around the buildings. The sky and trees would be reflected in the glass and birds would attempt to fly through and strike the window. Also the trees and vegetation around the buildings which attract birds would increase the chance of collisions. A possible contributing factor to the high number of strikes at the museum of anthropology could be that there is a pond combined with a forest patch in front of the 15m high window. The collision rate seems to decrease at most of the buildings towards the end of January 2015 (graph I and II). We observed that (graph IV) when the vegetation is very close to the window (within 2m) the rate of collision is lower compared to when the vegetation is farther away (above 2m) from the glasses.

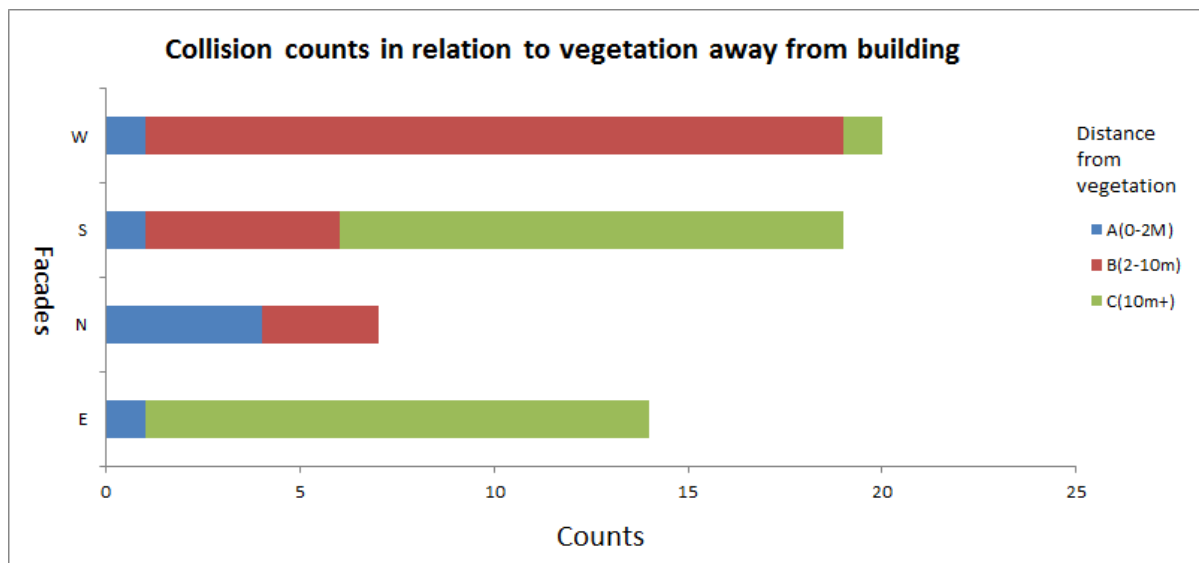
Graph III. Total collision counts at each facade and their distance from the nearest vegetation. Three levels of facade distance from the vegetation were used. Level A is 0-2 meters, B is 2-10 meters and C is a building distance of 10 meters or more from vegetation. Data collected on 27 days, across a fourteen-week period at UBC Vancouver.

In summary, we observed that the distances between the building to the nearby vegetation, in which is the most problematic, range from 2 to 10+ m. This is because if the nearby vegetation is too close to the building then it cannot be reflected off the glass windows, and instead blocks the window from view. For vegetation further from the window (2m+), the birds are relatively more easily tricked into seeing reflections of the nearby vegetation - increasing the number of bird collision occurrences as described above. As well, we also notice that % glazing cover of at least 60% as in the case of hēm'ləsəm' House, Museum of Anthropology,

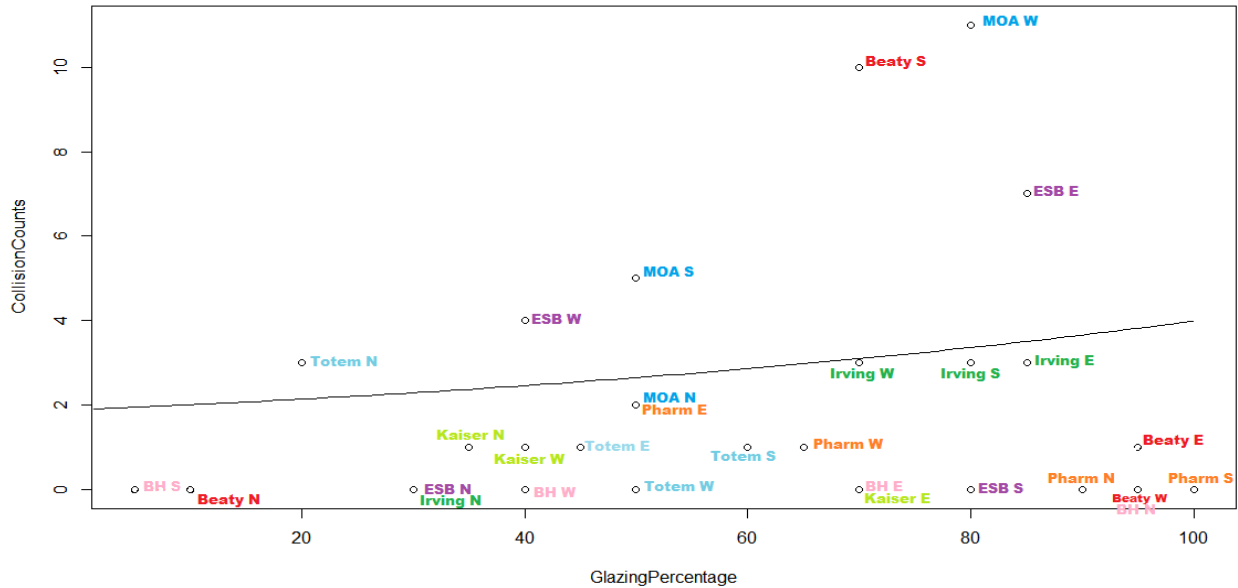
Graph IV. Glazing percentage versus total collision counts at each facade. Each data point is labeled with its respective facade of building. The Standard Error of estimated slope $\beta = 0.0113$ is 0.0052 which is small and the slope is statistically significant at 5% level with a P-value of 0.0294. A weak positive correlation of 0.19 was found between glazing percentage and collision counts.

A Poisson Regression analysis was used to fit on the data points of glazing percentage and total collision counts at each facade. From data points we found out that there is a weak

positive correlation of 0.19 between the glazing percentage of facades and the collision counts. The estimated regression model is:

$$\text{expected \# of collision} = e^{(-0.0925)} + e^{(0.0113 * \text{PercentGlazing})}$$

For every percent increase in the glazing the collision increased by the rate $e^{0.0113}$ and it is statistically significant with a p-value of 0.0294. However the intercept value, $e^{(-0.0925)} = 0.9116$, is not significant with p-value of 0.80.

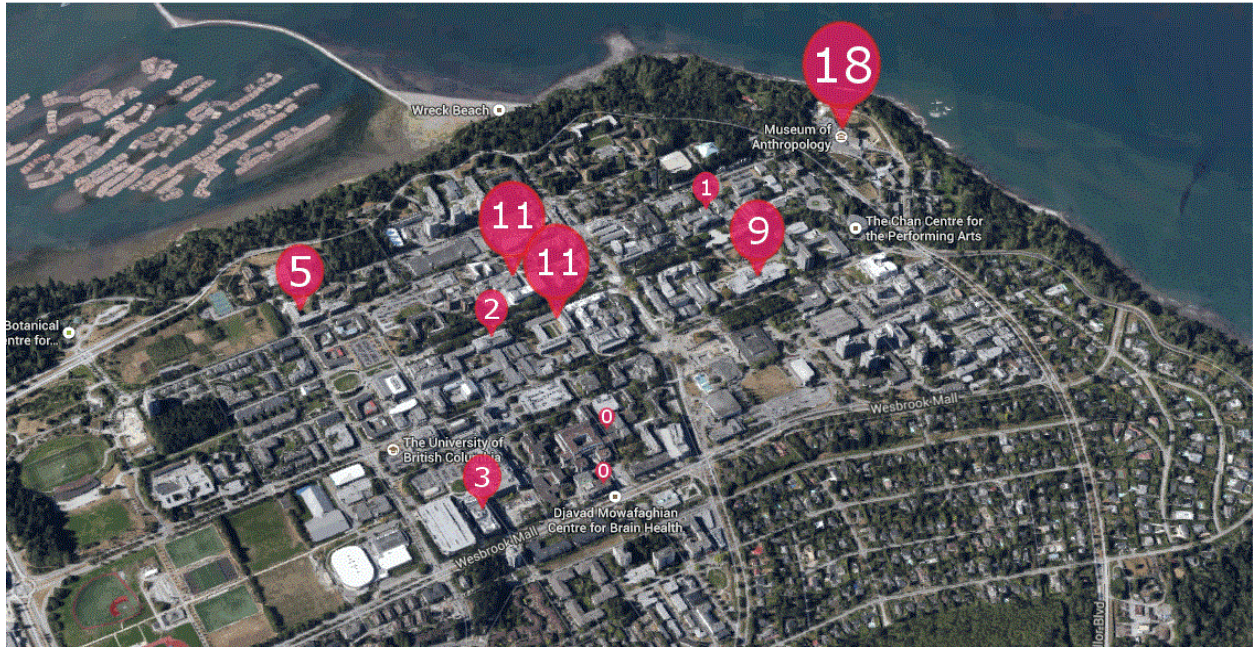
Figure 4. Relative positions of the buildings and their total collision counts on campus map.

The buildings have reasonably large forest patches (5-10 trees with shrubs) nearby which are attractive to birds. We also noticed (Figure 4) that buildings closer to the forest along Wreck Beach had higher incidences of strikes. The forest and forest patches are attractive because they provide food and shelter. The presence of these patches increases the number of birds present in the area, and thus increases the frequency of strikes. We measured distances from each building to nearby categories of vegetation. Our categories were shrubs, grass
