City of Vancouver

Dennis Fan  
Greenest City Scholar

# [GREENING A HERITAGE BUILDING]

Literature review and case study synthesis on the benefits of heritage building conservation and how sustainability focused strategies may be applied to enhance both environmental performance and heritage conservation.

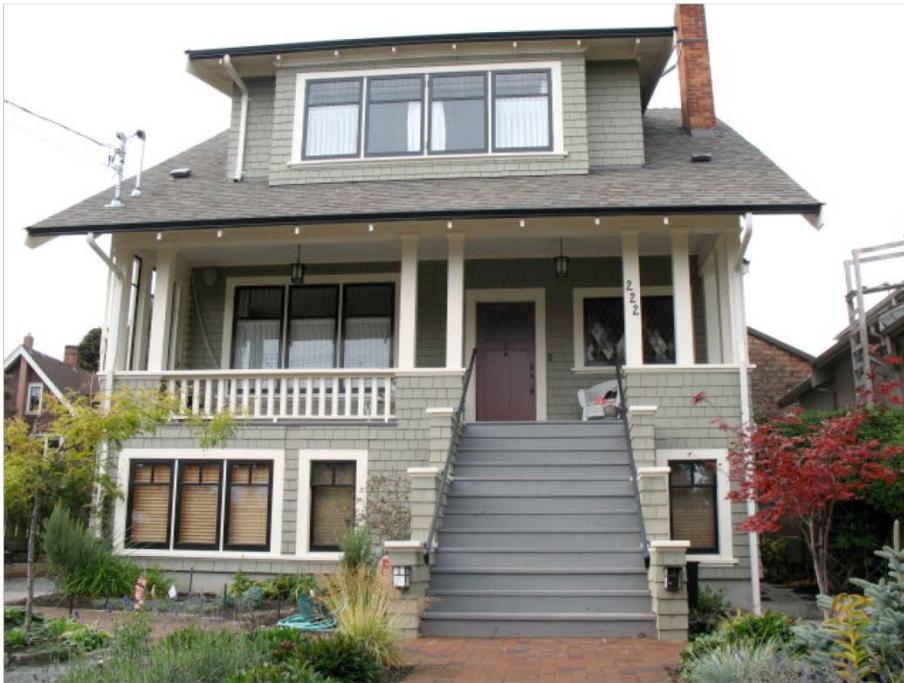
Figure 6: Front view from Vancouver Street (Ross & Coulson, 2008)

The Vancouver House case study is a LCA carried out for a 1910 Arts and Craft house on Vancouver Street in Victoria, BC.

The Vancouver House was renovated in a heritage sensitive manner, preserving its character-defining elements, and achieved better performance than new construction which follows new building code. The house earned an EnerGuide rating of 80. The comparative analysis was modeled in Athena Impact Estimator for environmental impacts and HOT2000<sup>8</sup> for energy efficiency and consumption. For detailed model methodology and data, please refer to Appendix A: Vancouver House.

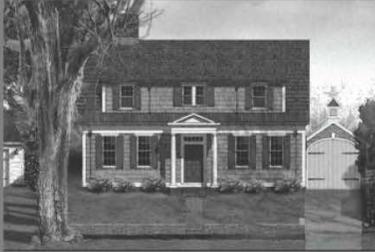
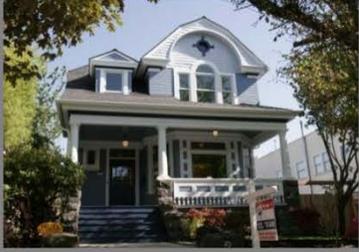
Table 1: Single-Family Residence Information for Quantis Study (Selection, 2011)

| Single-Family Residence | | |
|---|---|---|
| | <b>NEW CONSTRUCTION</b> | <b>REHABILITATION and RETROFIT</b> |
| Building name | SW 34 <sup>th</sup> Street | 2373 NW Pettygrove |

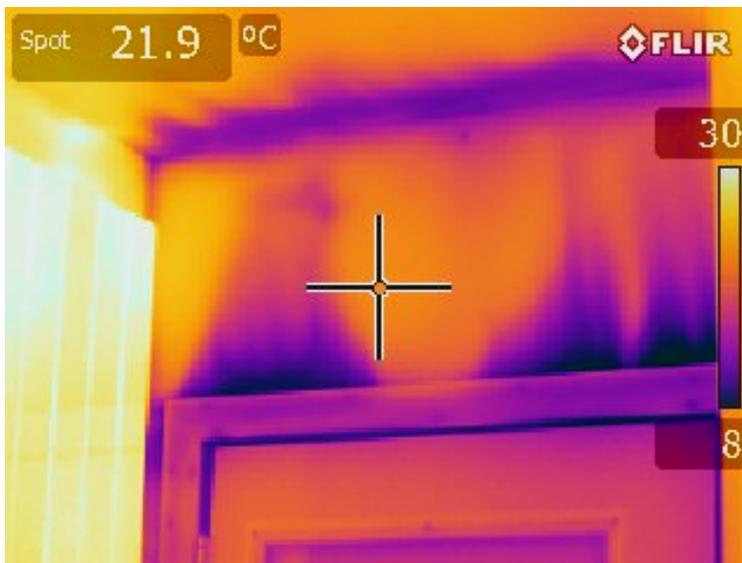
Figure 13: Cold air leaking above well insulated door (Alter, 2014)

It is important to first determine where the most energy is being wasted, either through thermal imaging, which displays the surface temperature of the building, or air pressure testing. These tests may be useful in identifying cold air intrusion and thermal imaging could help identify thermal bridging<sup>10</sup> and areas of missing insulation. Figure 12: Cold air leaking through behind window trim shows how a thermal imaging camera can detect cold air intrusion through the building. (Alter, 2014)

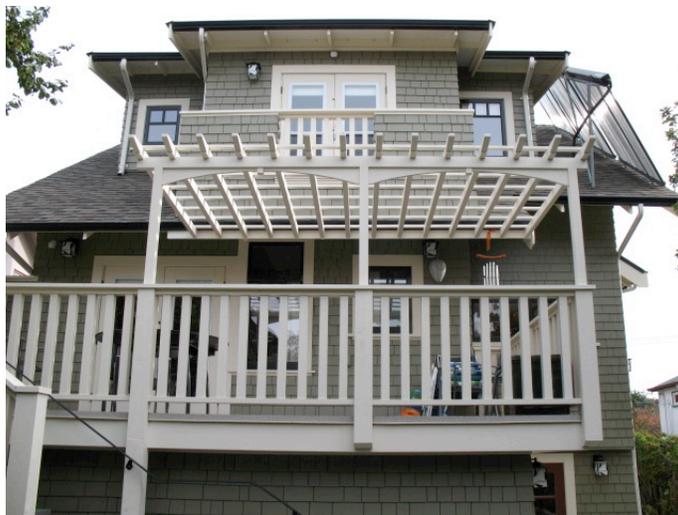
**Figure 8 - Back view (west); note solar panels on rooftop**

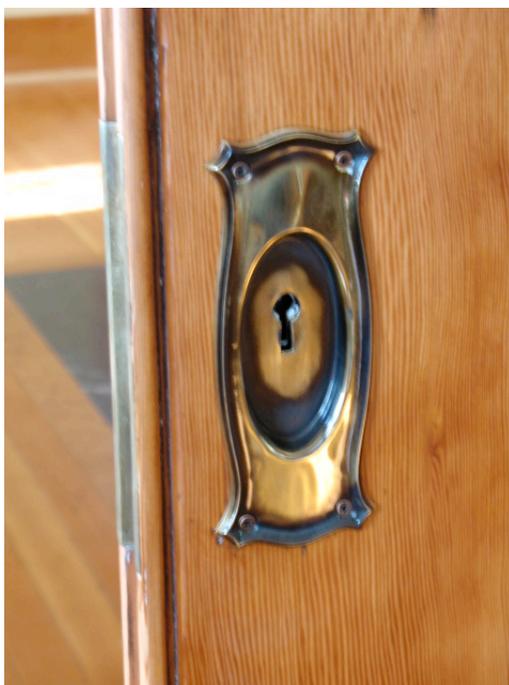
**Figure 10 - Original bronze-plated hardware on dining room pocket door**

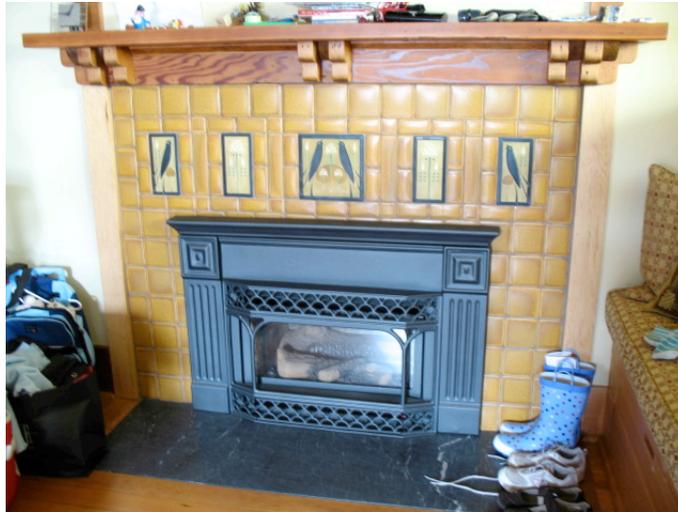
**Figure 11 - Restored Arts and Crafts fireplace in main entrance**

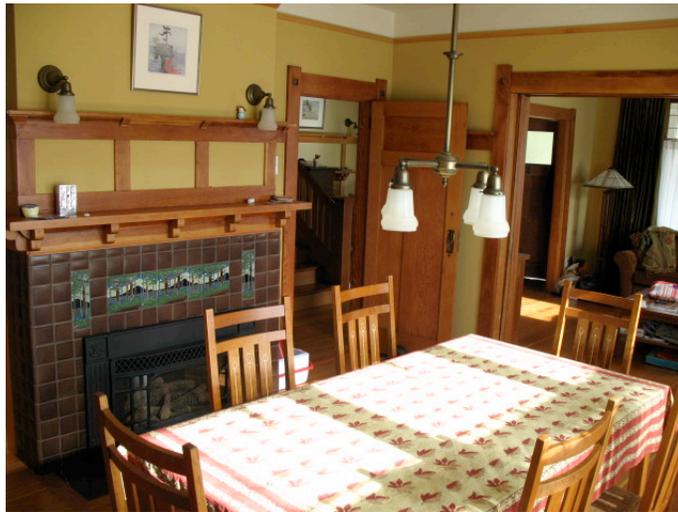
**Figure 12 - Original dining room (full scale, unchanged from 1910) showing second main floor fireplace and a selection of interior wood details and custom Arts and Crafts furnishings**
