**TESTING AND ANALYSIS OF UBC
WATER DISCHARGE SITES DURING
NON-STORM EVENTS
UBC SEEDS PROJECT**

CHBE 484

Date: April 18, 2005

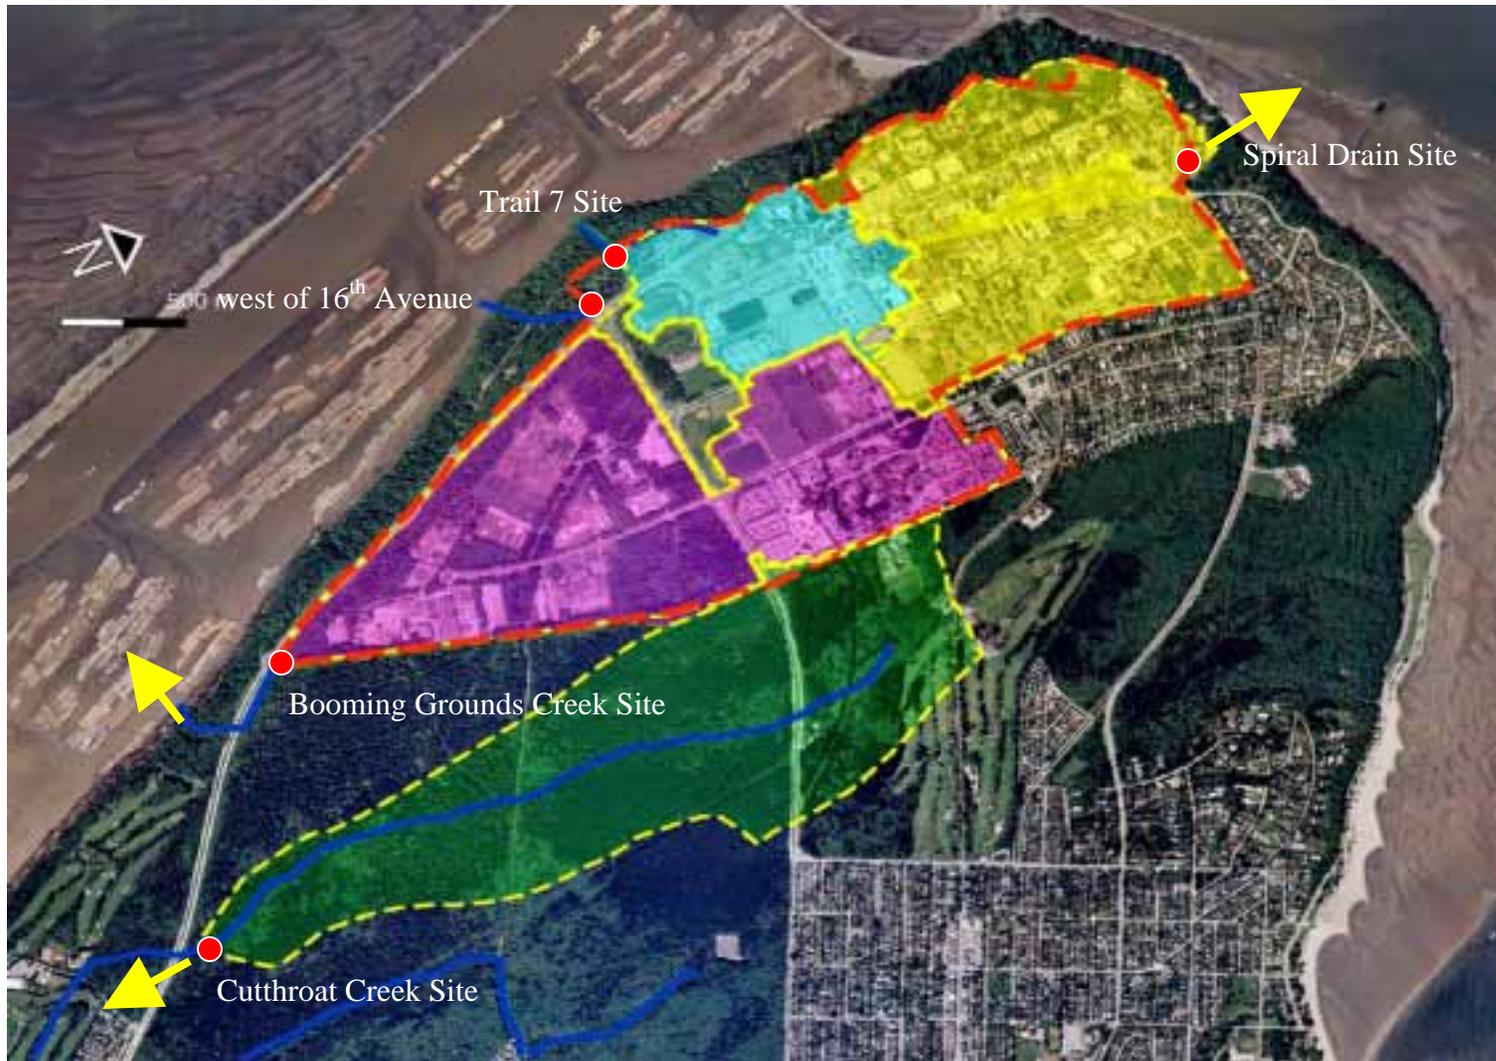
FIGURE4: A MAP OF THE FIVE SAMPLED CATCHMENT DISCHARGE POINTS.

Booming Grounds Creek is found on the east side of Southwest Marine Drive (refer to Figure 4). The South Catchment discharges into this creek, where the runoff originates from housing, playing fields and the Triumpf research area. A sample was taken in the center of the creek upstream of the green weir. Figure 6b illustrates the point from where samples were taken.

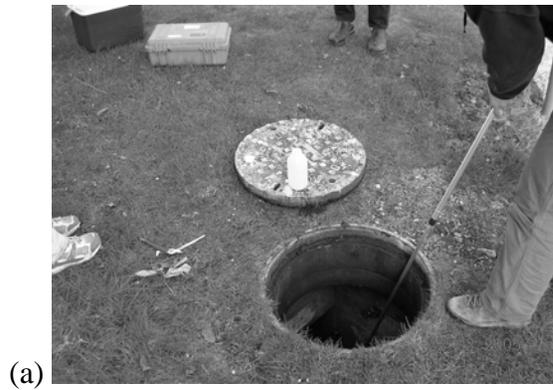
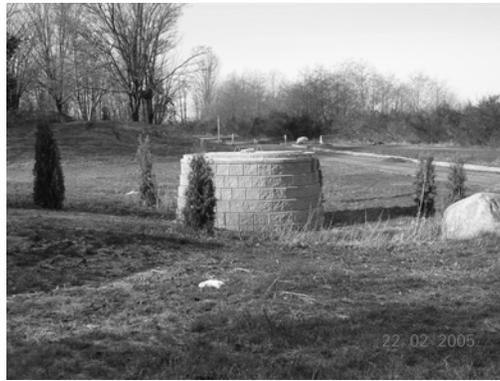
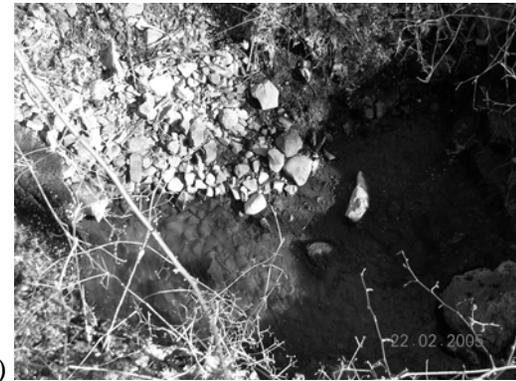
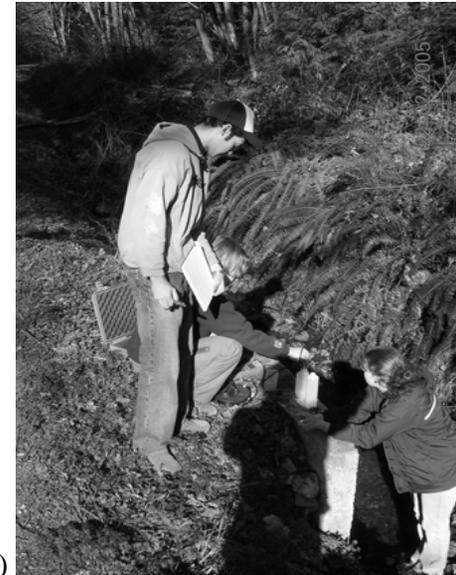
FIGURE5: a) A PICTURE OF THE SPIRAL DRAIN SAMPLING MANHOLE; b) WEST OF THE SAMPLING MANHOLE IS THE ACTUAL SPIRAL DRAIN; c) THE TRAIL 7 SITE WHERE SAMPLES WERE TAKEN FROM; d) A CULVERT ENTERING 'WEST OF 16TH AVENUE' SAMPLING SITE; e) A PICTURE OF THE THREE STUDENTS SAMPLING FOR CONDUCTIVITY AND TEMPERATURE ON SITE AT 'WEST OF 16TH AVENUE'.

Spiral Drain is located north of the Museum of Anthropology on Cecil Green Park Road. This site drains the north and central portions of campus, where there is currently construction. Before being discharged into the ocean, the stormwater spirals down a 60-m deep, 1.2-m diameter concrete drain. Figure 5a illustrates the manhole east of the Spiral Drain from which samples were taken.

Trail 7 and the west of 16th Avenue site are located along old Marine Drive, West of the UBC Botanical Gardens. This catchment area is the smallest of the three. Many parking lots (including Lot B) and sports fields drain into this catchment. The water travels through an eroded ravine into an estuarine habitat. Samples were taken at both Trail 7 (Figure 5c) and west of 16th Avenue (Figure 5d).

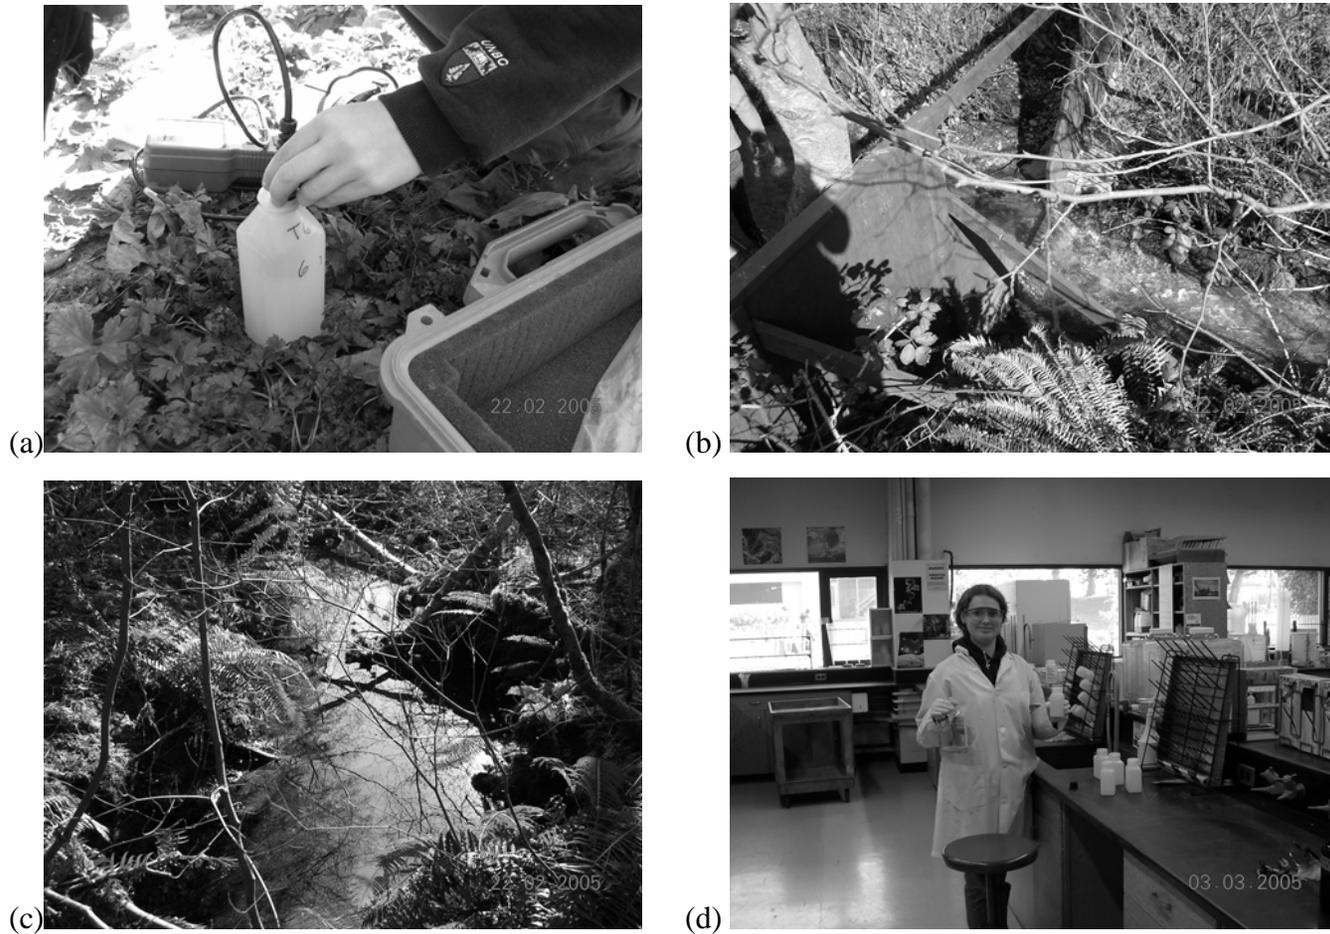
FIGURE6: a) A PHOTOGRAPH SHOWING HOW SPECIFIC CONDUCTIVITY AND TEMPERATURE WAS MEASURED; b) A WEIR AT BOOMING GROUNDS CREEK SAMPLING SITE; c) CUTTHROAT CREEK STREAM SAMPLING POINT, DOWNSTREAM OF THE RAINSTORM CUTTHROAT CREEK SAMPLING POINT; d) A PHOTOGRAPH OF A STUDENT ACID WASHING THE SAMPLING BOTTLES PRIOR TO SAMPLING.

Cutthroat Creek (Figure 6c), located in Pacific Spirit Park southwest of UBC, was used as a control. This stream is considered to be free of human contamination. All data was compared to this baseline site.

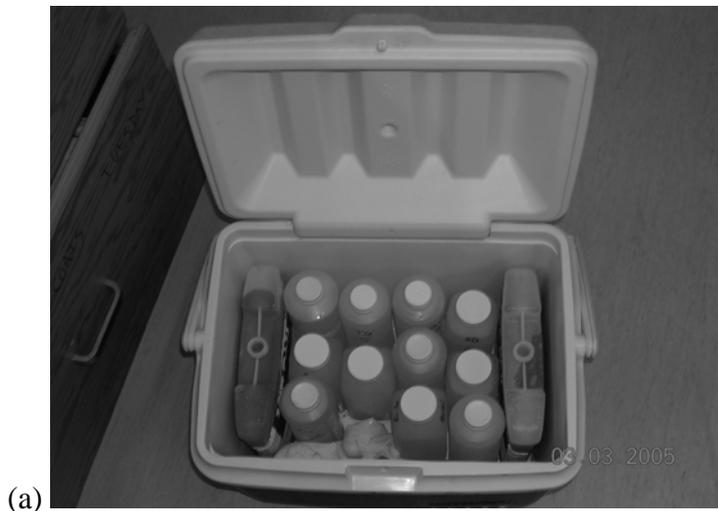
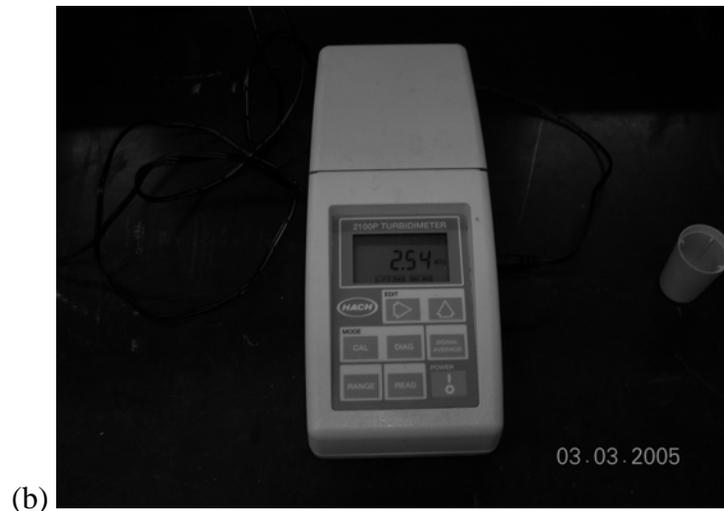
FIGURE7: a) A COOLER WITH ALL OF THE METALS SAMPLING BOTTLES INSIDE TO BE TAKEN TO ALS ENVIRONMENTAL; b) A PHOTOGRAPH OF THE TURBIDITY METER; c) A STUDENT PREPARING A SOLUTION FOR pH MEASUREMENTS.
