# Everett Crowley Park

An assessment of current and future restoration efforts

Greenest City Scholar  
Vancouver Park Board

Completed by Lorraine Campbell  
August 2017

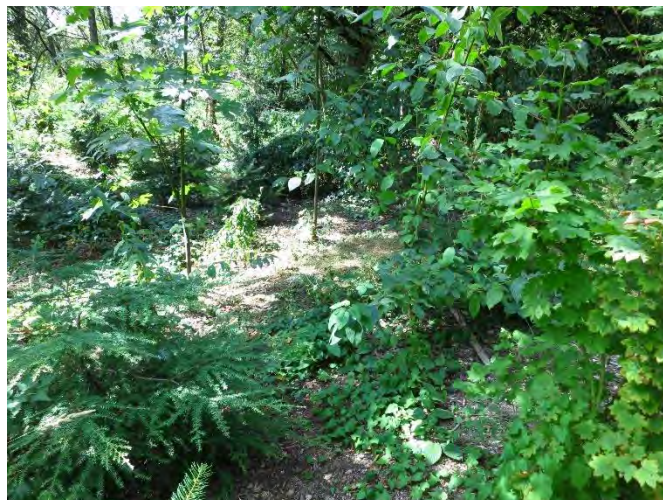
Western hemlock, big leaf maple, red osier dogwood and vine maple saplings in site 2015 a

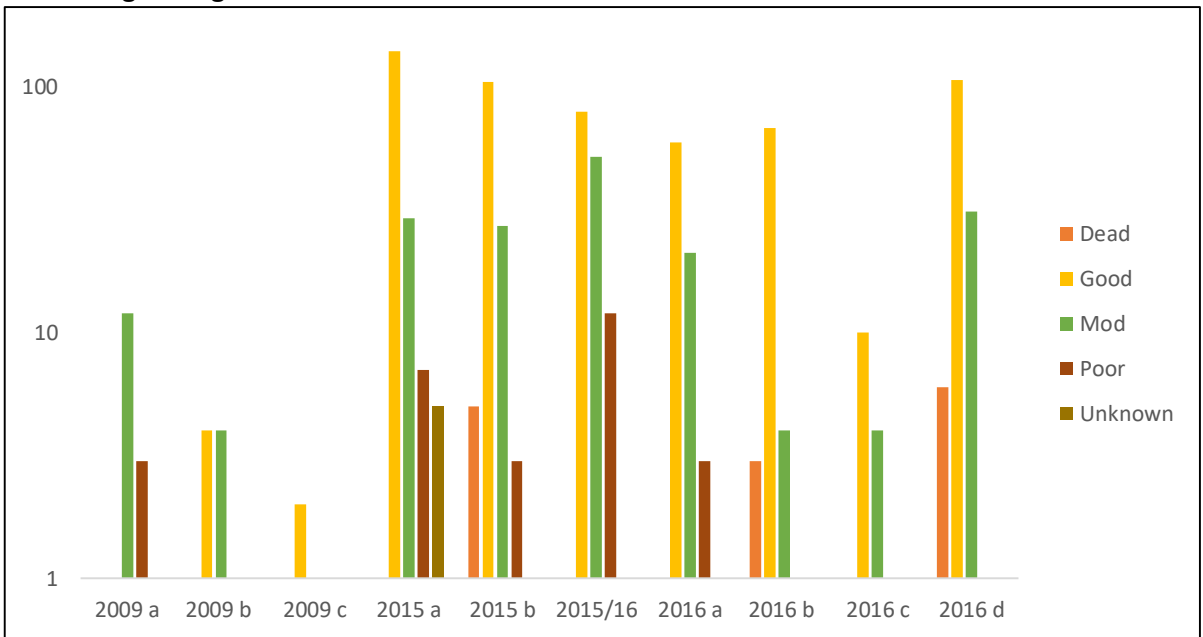
Overall, Douglas-fir health was good and survival was high. It is normal for about 30-40% of planted saplings not to survive their first year (Duncan & Richter 2012). There is no way to know the exact number of individuals planted in ECP that have survived or died because those that die may have been removed over the years and deaths are not recorded. Based on the Douglas-fir analysis observed in restoration plots, only 2% of the total were identified as dead and 4% were in poor condition. This is an excellent outcome. Additionally, 23% were considered in moderate condition and 71% were considered in good condition. Even if only those in good condition survive, it is within track of normal survivability (Duncan & Richter 2012). Trees in poor condition are unlikely to survive until the next growing season.

Douglas-fir health per restoration site

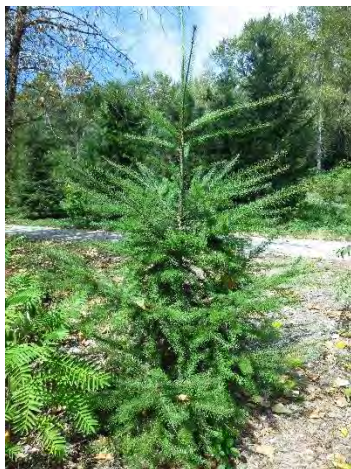
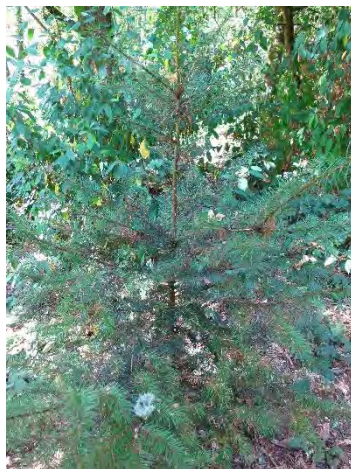
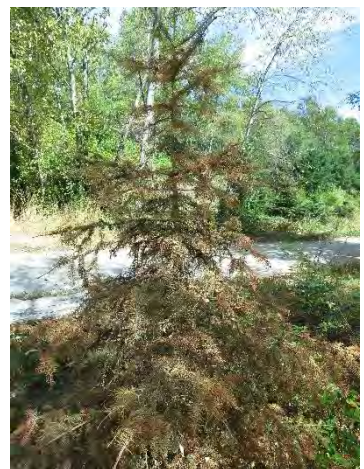
Douglas-fir health: **good** (left), **moderate** (middle) and **poor** (right)

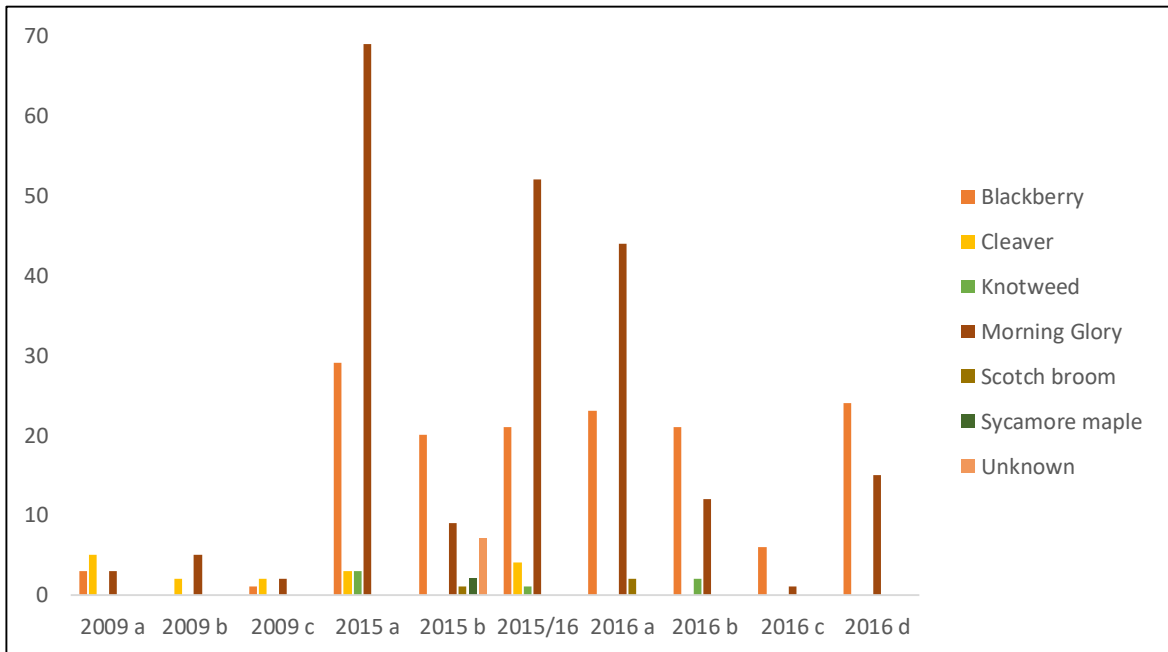
In the sites planted in 2009, invasive plants have established throughout the entire area and are smothering a large number of native plants. In the 2015 and 2016 sites, invasive plants are beginning to creep in from the periphery. Almost 50% of the Douglas-fir had an invasive plant in contact with it. Himalayan blackberry and morning glory are the greatest problem by a large margin, 38% of the invasive plants contacting the Douglas-fir were blackberry and 54% were morning glory. The proliferation of invasive plants is the worst in the 2009 sites; these plants will regain control and likely kill the majority of the planted individuals within the next year or two without intervention.

Number of Douglas-fir trees with an invasive plant in contact with it per restoration site

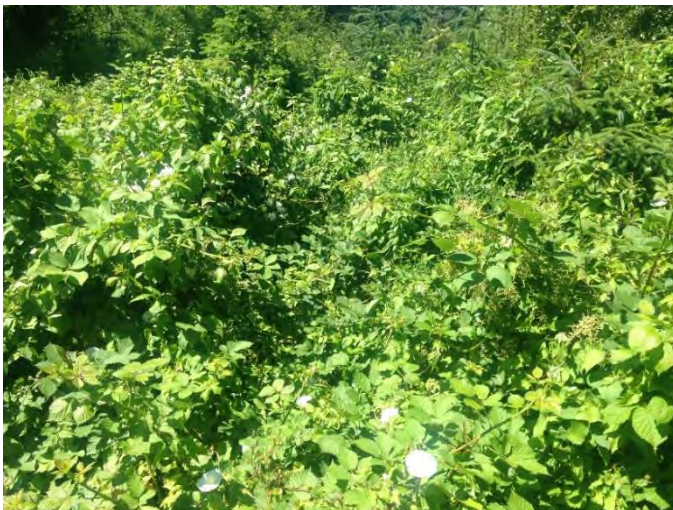
Morning glory and blackberry overtaking Douglas-fir and ocean spray

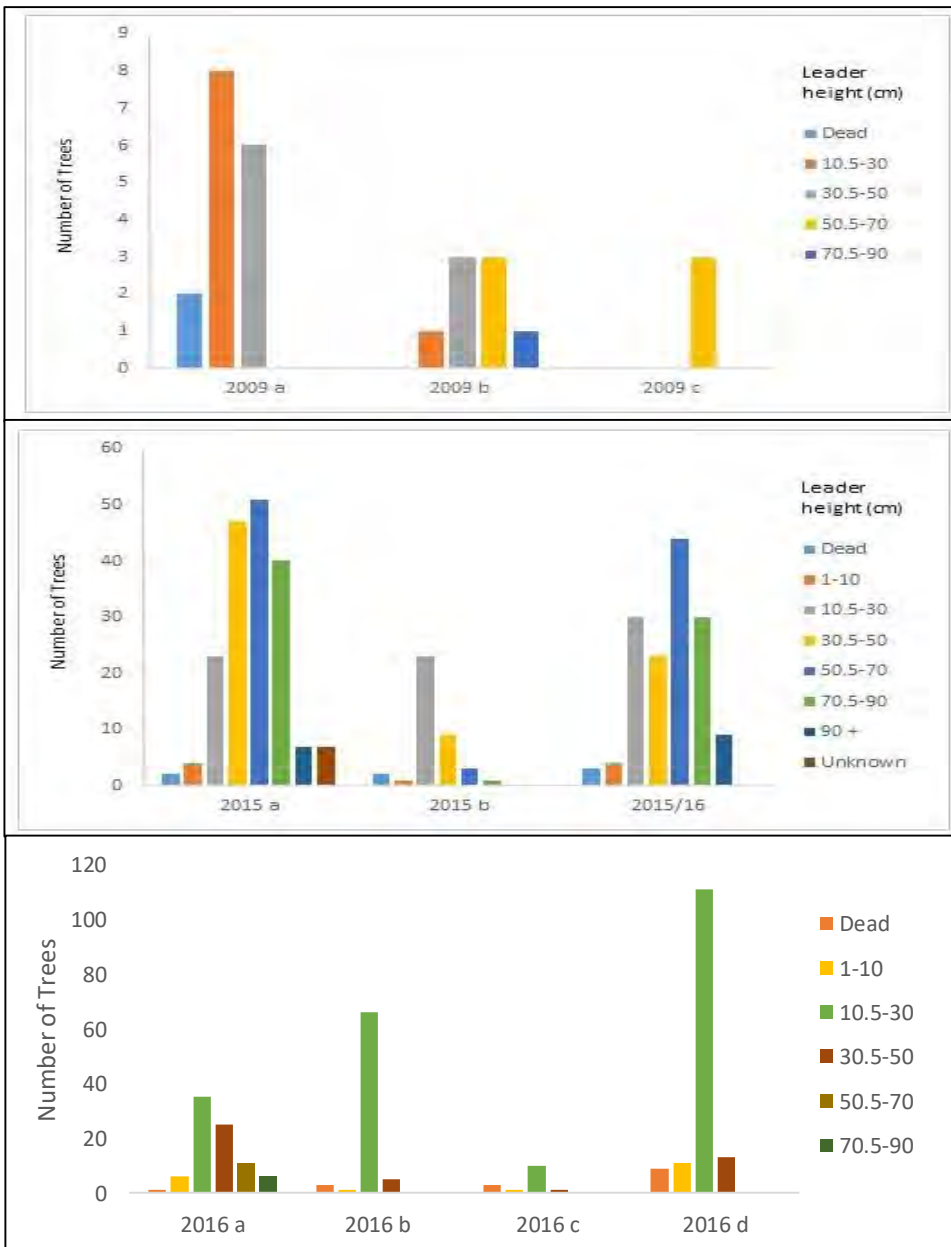
Douglas-fir height growth is slow for the first five years, numbers vary depending on site conditions (e.g., soil, rainfall, temperature). Annual height growth can be approximately 6 – 9 cm in the first year (U of C, n.d.) increasing to 10 to 30 cm per year by age 13 (Nabel et al. 2013), and by age 30 can average 61 cm growth annually (Hermann and Lavender, n.d.). Most Douglas-fir measured on restoration sites showed excellent growth; 44% of individuals had leader growth between 10.5 and 30 cm and another 33% experiencing between 30.5 and 70 cm growth. Over 50% of the growth in the 2009 and the 2016 sites was between 10.5 and 30 cm. Growth was spread more evenly in the 2015 (including 2015/16) sites with the categories 10.5-30 cm, 30.5-50 cm, 50.5-70 cm and 70.5-90 cm having 21%, 22%, 27%, and 20% of the individuals respectively.

Leader height of Douglas-fir per restoration site

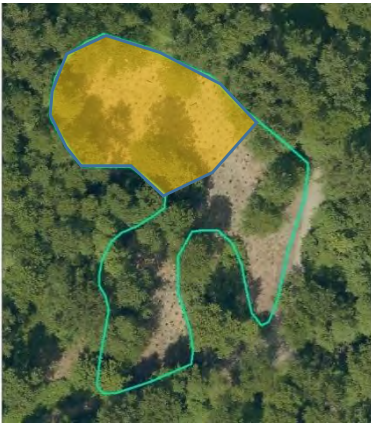
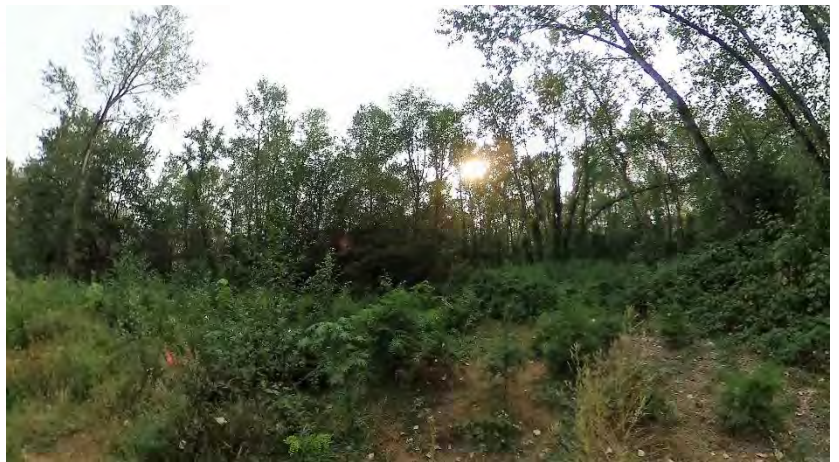
## North

- Fabaceae species (various woody and herbaceous)
  - Himalayan blackberry creeping in, especially at the margins. Smothering some Douglas-fir and other species
  - Morning glory, which is smothering some species including Nootka rose, Douglas-fir and black hawthorn
  - Scotch broom (limited amounts)
-

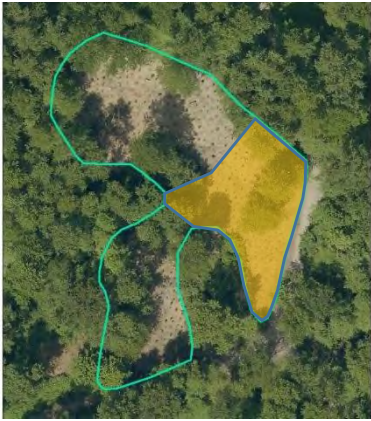
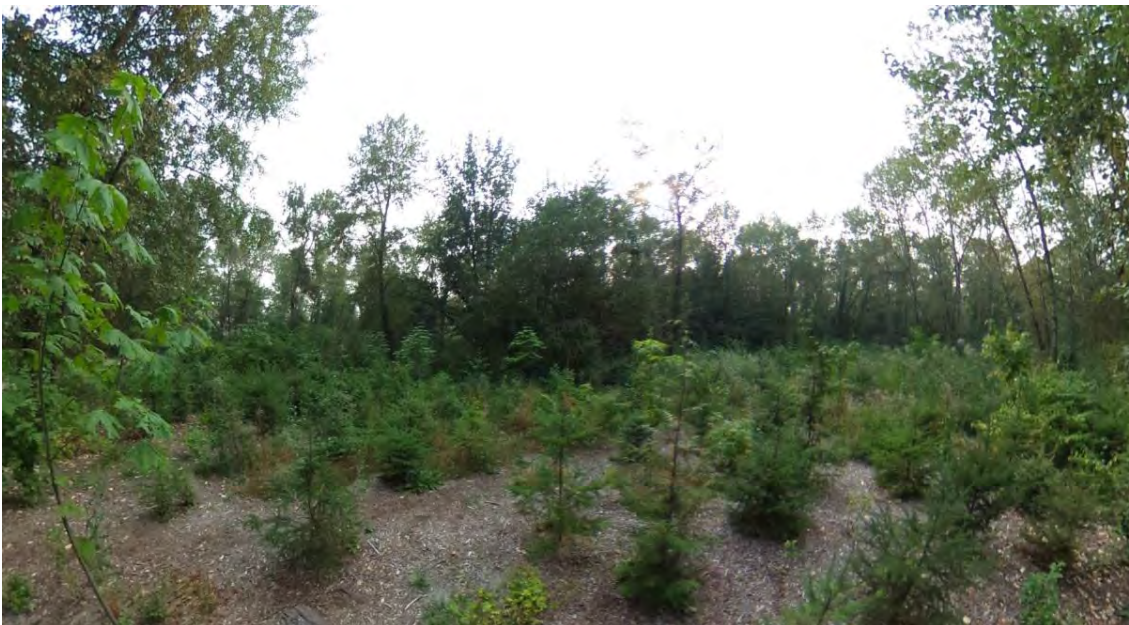
## Centre East

- Cherry species; a few
- Himalayan blackberry
- Knotweed; small patch
- Morning glory; smothering species including cedar, current and Douglas fir

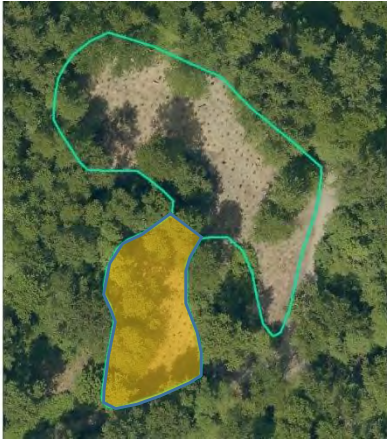
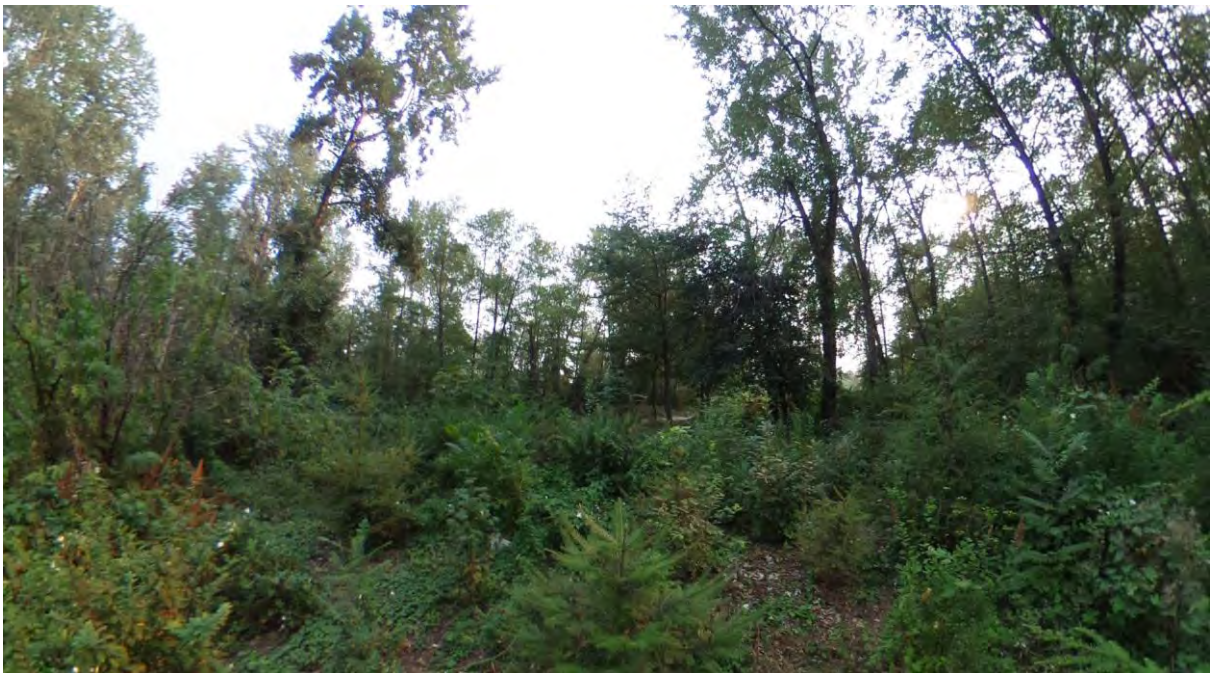
## South

- Himalayan blackberry; throughout site
  - Morning glory; smothering many of the trees, including Douglas fir
-

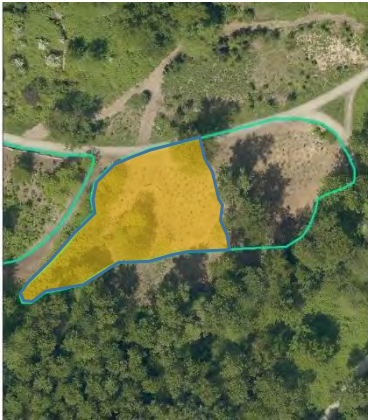
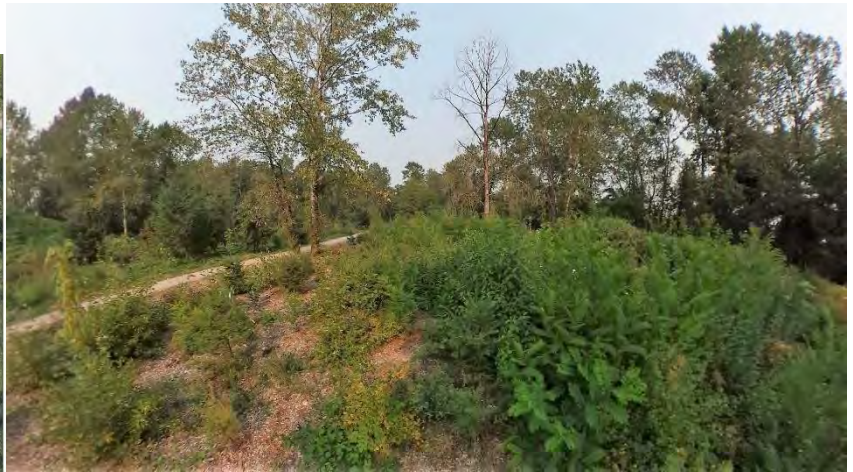
## West

- Black locust regenerating; should be removed
  - Himalayan blackberry; is covering much of the floor in the south end and spotty in west corner
  - Morning glory: it is abundant and smothering some of the Douglas fir; it is growing thick amongst the ocean spray and red osier and it is covering much of the floor
  - Scotch broom; spotty throughout west corner
-

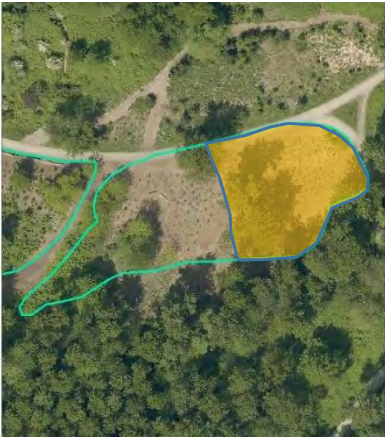
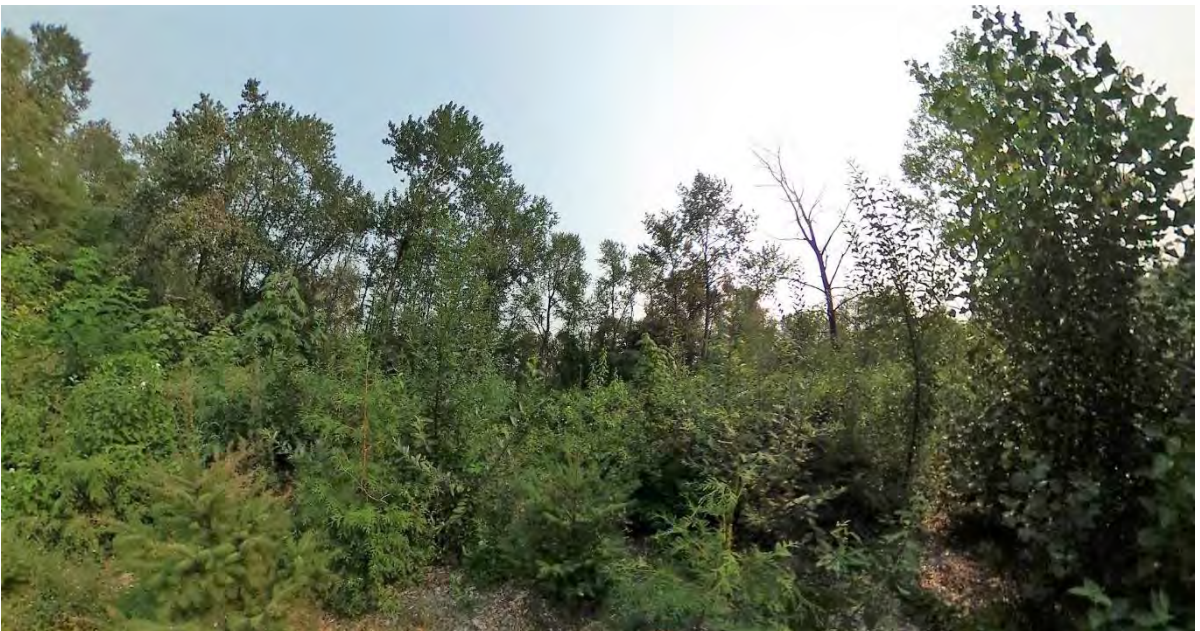
## East

- Himalayan blackberry; is covering much of the floor
- Knotweed
- Scotch broom
- Morning glory: it is abundant and smothering some of the ocean spray and red osier and encroaching onto the willow

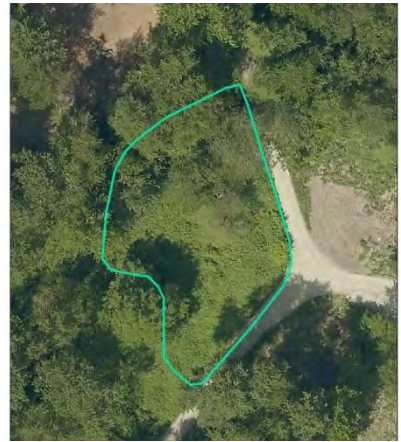
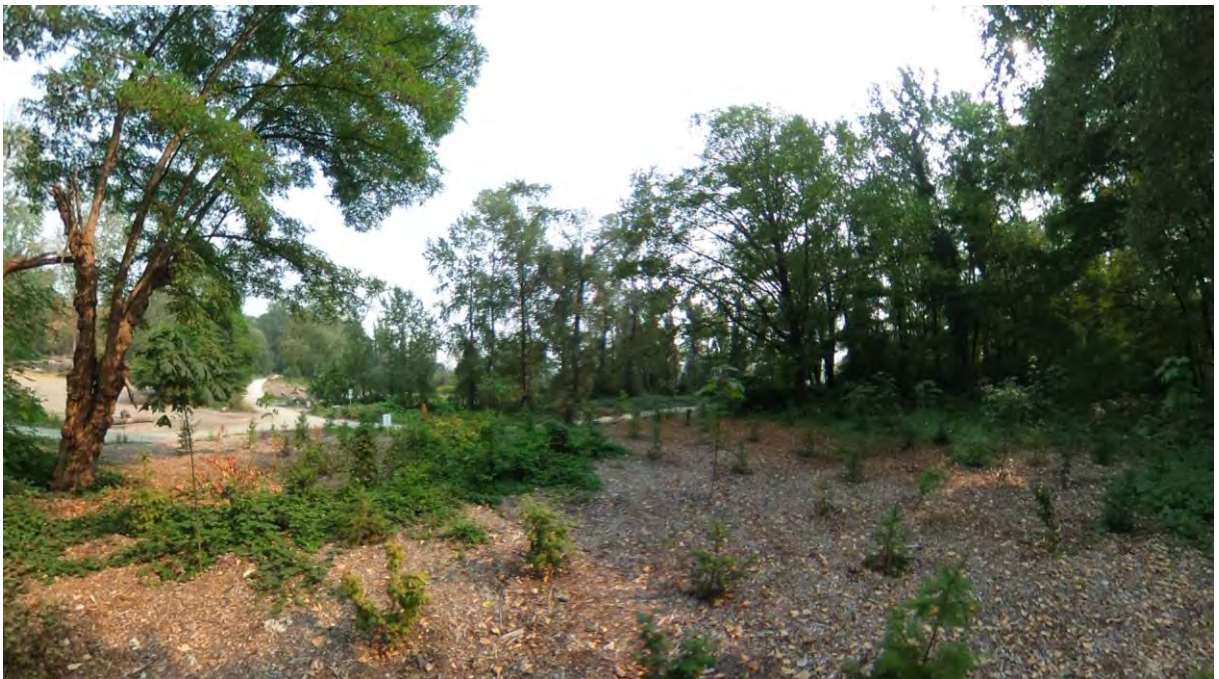
## 2016 b

- Himalayan blackberry is in a large patch in centre to NE corner of plot
  - Knotweed; small patch near centre
  - Morning glory is in a large patch in centre to NE corner of plot
-

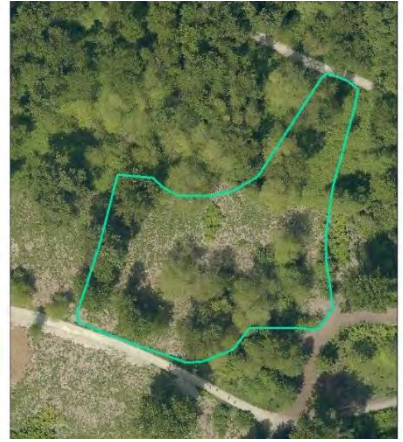
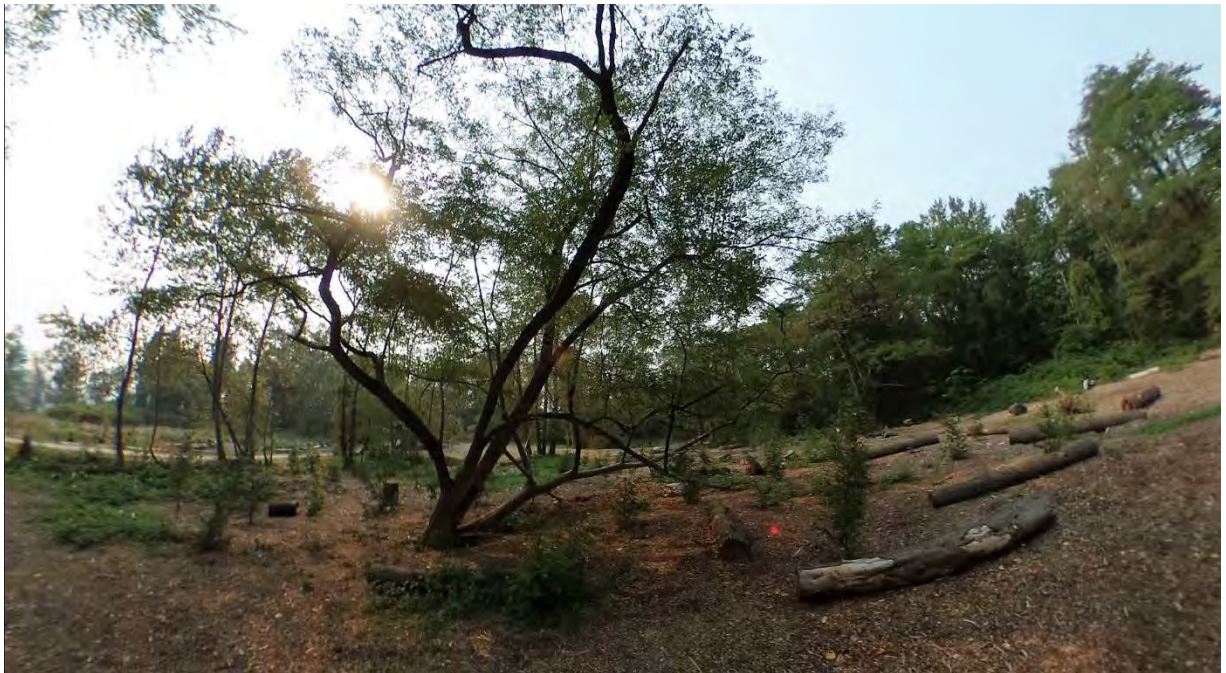
## 2016 d

- Hay (or straw) has been put down by unknown people around some seedlings and is now sprouting.
  - Himalayan blackberry; patches of sprouting blackberry throughout and a large patch in SW corner
  - Morning glory; primarily in a large patch in SW corner and in the NW corner is starting to spread into site
-
