Everett Crowley Park

An assessment of current and future restoration efforts

Greenest City Scholar
Vancouver Park Board

Completed by Lorraine Campbell
August 2017

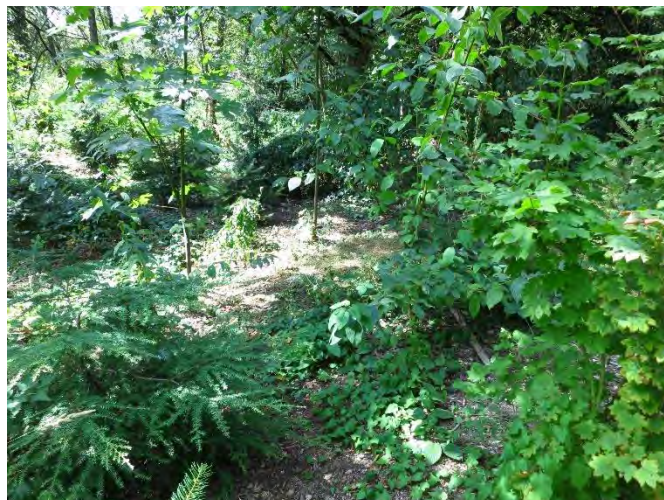
Western hemlock, big leaf maple, red osier dogwood and vine maple saplings in site 2015 a

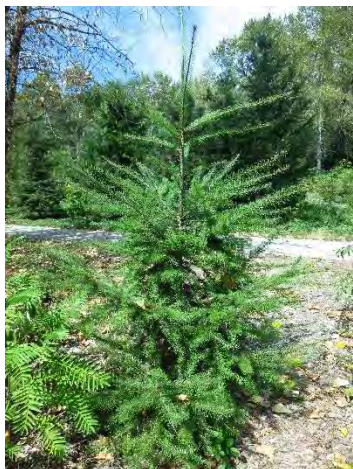
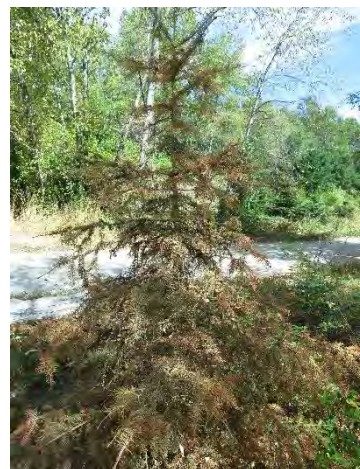
Douglas-fir health: **good** (left), **moderate** (middle) and **poor** (right)

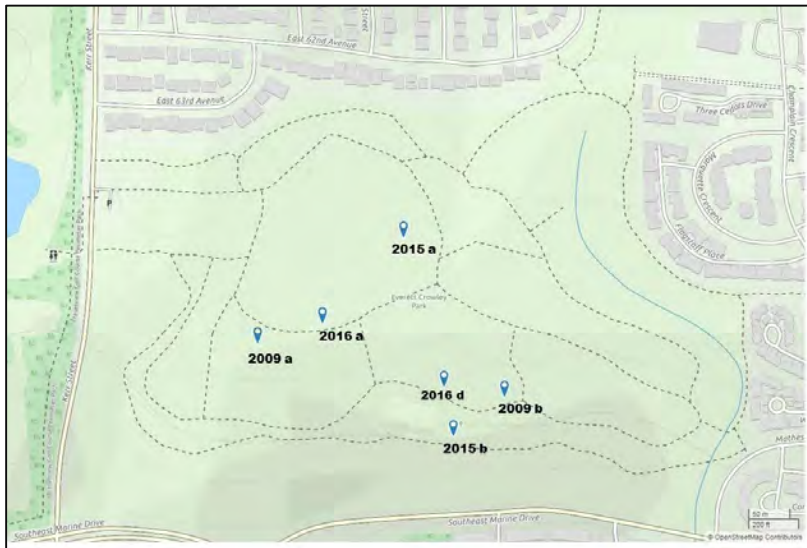
Fig 3: Locations of soil pits within restoration plots

Plot	Mulched	Mulch and/or O-horizon depth (cm)	A-horizon depth (cm)	E-horizon depth (cm)	Comments
2009 a	N	5	10	NA	<ul style="list-style-type: none"> Organic layer very dry Hardpan at 15 cm
2009 b	N	2	4	37	
2015 a	Y	26	7	NA	<ul style="list-style-type: none"> E-horizon smelled of sulphur
2015 b	Y	50	5 +	NA	
2016 a	Y	28	14	NA	<ul style="list-style-type: none"> Hardpan at 35 cm
2016 d	Y	41	15	NA

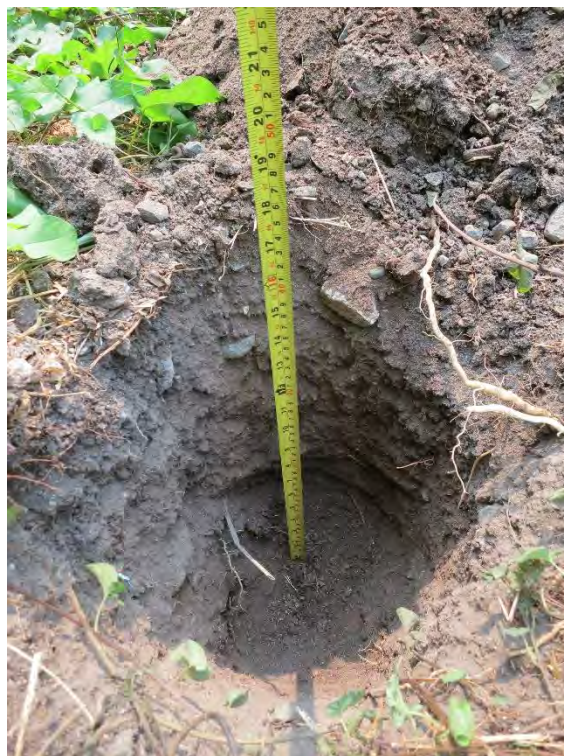
Soil pits for restoration sites 2009 a (left) and 2009 b (right)

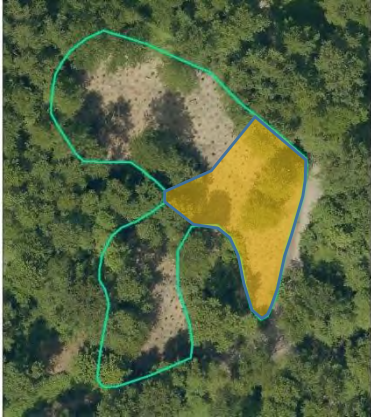
Centre East

- Black hawthorns; a few small ones
- Cedar
- Current
- Douglas fir; generally in good health
- Grand fir
- Hardhack; healthy
- Horse chestnut; healthy
- Oregon grape; healthy
- Red osier dogwood in good shape
- Thimbleberry; healthy and many are flowering
- Vine maple; mostly doing poorly (insect attack?)
- Western hemlock; healthy

- Cherry species; a few
- Himalayan blackberry
- Knotweed; small patch
- Morning glory; smothering species including cedar, current and Douglas fir

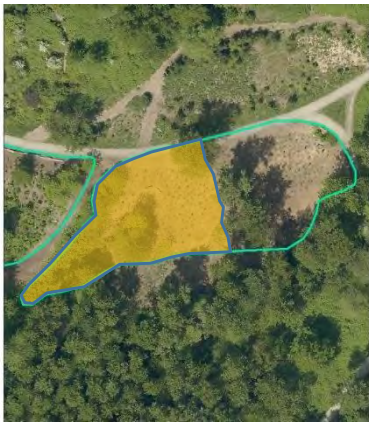
West

- Douglas fir; abundant and most is in moderate to good healthy
- Ocean spray; have many new shoots regenerating and look healthy and getting large
- Red osier dogwood have many new shoots regenerating and look healthy and getting large.
- Maple (vine and big leaf); moderate to healthy
- Willow species; healthy

- Black locust regenerating; should be removed
 - Himalayan blackberry; is covering much of the floor in the south end and spotty in west corner
 - Morning glory: it is abundant and smothering some of the Douglas fir; it is growing thick amongst the ocean spray and red osier and it is covering much of the floor
 - Scotch broom; spotty throughout west corner
-

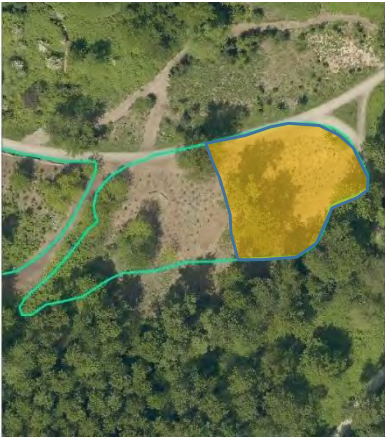
East

- Cedar
- Douglas fir; abundant
- Maple (vine and big leaf)
- Ocean spray; have many new shoots regenerating and look healthy and getting large
- Red elderberry; large, healthy on in NE corner
- Red osier dogwood have many new shoots regenerating and look healthy and getting large.
- Willow species; mostly towards south end

- Himalayan blackberry; is covering much of the floor
- Knotweed
- Scotch broom
- Morning glory: it is abundant and smothering some of the ocean spray and red osier and encroaching onto the willow

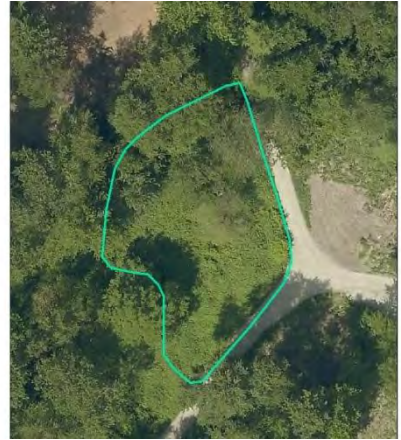
2016 b

Site preparation: Flail mowed fall 2016; mulched spring 2017; planted February 2017

- Douglas fir; good health
- Maple (big leaf and vine); moderate health. However, many are experiencing wilt and 5 or more have died
- Sitka spruce; good health

- Himalayan blackberry is in a large patch in centre to NE corner of plot
 - Knotweed; small patch near centre
 - Morning glory is in a large patch in centre to NE corner of plot
-

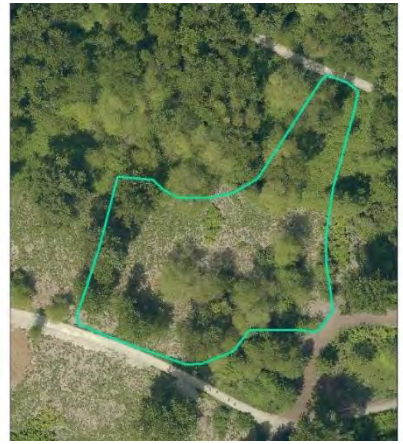
2016 d

Site preparation: Flail mowed in fall 2014 and again summer 2016; mulched summer 2016; planted fall 2016

- Cedar; generally good health
- Douglas fir; generally good health
- Maple (vine and big leaf); generally good health
- Red alder; generally good health
- Sequoia; one sapling in decent health
- Yew; one sapling in poor health

- Hay (or straw) has been put down by unknown people around some seedlings and is now sprouting.
 - Himalayan blackberry; patches of sprouting blackberry throughout and a large patch in SW corner
 - Morning glory; primarily in a large patch in SW corner and in the NW corner is starting to spread into site
-
