Student Research Report

**Main Mall Tree Inventory**

**Jane Ho**

**April 12, 2018**

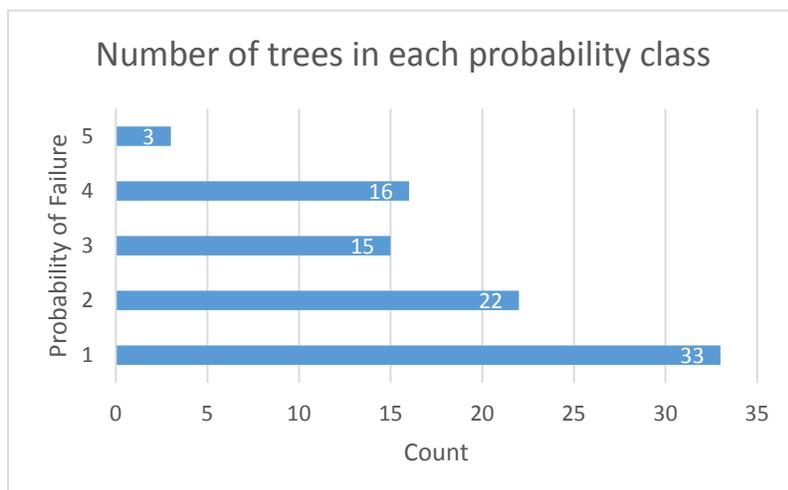
For rating the probability of failure, most trees (37%) were assigned a rating of 1, meaning they only exhibited minor architectural problems. Only 3 trees (3%) were given a rating of 5 as they seem to be severely damaged. When a tree matches any of the description ratings from table 2, they would be assigned the highest matched rating. The percentage of decay helps to define the rating of probability of failure. University arboriculturalist, Collin Varner, says that it is difficult to visually determine the amount of decay and that most common decay fungus, turkey tail (*Trametes versicolor*), is usually only visible high into the crown. Other potential indicators of decay are cracks, wounds, bulges, carpenter ants, fruiting bodies, and small cavities (Lilly et al., 2010).

Figure 3: Number of trees in each probability class.
