UBC Intersection Redesign Project Adam Ostereicher, Alexandr Shklyar, David Tran, Emir Hot, Greg Eng, Sarah Thompson University of British Columbia CIVL 446 April 08, 2016

CIVL 447: DETAILED DESIGN REPORT UBC INTERSECTION REDESIGN PROJECT

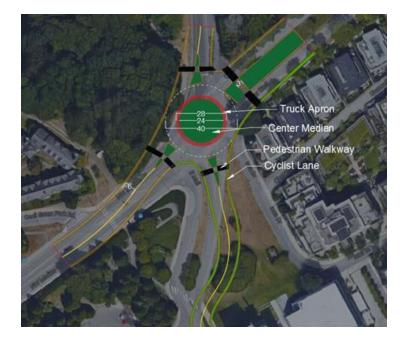
The design is comprised of a 40 meter wide roundabout shifted in the north-east direction compared to the current intersection as seen in Figure 2. A shift is required to reduce the impact on surrounding properties and on the emergency route, as well as limiting vehicle turning radius and entry skew. Due to the initial conditions and drainage requirements, the entire intersection will be sloped at 1.5%.

The raised center island is 24 meters in diameter, with an additional 2 meters on each side acting as a truck apron. Entering lanes are 6 meters wide, and approaching lanes are 6 meters wide. To ensure trucks of a Wb-65 class or smaller have adequate turning space, a truck apron will be included. As per the BC

Supplement to TAC Geometry Design Guide, the truck apron will be 2 meters in width, with a 2% slope down and away from the central island. The interior height of the truck apron is 50 mm.

Figure 2: Roundabout Geometry

Cyclists and pedestrians have designated lanes and crossings; the cyclist lanes are 1.5 meters wide and are connected to the road. Pedestrian crosswalks are 3 meters wide and have a 1.5 meter buffer zone in the middle of the splitter islands, for rest when necessary. The splitter islands are 6 meters long closest to the roundabout, offset by 0.5-1 meter and 15 meters in total length. The existing eastern island will be reduced in length to fit the roundabout and split to allow pedestrian crossing.

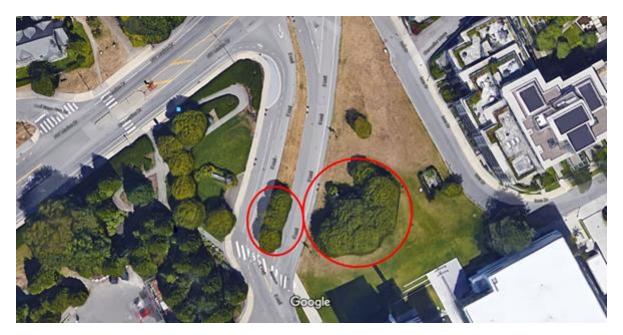
A result of the realignment is the relocation/removal of the trees on East Mall. UBC places high value on every one of it's trees and thus measures have been taken to reduce this impact, as much as possible. Only 6 trees in total will be affected by the realignment, as seen in Figure 3. Preventative measures will be incorporated to avoid total removal of foliage on the East Mall side. The trees highlighted on the left side of Figure 3 are smaller in size and will be relocated onto the viewing platform. The larger cluster of trees highlighted on the right will be removed and replanted in appropriate locations elsewhere on campus.

Figure 3: Trees Affect from Realignment

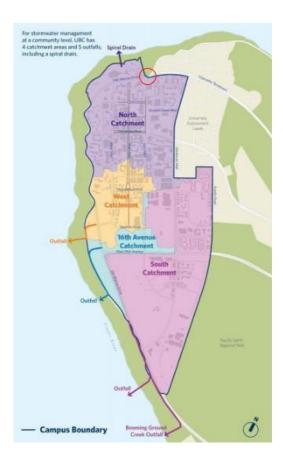
Rather than being one large watershed, the campus sits on four smaller watersheds, each with a different draining location (Stormwater Management Infrastructure at UBC Vancouver, 2013). The project site, as indicated by the red circle in Figure 9, is just over 300m south of the shore cliffs, located on a watershed known as the North catchment. Water from the North catchment travels to a spillway known as the spiral drain which provides approximately 4000m³ of detention, allowing water to slowly drain into the ocean (UBC Integrated Stormwater Management Plan, 2014). The discharge from the spiral drain is limited to 4m³/s which helps to minimize erosion on the cliffs that surround UBC.

Figure 9: Watersheds on the UBC Campus (Stormwater Management Infrastructure at UBC Vancouver, 2013)
