UBC Social Ecological Economic Development Studies (SEEDS) Student Report

Agricultural Road Walkway

Sustainable Sites Initiative - Water

CIVL 202

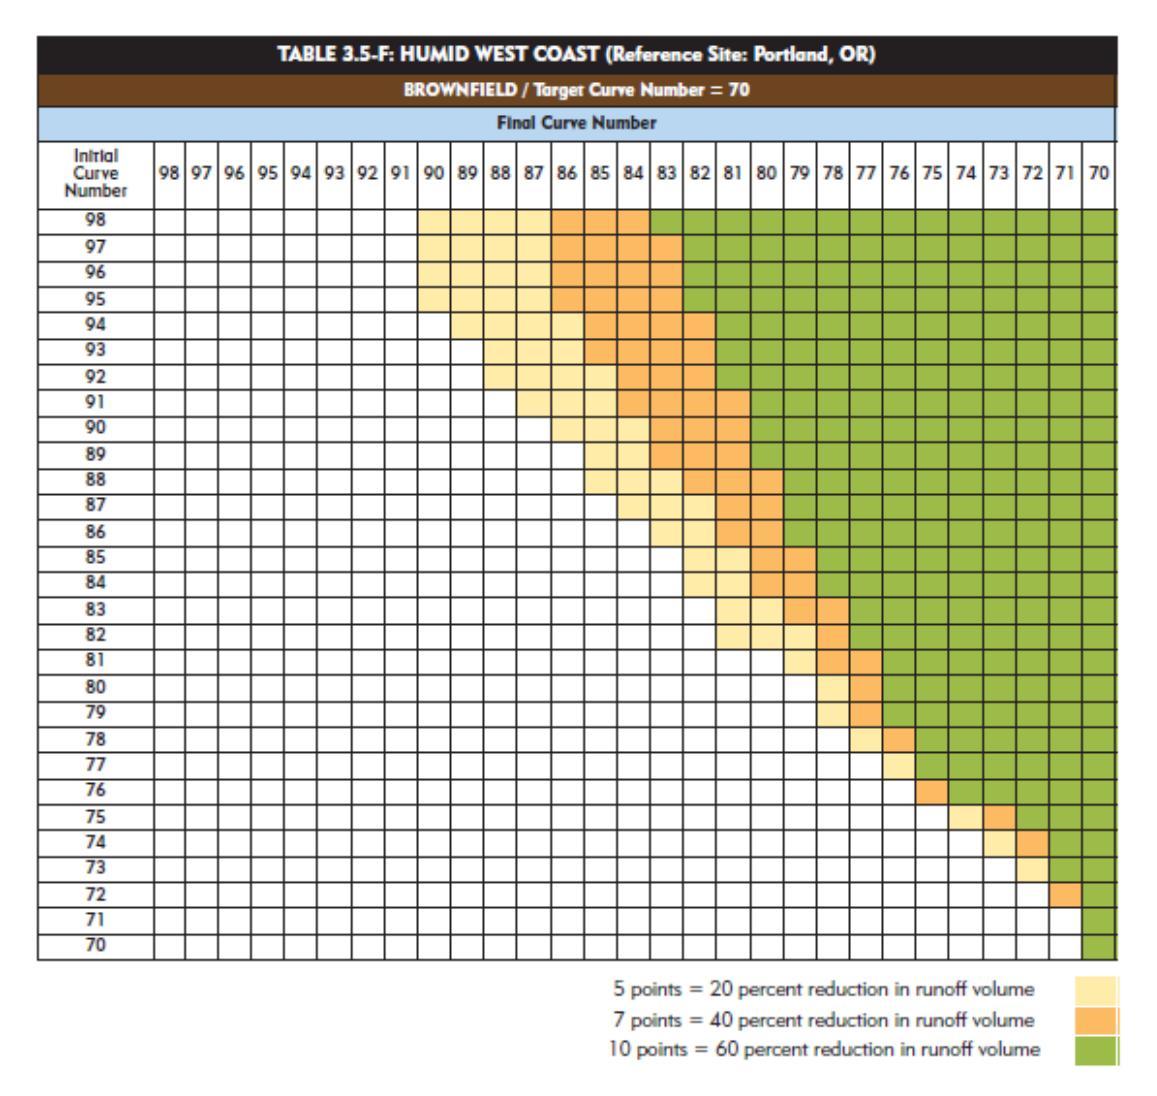
Therefore, by looking at the table below (obtained from Sustainable Sites Handbook 2009), 7 points are earned due to the construction.

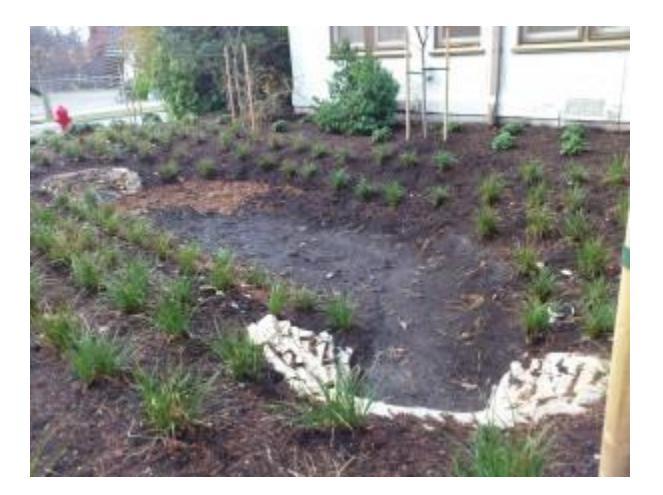
Rain Garden

The only created water feature is a rain garden that is located near the intersection of West Mall and Agricultural Road Walkway. Although this rain garden is not for aesthetic purpose, it can collect non-potable rain water for irrigation.

Since the rain garden is filled by sustainable water sources (non-potable rain water) and requires no make-up water from potable sources, the site receives a full 3 points. In addition, water movement/ circulation are all caused by gravity and no electricity is used. Therefore, an additional point is rewarded, totaling it to 4 points.

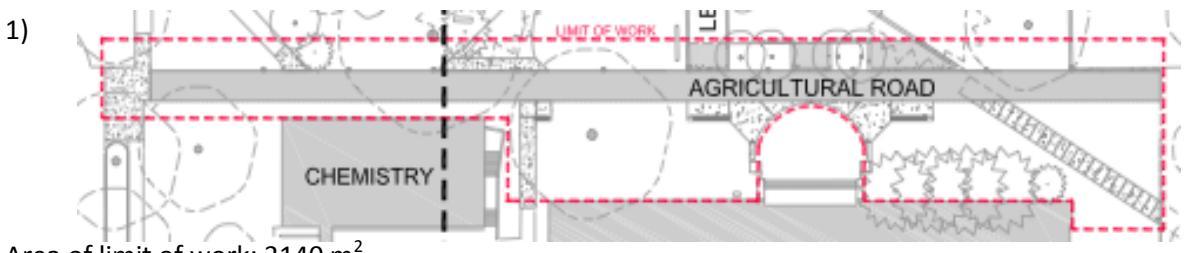
Area of limit of work: 3140 m²

Area of land without irrigation: 1100 m²

Area of turf: 840 m²

Area of trees/shrubs/ground cover: 1200 m²

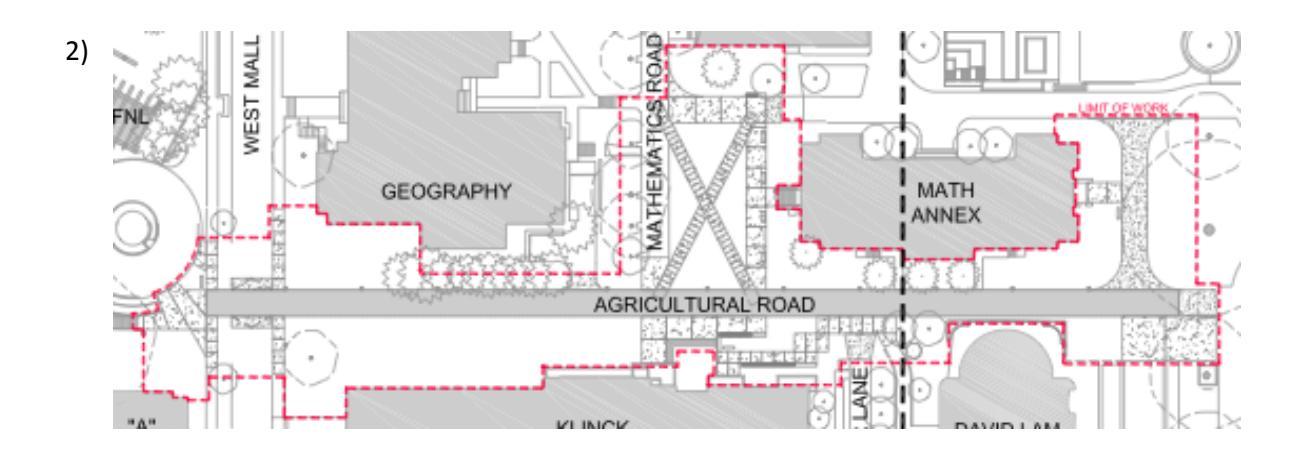
Area of limit of work: 5340 m²

Area of land without irrigation: 2200 m²

Area of turf: 2250 m²

Area of trees/shrubs/ground cover: 890 m²

Total area of limit of work: 8480 m²
