Sustainable Landscapes at UBC: An environmental and social sustainability assessment of UBC Vancouver's stormwater terraces using the SITES v2 Rating System and the UBC community's input

ENVR 400

April 12, 2015

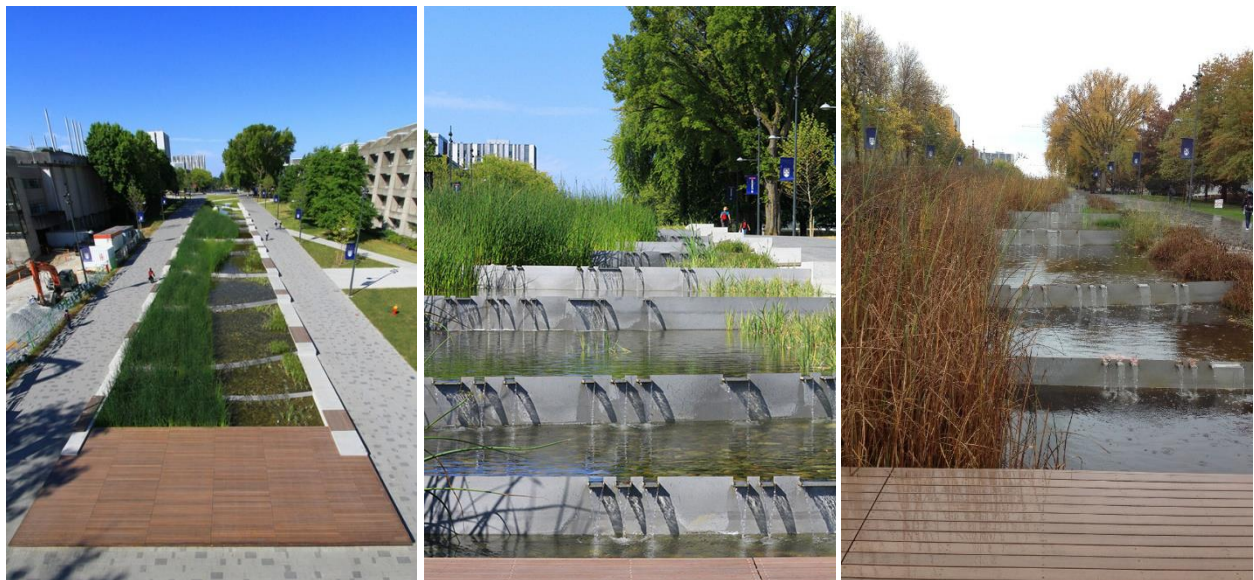
Figure 2. Various photos of UBC Vancouver's stormwater terraces taken by Krista Jahnke in 2013 (left, centre) and our project team in 2014 (right).

The stormwater terraces on University Boulevard (Figure 1 and Figure 2) are one of a few sustainably designed water features at UBC's Vancouver Point Grey Campus. Stormwater is collected from the nearby catchment area (a portion of Main Mall) and fed into the terraces, where it then flows through eight terraced pools from west to east (Main Mall towards East Mall) on University Boulevard. The stormwater is cleaned via biofiltration by the vegetation within the terraces and then subsequently stored in an underground cistern when the terraces

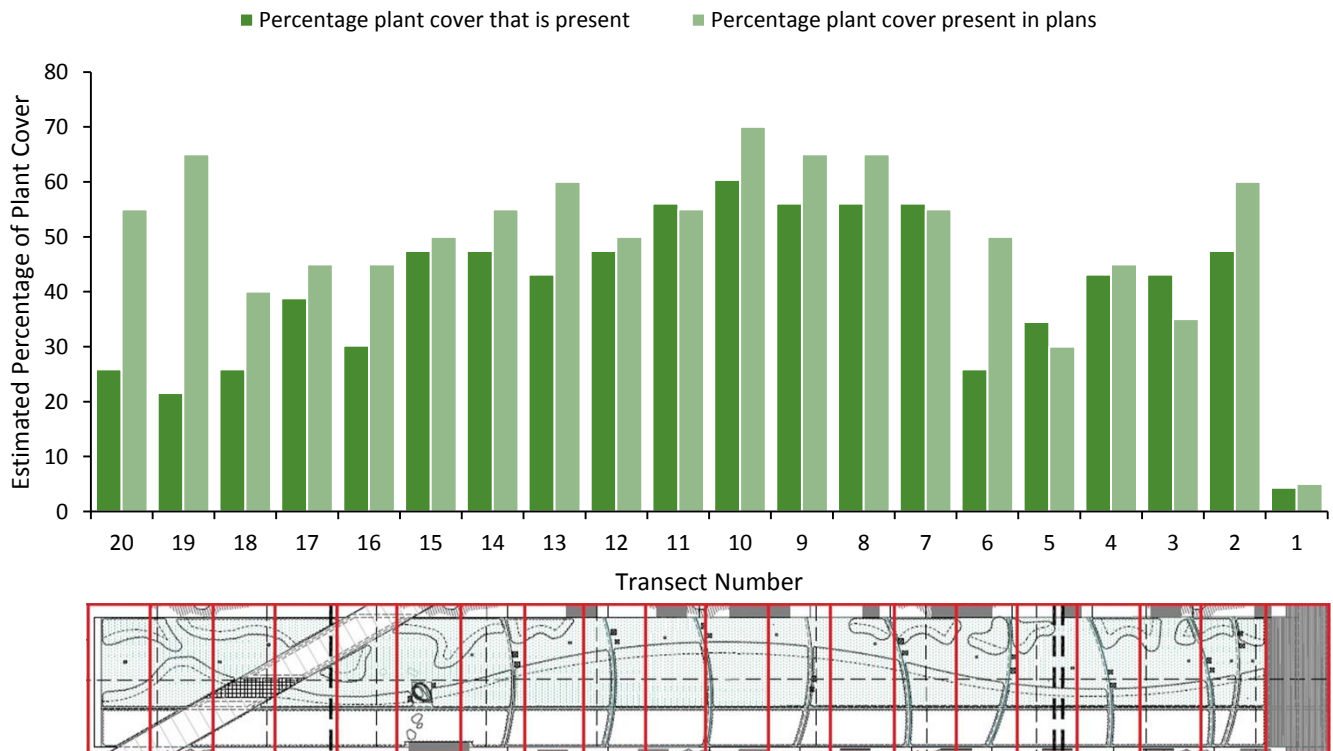
Figure 4. Actual percentage of vegetation cover on site for each transect compared to the planned vegetation cover (from the planting plan) in percentage of each transect. The planting plan (PFS Studio, 2014) scale shown here is 1:687.

Based on our field data, 40.5% of the water feature is covered with wetland plants. Based on our estimates from the planting plan, the plant cover should be 50.0%. Therefore, the actual percent cover is less than what was planned. 16 out of 20 transects have lower plant cover at the actual site than in the planting plan when comparing the actual and planned plant cover in percentage for each transect (Figure 4). Each transect measures 5.64m (east to west) by 13.82m (north to south), giving an area of 77.94m².

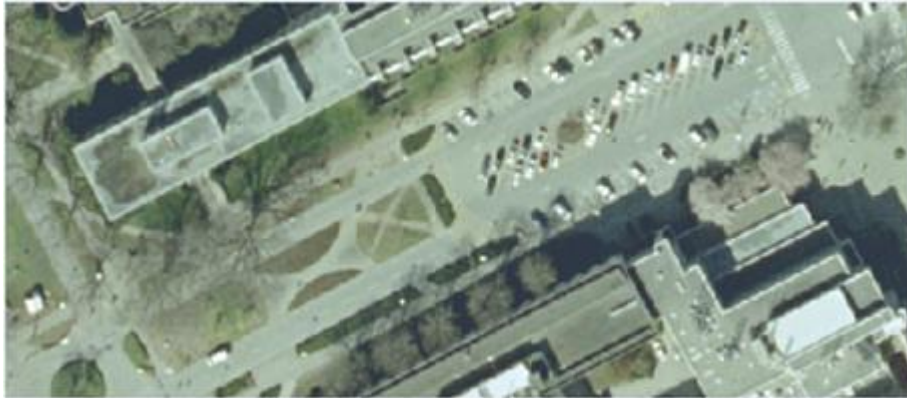
Figure 5. Aerial photo of the site before construction.

SITES requires a comparison of the previous and current site BDI to assign a score for credit 4.8. Due to lack of data for the previous site conditions, we relied on an aerial photo of
