**The Buchanan Building Complex:
Water Consumption**

PLAN 597

The Buchanan Building Complex: Water Consumption

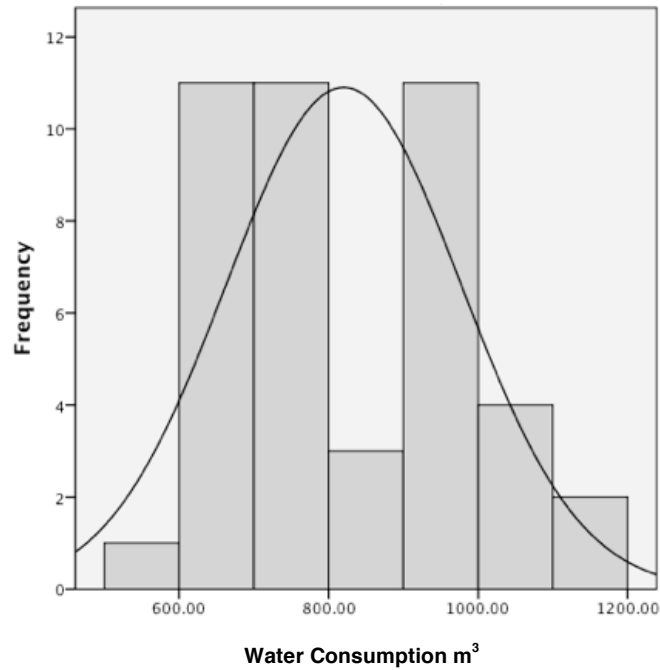
Figure 1: Central Tendency Buchanan A-C

Buchanan A-C is currently consuming less water than Buchanan D-E on average (See Table 1). The data for Buchanan A-C also have a lower standard deviation and variance than those of Buchanan D-E (See Figure 1 & 2) demonstrating more efficient control of water consumption in that portion of the complex.

The water consumption results indicate a lower standard deviation and variance in Buchanan A-C compared to Buchanan D-E. This can be seen to demonstrate a more consistent rate of water consumption in Buchanan A-C. It would be worthwhile to explore what water conservation measures are in place in each portion of the complex, and how to ensure that similar practices are in place throughout the buildings to better control for this variance.

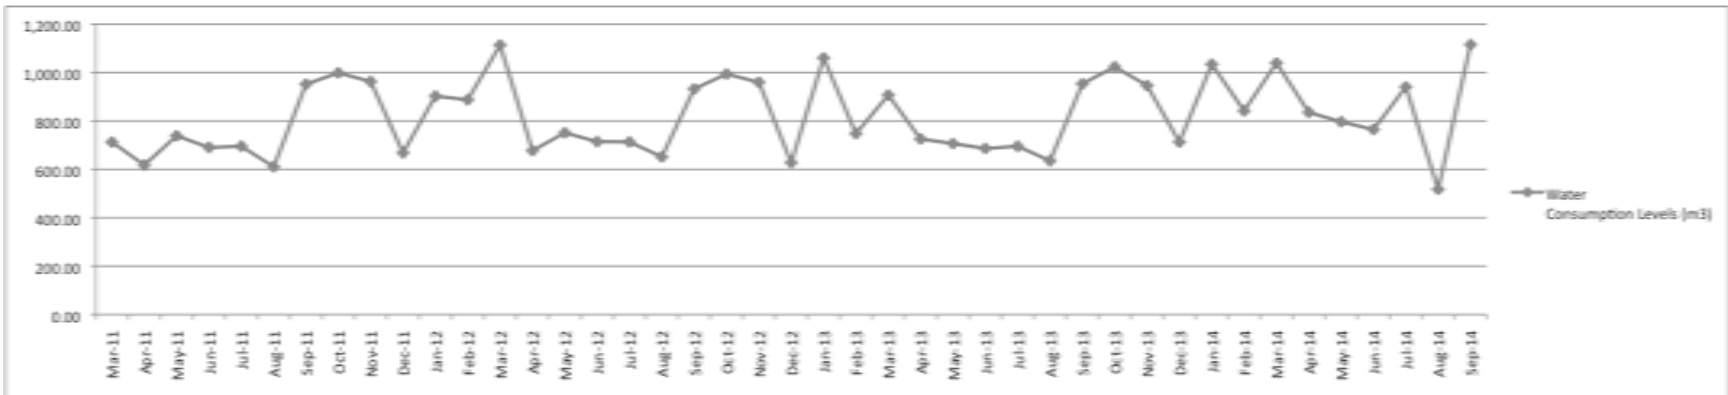
Figure 1: Water Consumption in Buchanan A-C over time

Buchanan A-C follows a consistent cycle of reduced water consumption during the summer months of May to August, and the month of December. This is presumably a result of the decrease in student activity in the complex during those times. However, Buchanan D-E does not follow a similar or consistent pattern of high and low water usage.

Monthly consumption rates indicate that water usage in the Buchanan complex is largely dependent on student use of the facilities. This means that water conservation efforts need to target students, particularly at peak use times when term is in session.

The implementation of these types of programs may prove to be necessary, as water consumption rates appear to be heading into their highest overall trend since water data first began to be gathered post-renovation. The consumption rate has been higher in almost every month in 2014 compared to those in previous years (See Figures 1 & 2). It will be important to monitor this trend to determine what might be causing this increase in water consumption patterns in the facilities, and to seek solutions to mitigate the issue.
